**Officer:** John Gribben (JEG)  
**Route:** BU-Cond Surv Princess Park (BU29)  
**Report Type:** Assessment

**Site:** Princess Park (Shepparton) (F0062)

**Date:** 13/10/2017

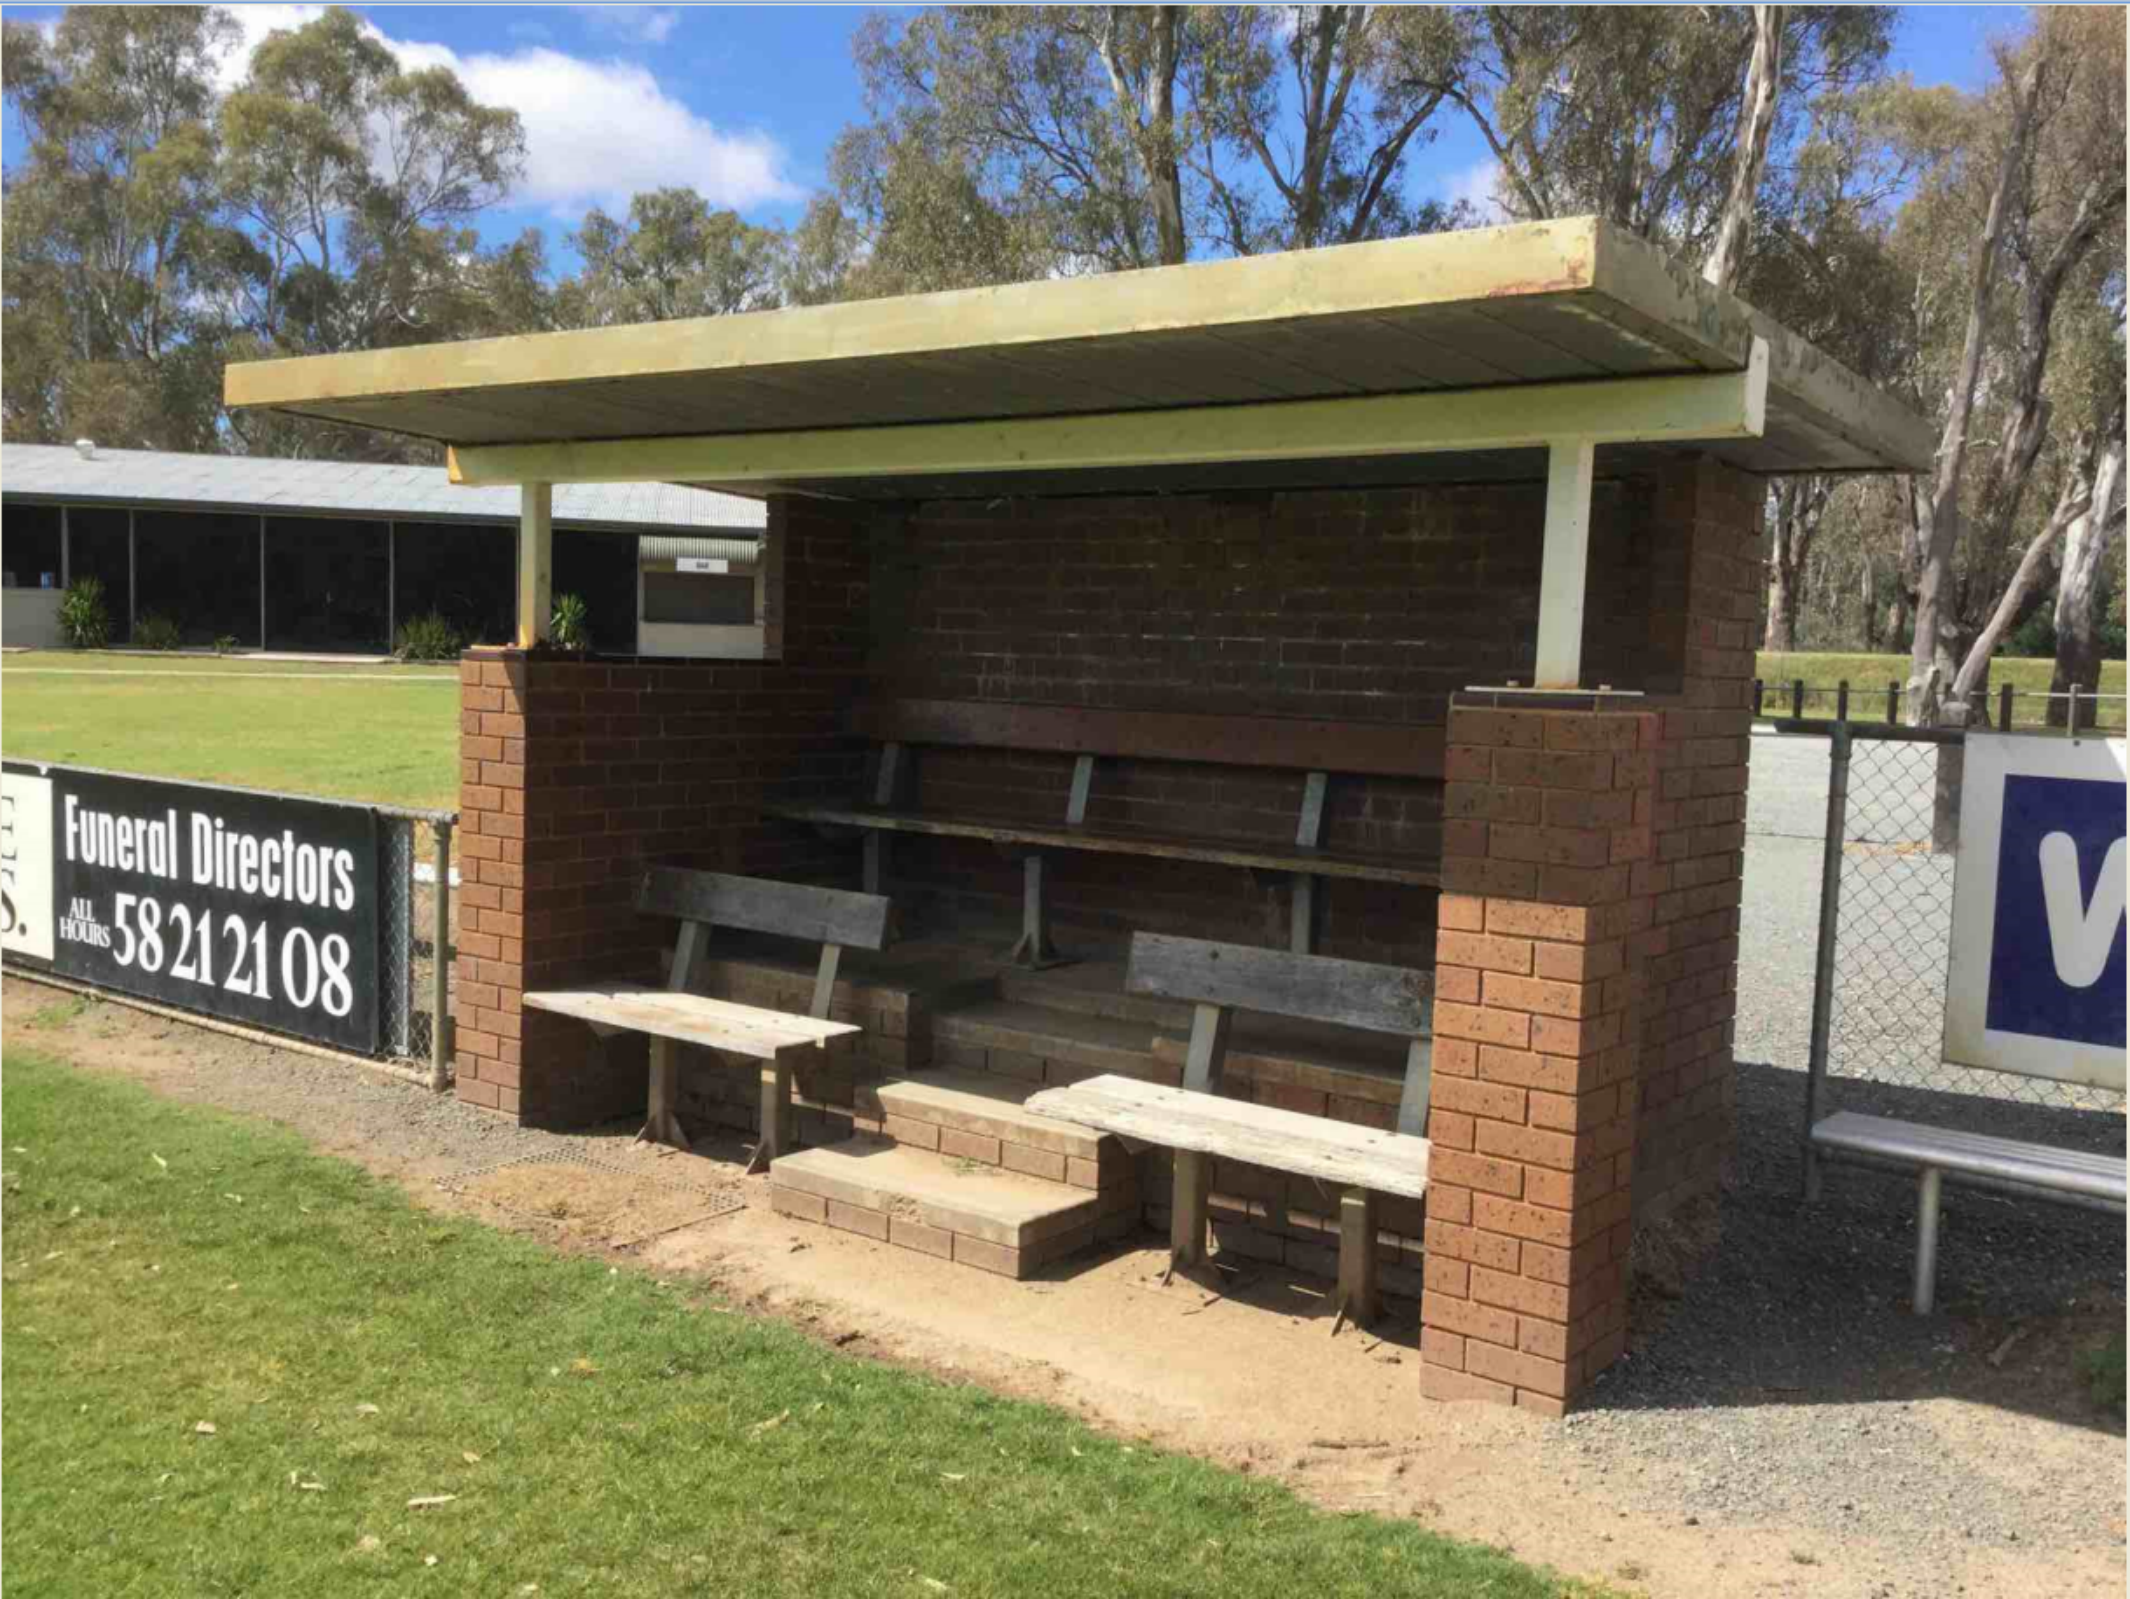
**Asset Id - Location:** B1221 - Princess Park Coaches Box Southern End Eastern Side

Observation Type	Code	Grade	Score	Notes
BU-Building Overall Condition	BUOC	Moderate	5.0000	Building is generally in good condition, but some structural steel posts need to be painted to prevent further rusting.
BU-Ceiling Condition	BUCE	Excellent	.0000	N/A ((Galvanised ironj)
BU-Fitout Condition	BUFI	Good	4.0000	Fixed galvanised and timber seating.
BU-Floor Condition	BUFC	Good	3.0000	Concrete.
BU-Internal Wall Condition	BUIC	Excellent	.0000	N/A
BU-Mechanical Condition	BUMC	Excellent	.0000	N/A
BU-Roof Cladding Condition	BURC	Good	3.0000	Concrete roof in good condition.
BU-Roof Structure Condition	BURT	Moderate	6.0000	Iron posts are starting to rust.
BU-Wall Condition	BUWC	Excellent	2.0000	Brick walls in very good condition.

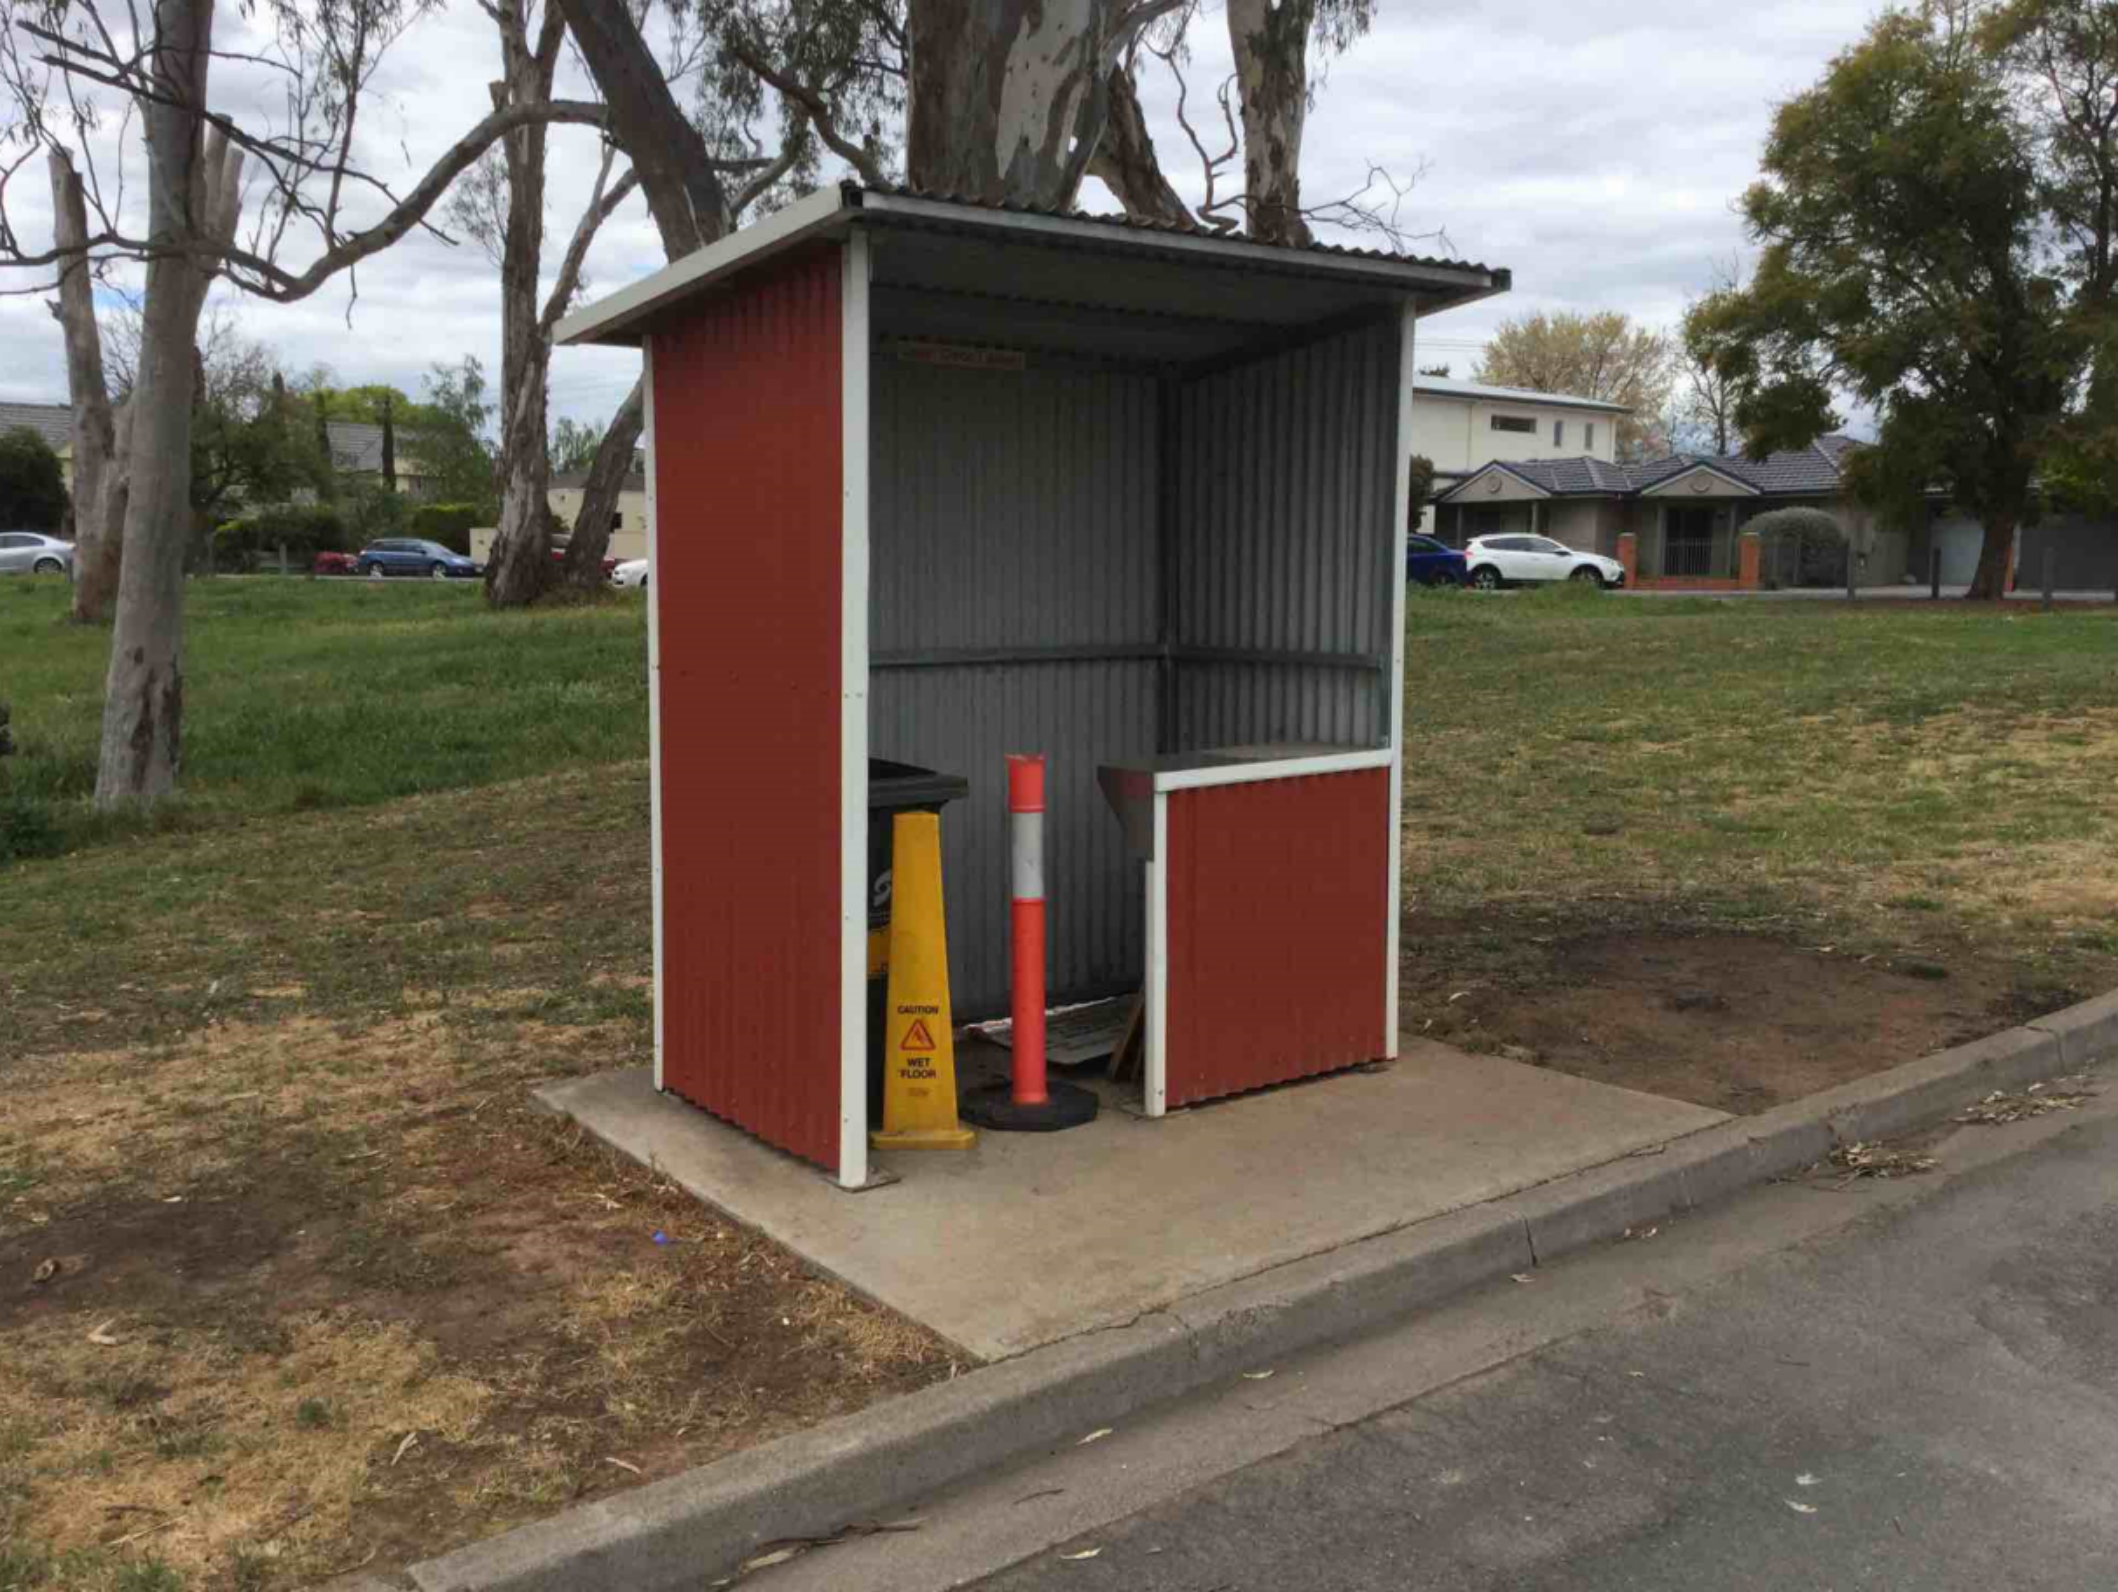
**Asset Id - Location:** B1225 - Princess Park Ticket Box Quinan Parade Entry

Observation Type	Code	Grade	Score	Notes
BU-Building Overall Condition	BUOC	Good	3.0000	Small building in very good condition.
BU-Ceiling Condition	BUCE	Excellent	.0000	N/A (iron roof)
BU-Fitout Condition	BUFI	Excellent	2.0000	Stainless steel bench in very good condition.
BU-Floor Condition	BUFC	Good	3.0000	Concrete floor in very good condition.
BU-Internal Wall Condition	BUIC	Excellent	.0000	N/A
BU-Mechanical Condition	BUMC	Excellent	.0000	N/A
BU-Roof Cladding Condition	BURC	Good	3.0000	Colorbond roof in very good condition.
BU-Roof Structure Condition	BURT	Good	3.0000	Steel structure in very good condition.
BU-Wall Condition	BUWC	Good	3.0000	Colorbond walls in ver good condition.

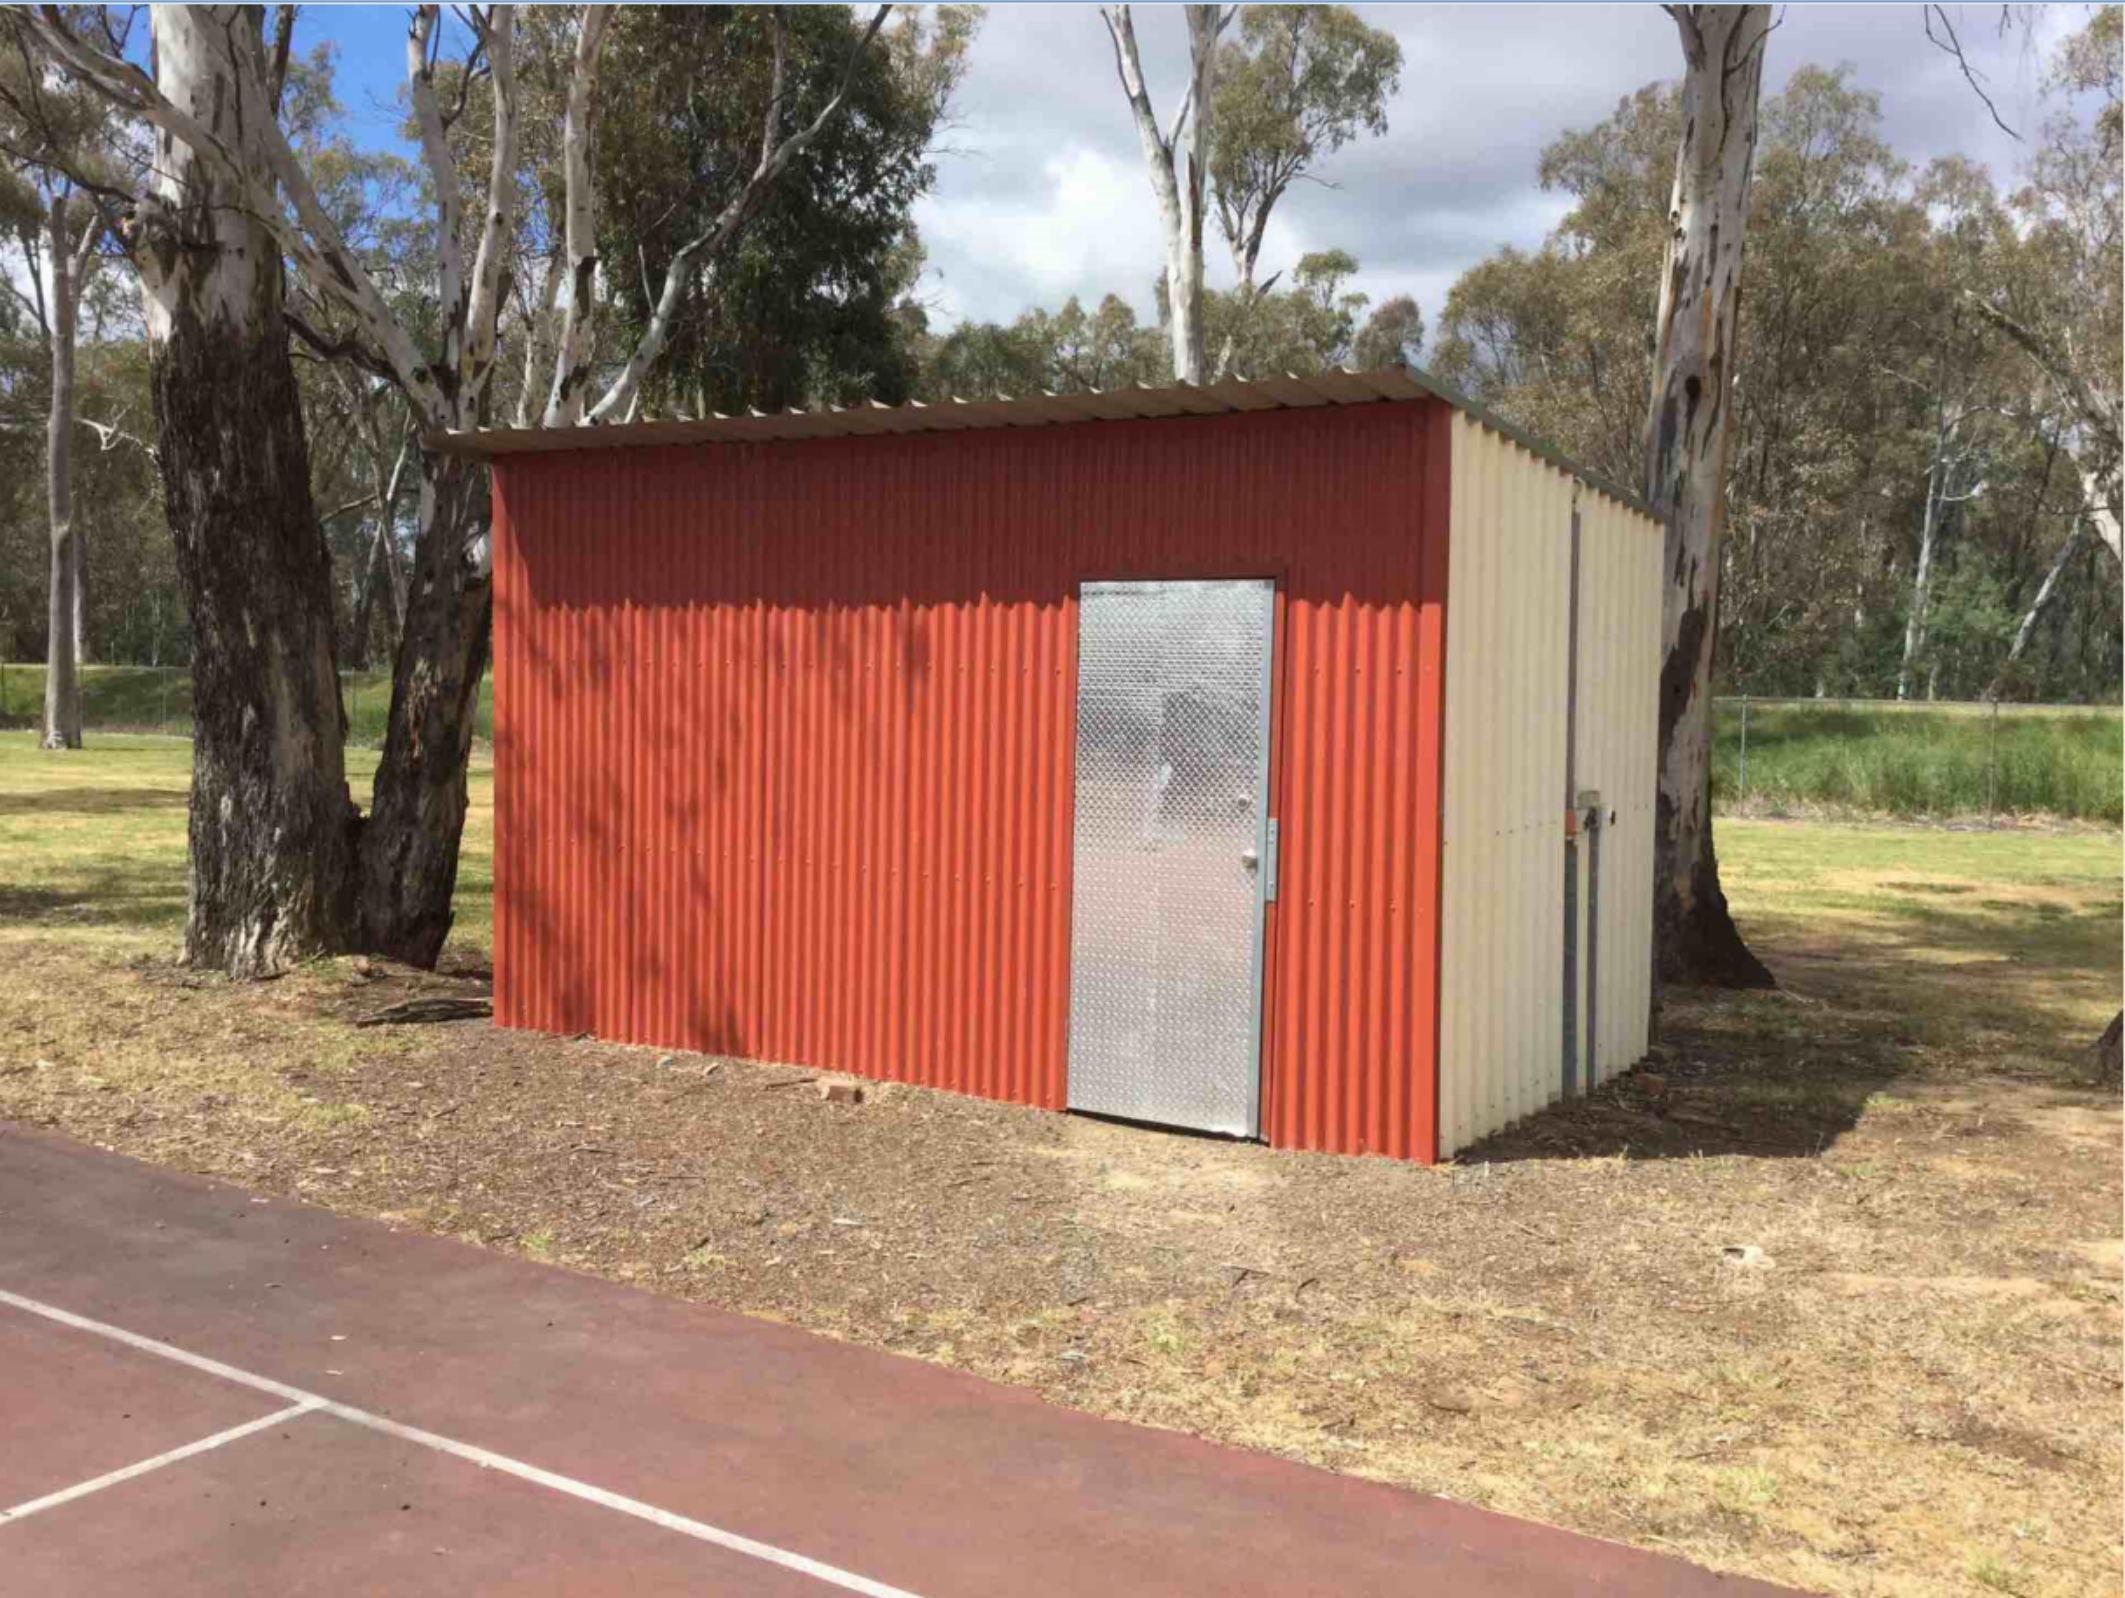
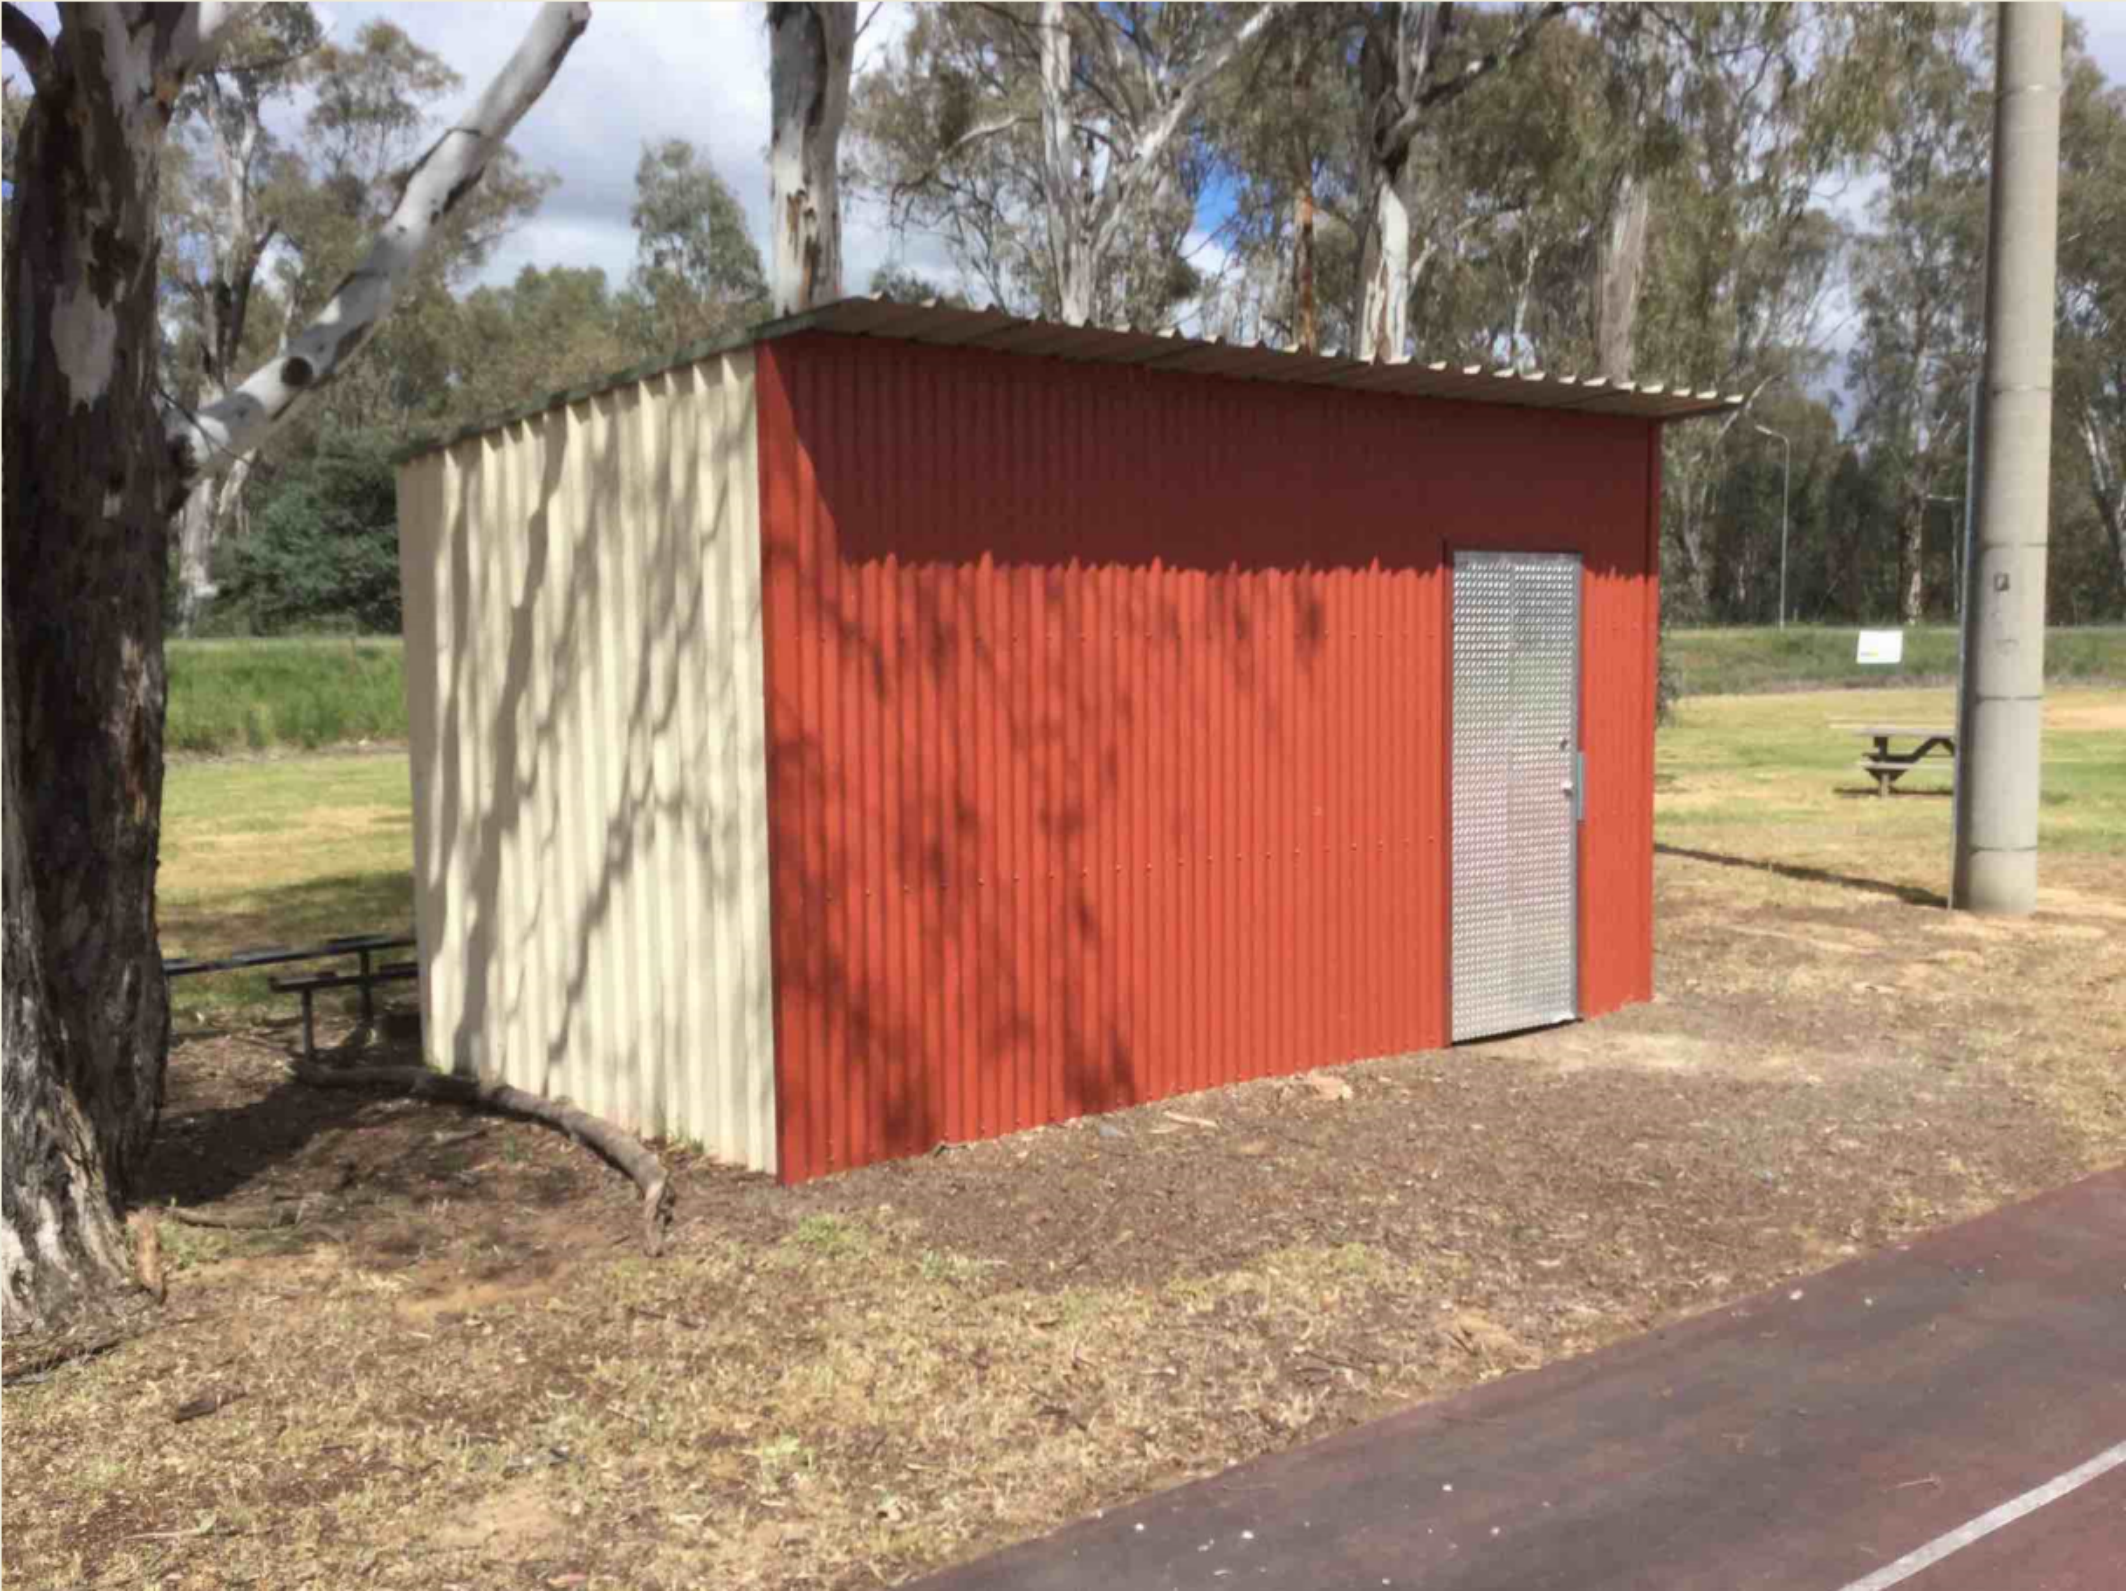
**Asset Id - Location:** B0493 - Princess Park Shed (Eastern Netball Court)Maude Street

Observation Type	Code	Grade	Score	Notes
BU-Building Overall Condition	BUOC	Moderate	5.0000	Shed appears to be in good condition.
BU-Ceiling Condition	BUCE	Excellent	.0000	N/A
BU-Fitout Condition	BUFI	Excellent	.0000	N/A
BU-Floor Condition	BUFC	Good	3.0000	Concrete floor.
BU-Internal Wall Condition	BUIC	Excellent	.0000	N/A
BU-Mechanical Condition	BUMC	Excellent	.0000	N/A
BU-Roof Cladding Condition	BURC	Moderate	5.0000	Iron roof with no roof gutter.
BU-Roof Structure Condition	BURT	Good	4.0000	Appears to be a solid steel structure.
BU-Wall Condition	BUWC	Moderate	5.0000	Colorbond walls are good, but some of the iron installation hasn't been finished off properly.
