| Agenda Item 8.3 | Cussen Park Environmental Management Plan | |

Cussen Park

Environmental Management Plan 2016

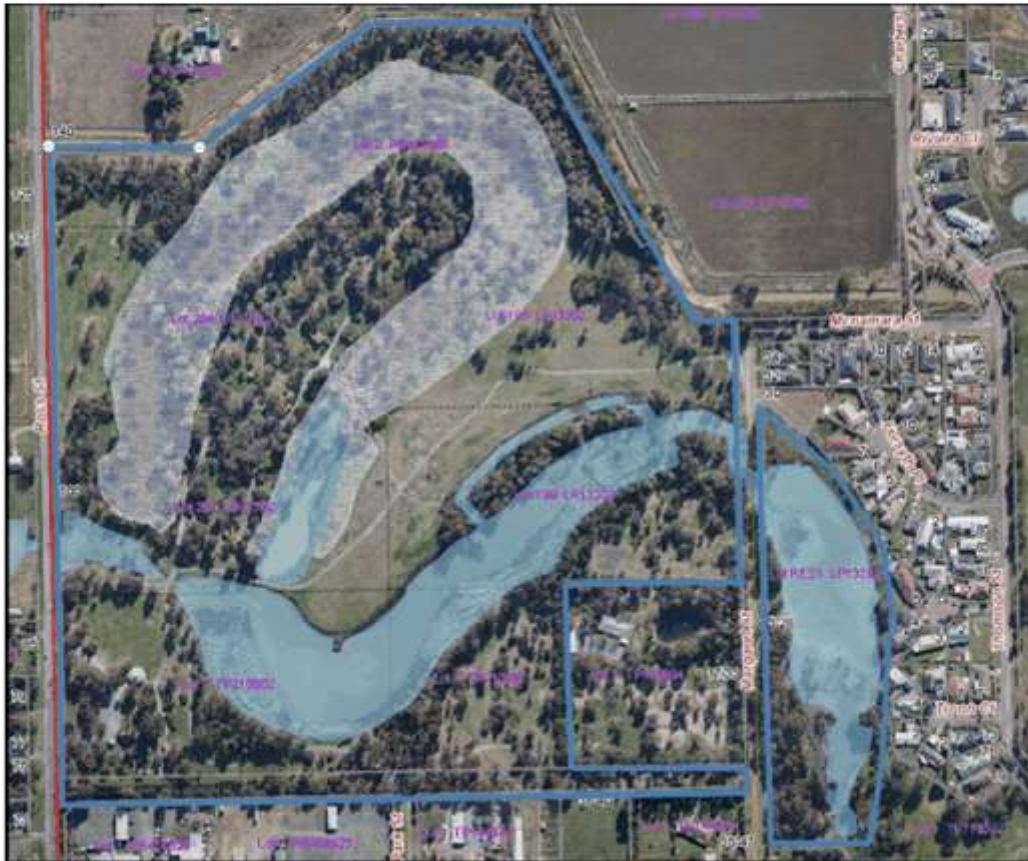
Figure 1. Aerial view of Cussen Park.

Cussen Park is an Australian bushland-style park encompassing 33 ha of wetlands, woodlands and open space on the northern outskirts of the town of Tatura in northern Victoria (Figure 1). The land that forms the Park is owned by the Greater Shepparton City Council (Council), and is surrounded by freehold industrial, residential and irrigated farm land.

| Comment From | How often do you use Cussen Park? | What is the main reason you use Cussen Park? | Comment Number | Comment | How the feedback was considered |
|---|---|---|---|---|--|
| | | | 46 | 8.1 Consideration should be given to appropriate buffer zone, which should be in the area designated as Elizabeth Street. The cycling and walking path referred to in the document is not where Elizabeth Street would be. The aerial view Fig 1 and Fig 2 show Elizabeth street as included in Cussen Park. The boundary should be to the east west boundary continuation of the private property and not include the land designated for Elizabeth Street. | Noted |
