ENVIRONMENTAL SITE ASSESSMENT

**335 RUTHERFORD ROAD
TOOLAMBA VICTORIA**

Herdstown Pty Ltd

Report No.: AL10-093-1B

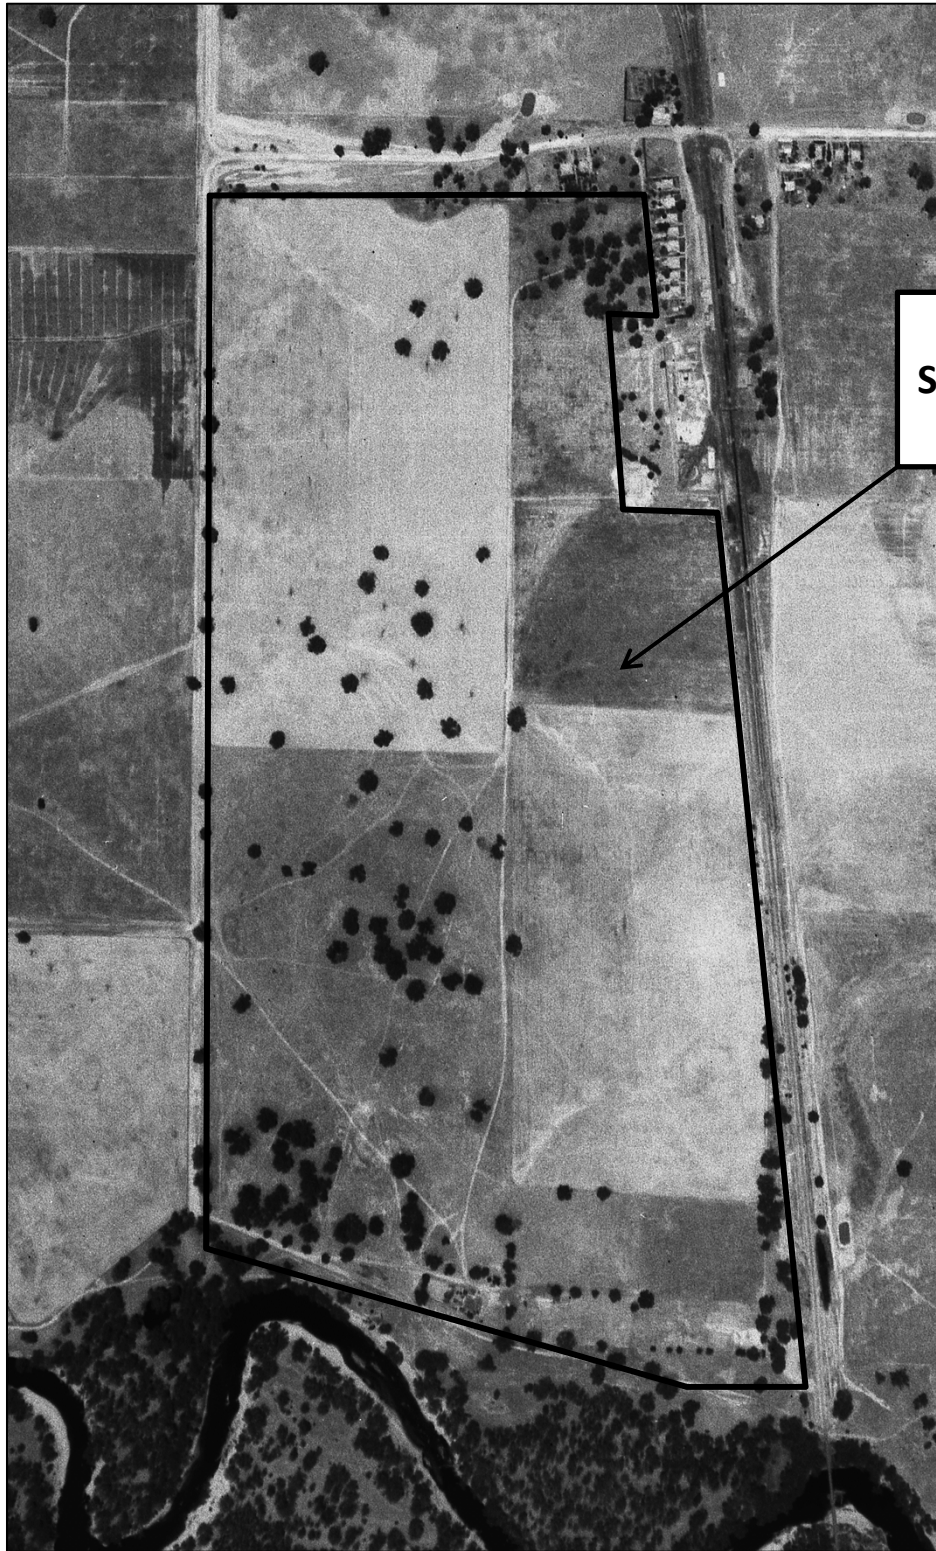
**Figure 4: HISTORIC AERIAL PHOTOGRAPH - 1949
335 Rutherford Road, Toolamba VIC**

Date of Photograph	Subject Site Observations	Surrounding Site Observations
1949	<p>No significant development is noted on this photograph apart from adjacent to the southern property boundary where a residential type dwelling is apparent.</p> <p>Some poorly formed access tracks are present across the broader area of the site – some of these may be associated with grazing stock movement.</p> <p>Some mature to semi-mature trees are evident across the western and north-eastern portion of the site.</p>	<p>The lands directly to the north and north-east of the site are noted to be partially developed with residential-type dwellings associated with the township of Toolamba.</p> <p>A rail line adjacent to the eastern property boundary is present and an area of soil disturbance is present to the west of the rail line near the northeast boundary of the site. This area is considered to be associated with the railway line and may have been used for the storage of rail equipment.</p> <p>Rural lands are noted to the west of the site and forested lands associated with the Goulburn River and floodplain are present to the south of the site.</p>

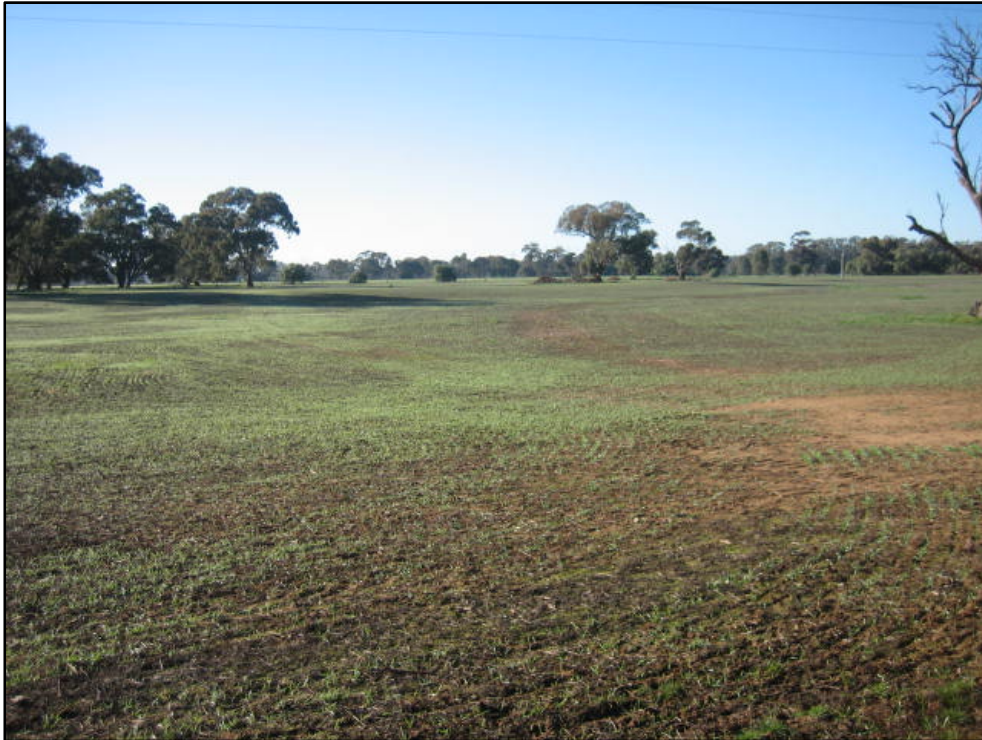
Plate 1: View of the subject site looking from the west toward the east and south. Evidence of germination of a recently seeded fodder crop was noted. Mature paddock trees were also noted at various locations across the site.

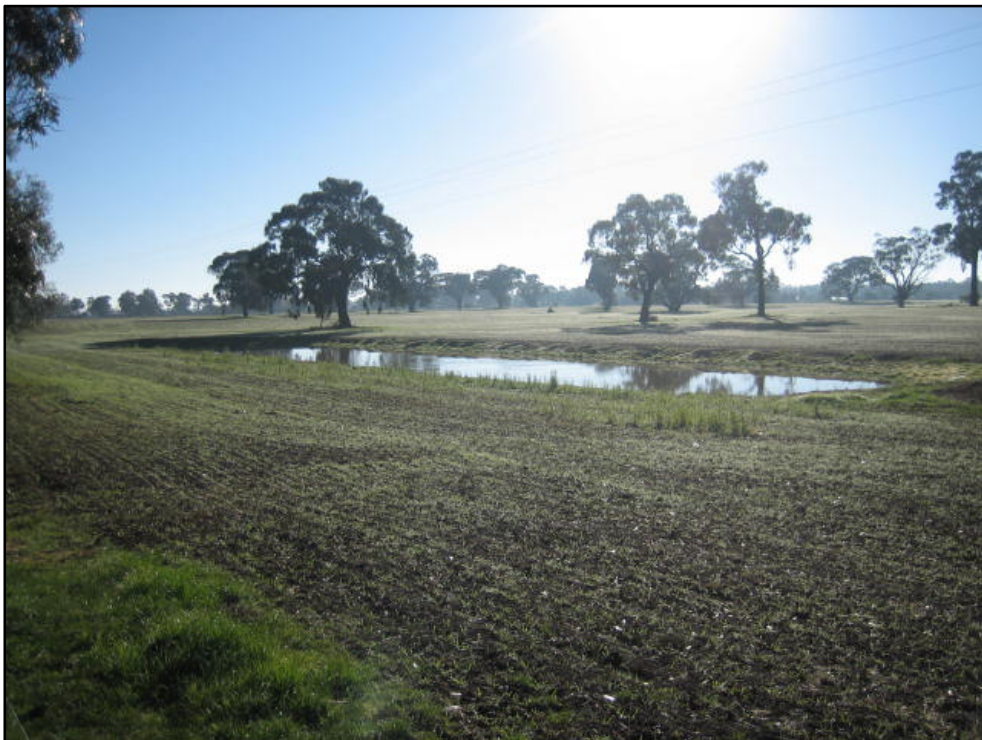
Plate 2: View of the subject site looking toward the north-east. One of the three farm dams present on the site is visible on the central portion of this photo.

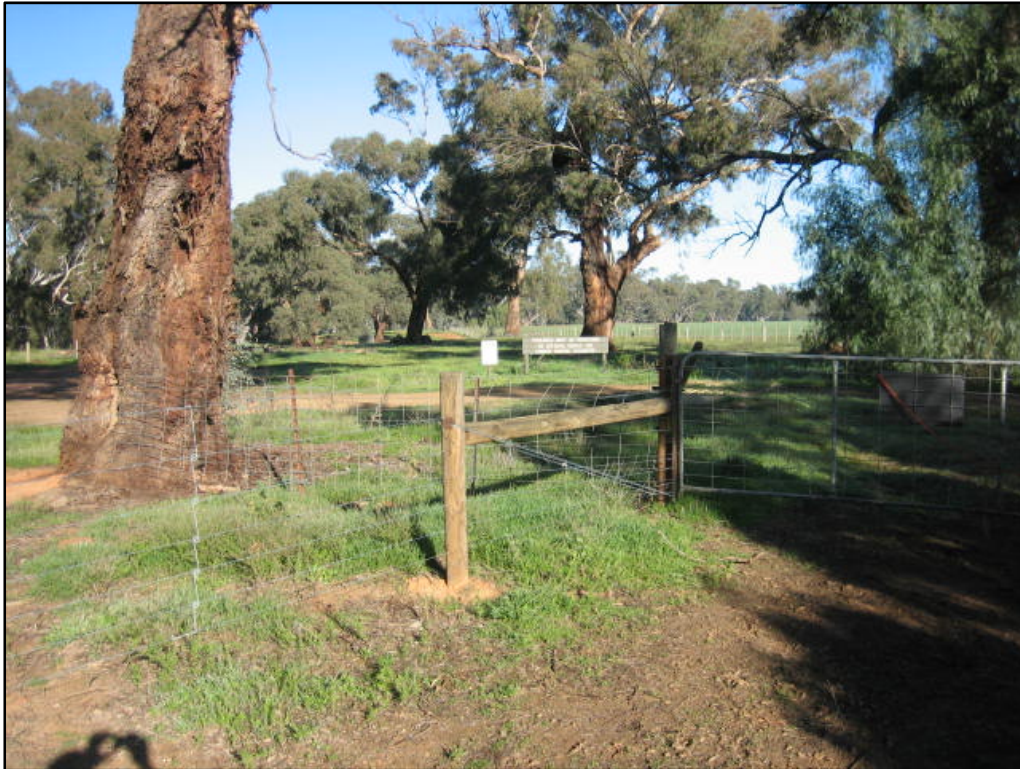
Plate 3: View of the southern portion of the site looking toward the Goulburn River and associated reserve areas.

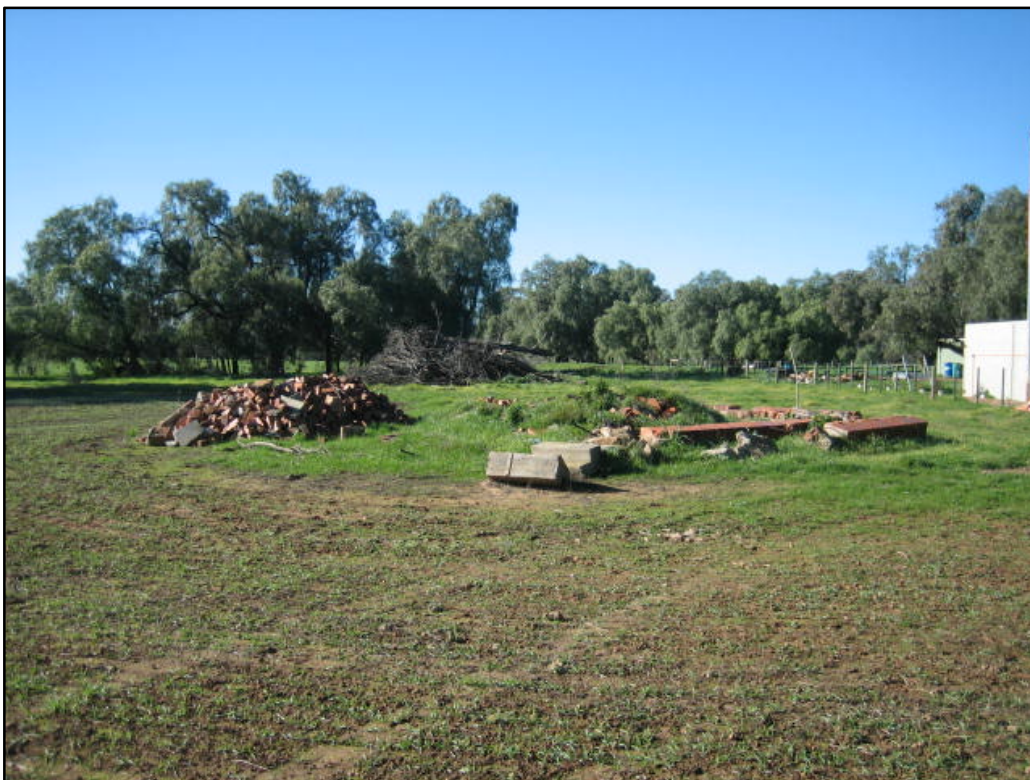
- The dwelling on the southern portion of the site was constructed of brick and timber with an associated corrugated iron shed and site fencing.
- A small stockpile (approximately 15m³) of demolition waste, including bricks, timber and concrete rubble was noted to the north of the dwelling. Some evidence of burning/incineration was also noted at this location.

Plate 4: View of a stockpile of demolition waste observed on the southern portion of the site. Some evidence of burning of materials was also noted at this location. The structure on the right of the photo is a shed associated with the on-site dwelling.

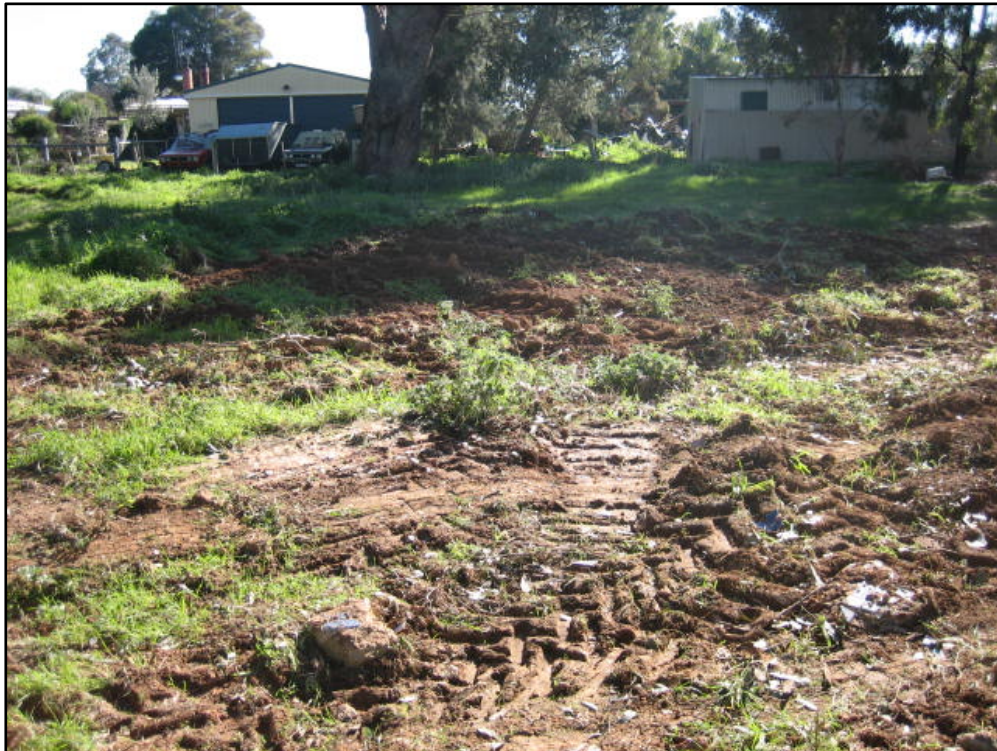
- Some trace amounts of debris associated with the storage of old vehicles and possibly some demolition waste were noted to be present on the north-east portion of the site. This debris included metal automotive parts, wire, brick and some ceramic tile fragments. Some evidence of ground disturbance was noted at this location – this disturbance was considered to be associated with the removal of the stored vehicles which reportedly occurred in early 2010.

Area on the north-east portion of the site where old vehicles were stored and some soil disturbance was noted	Leakages/spills of fuels and lubricants associated with storage of old vehicles	Hydrocarbon based fuels/oils and solvents, heavy metals

Plate 5: View of the north-east portion of the site in an area where soil disturbance was observed and old vehicles were reportedly stored. These vehicles were removed from the site during early 2010.

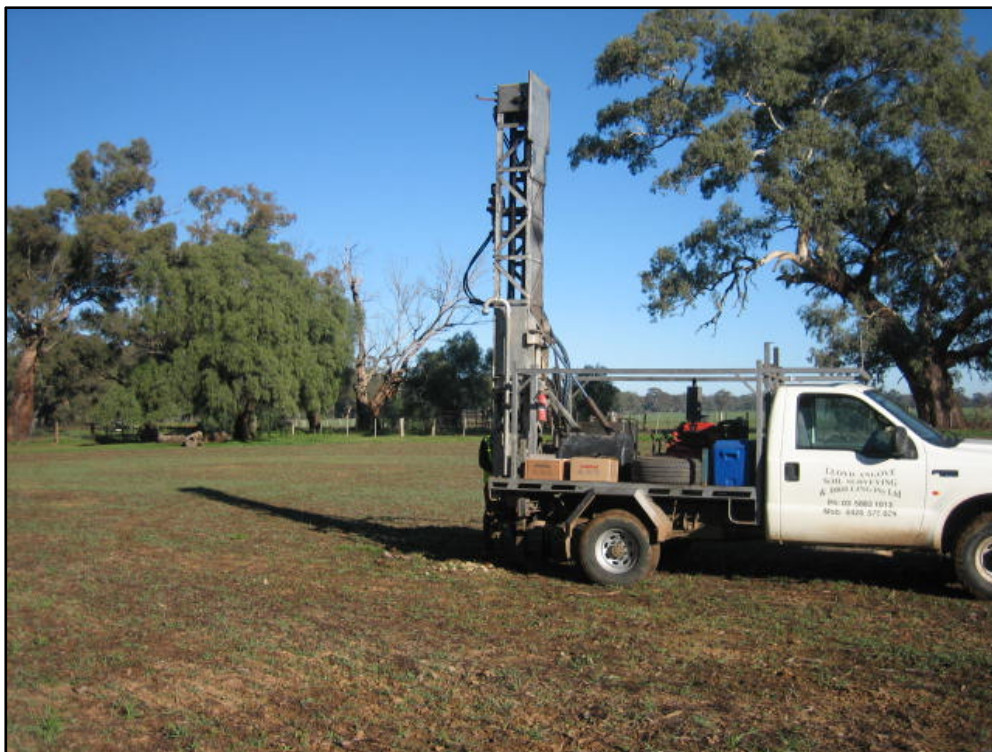
Plate 6: View of drilling works in progress on the southern portion of the subject site. Drilling was completed with a rotary auger drill rig operated by Llyod Angove Soil Surveying & Drilling.
