**Officer:** John Gribben (JEG)  
**Route:** BU-Cond Surv Princess Park (BU29)  
**Report Type:** Assessment

**Site:** Princess Park (Shepparton) (F0062)

**Date:** 13/10/2017

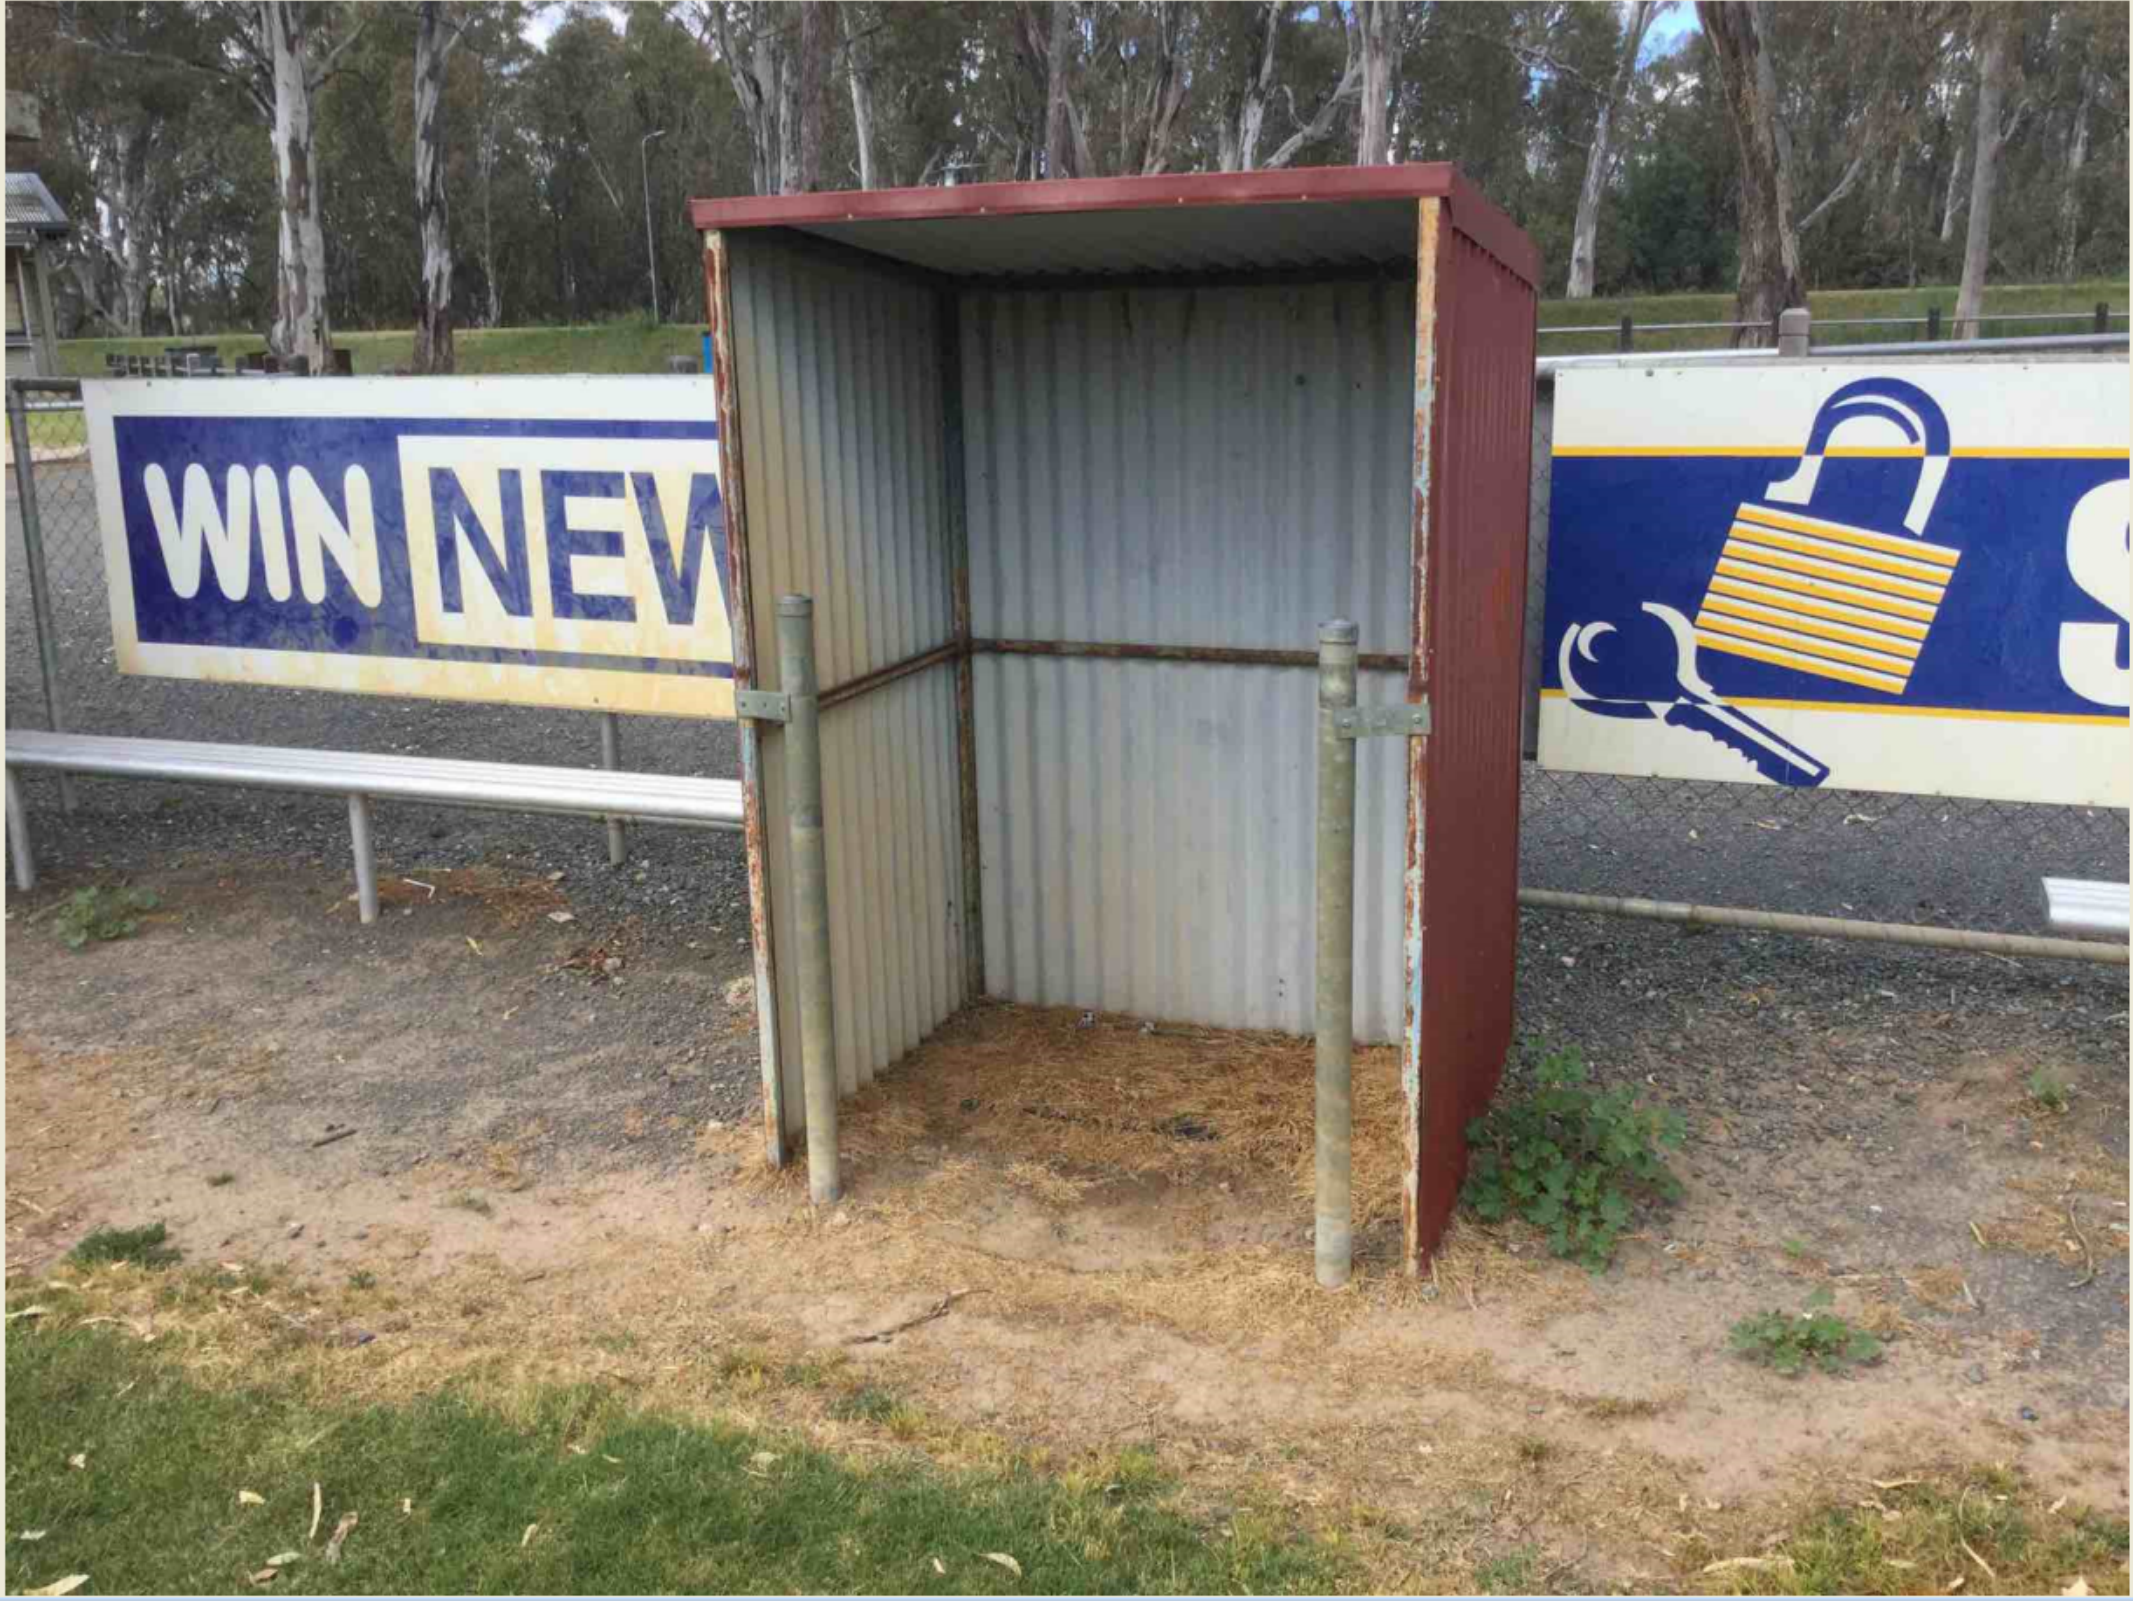
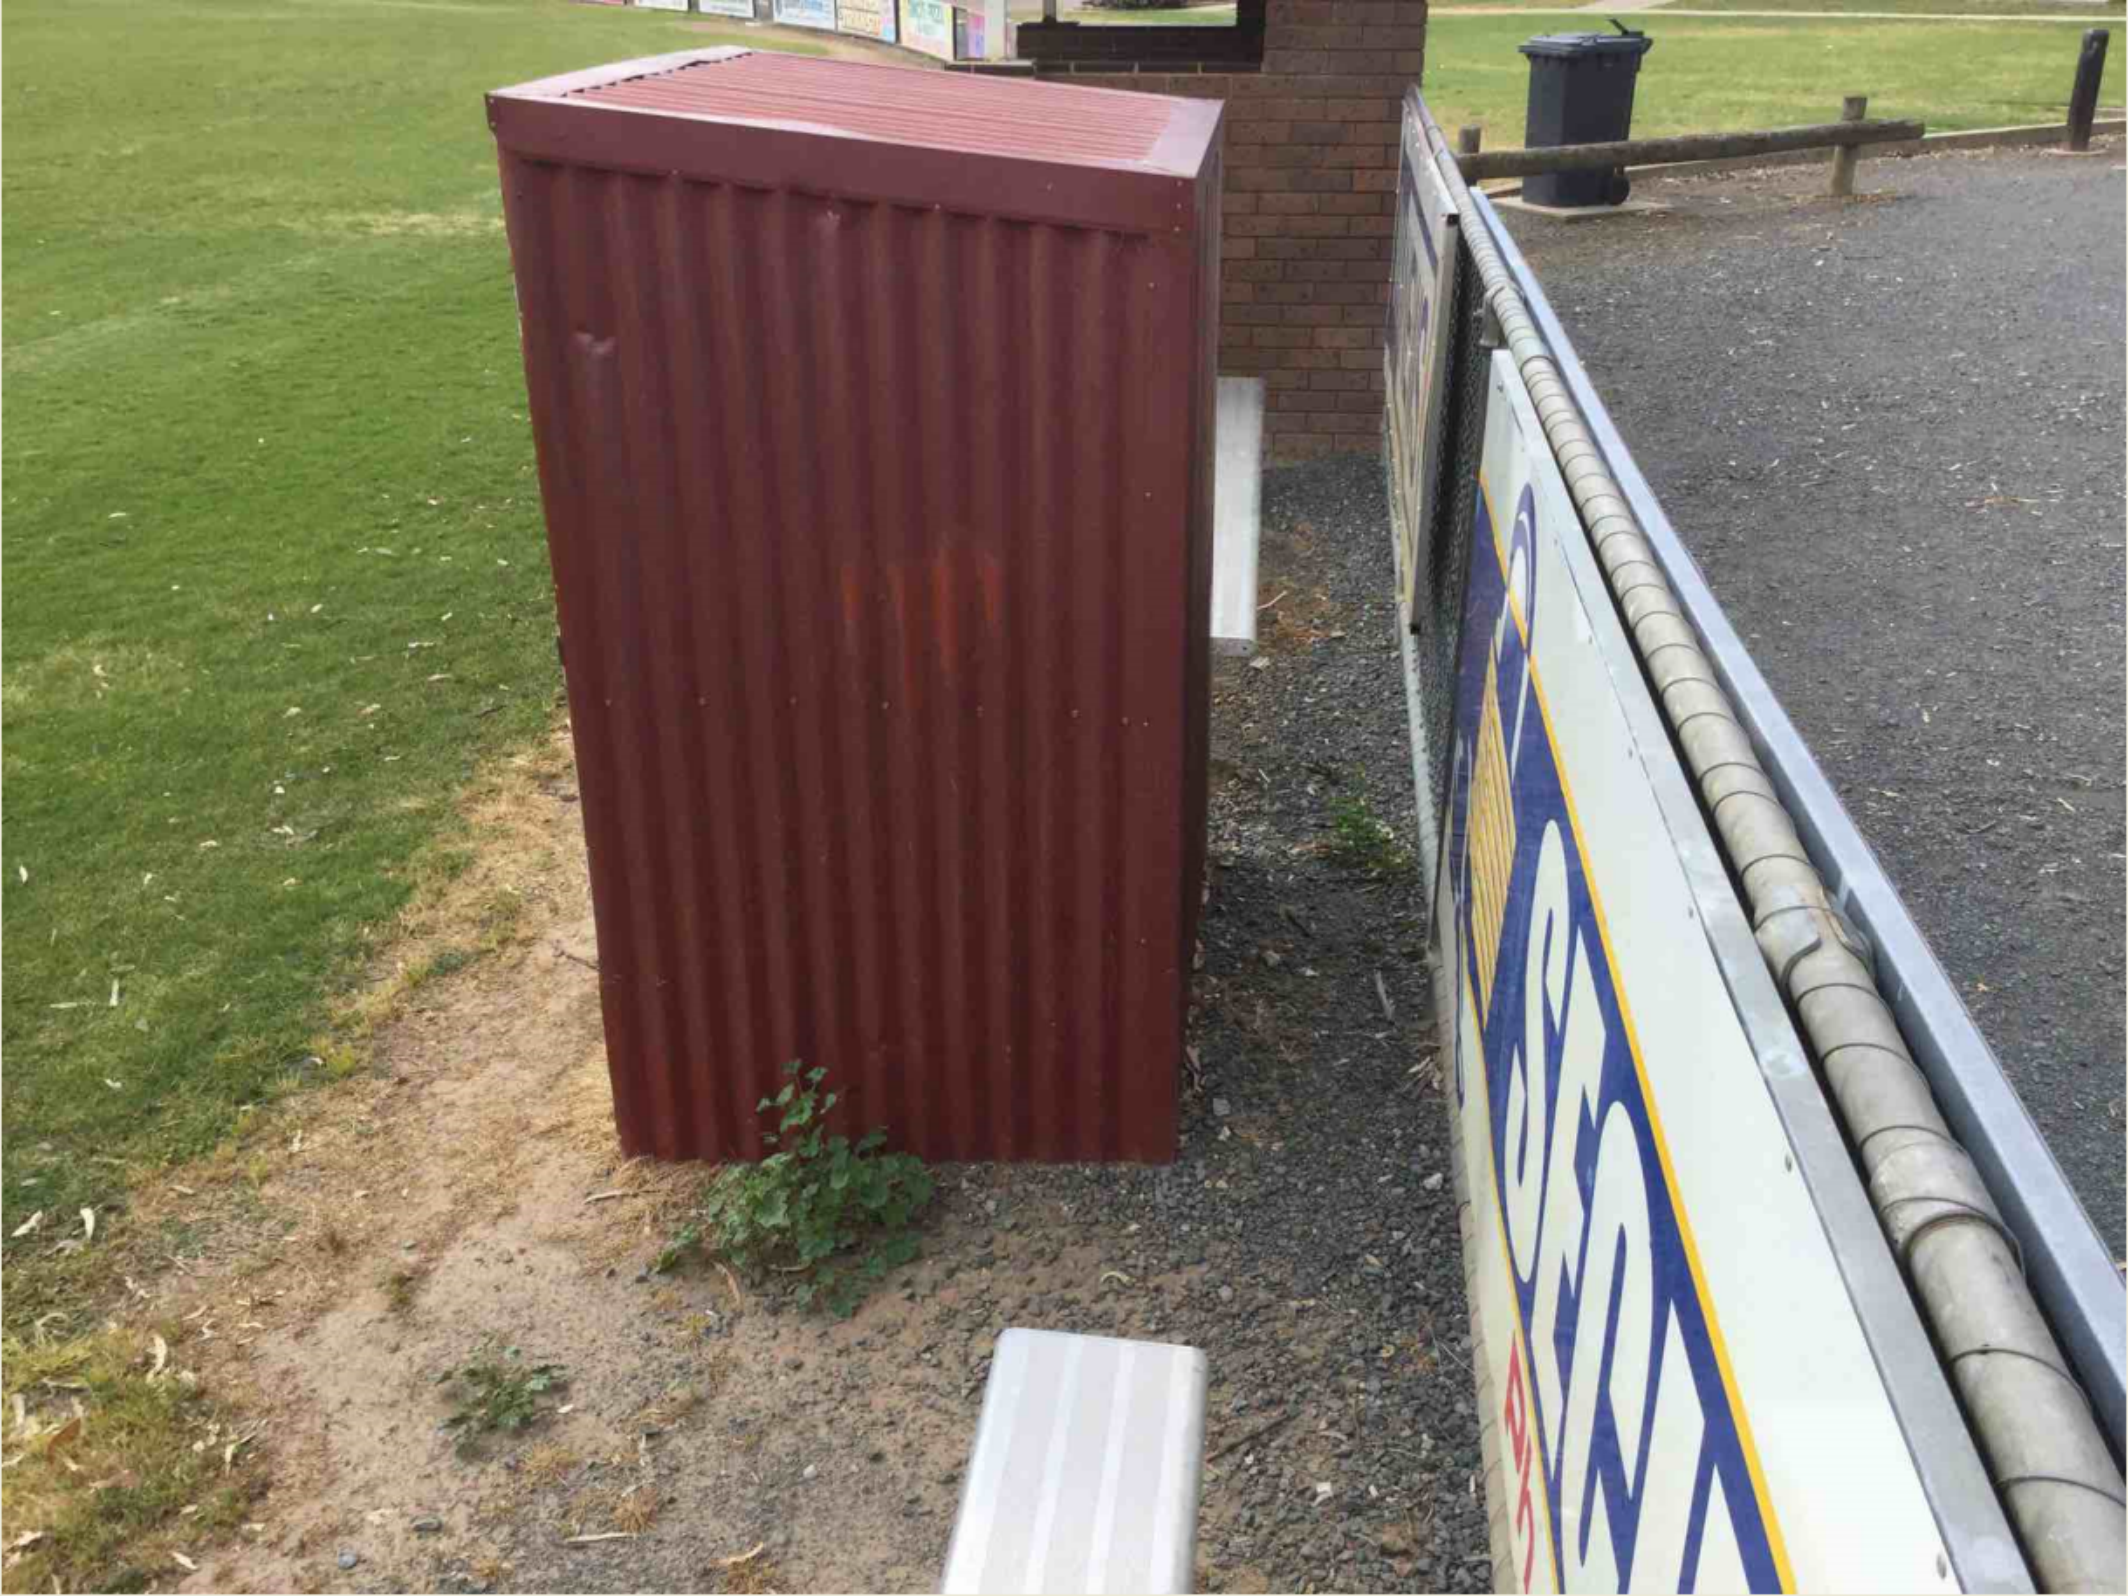
Observation Type	Code	Grade	Score	Notes
BU-Building Overall Condition	BUOC	Good	4.0000	Building is in good condition. And, while small and not very appealing, it is adequately meeting the needs for which it was built.
BU-Ceiling Condition	BUCE	Good	4.0000	Colorbond in good condition.
BU-Fitout Condition	BUFI	Excellent	.0000	N/A
BU-Floor Condition	BUFC	Excellent	.0000	N/A (Dirt)
BU-Internal Wall Condition	BUIC	Excellent	.0000	N/A
BU-Mechanical Condition	BUMC	Excellent	.0000	N/A
BU-Roof Cladding Condition	BURC	Moderate	5.0000	Colorbond in good condition.
BU-Roof Structure Condition	BURT	Good	3.0000	Light steel frame.
BU-Wall Condition	BUWC	Moderate	5.0000	Colorbond in good condition.

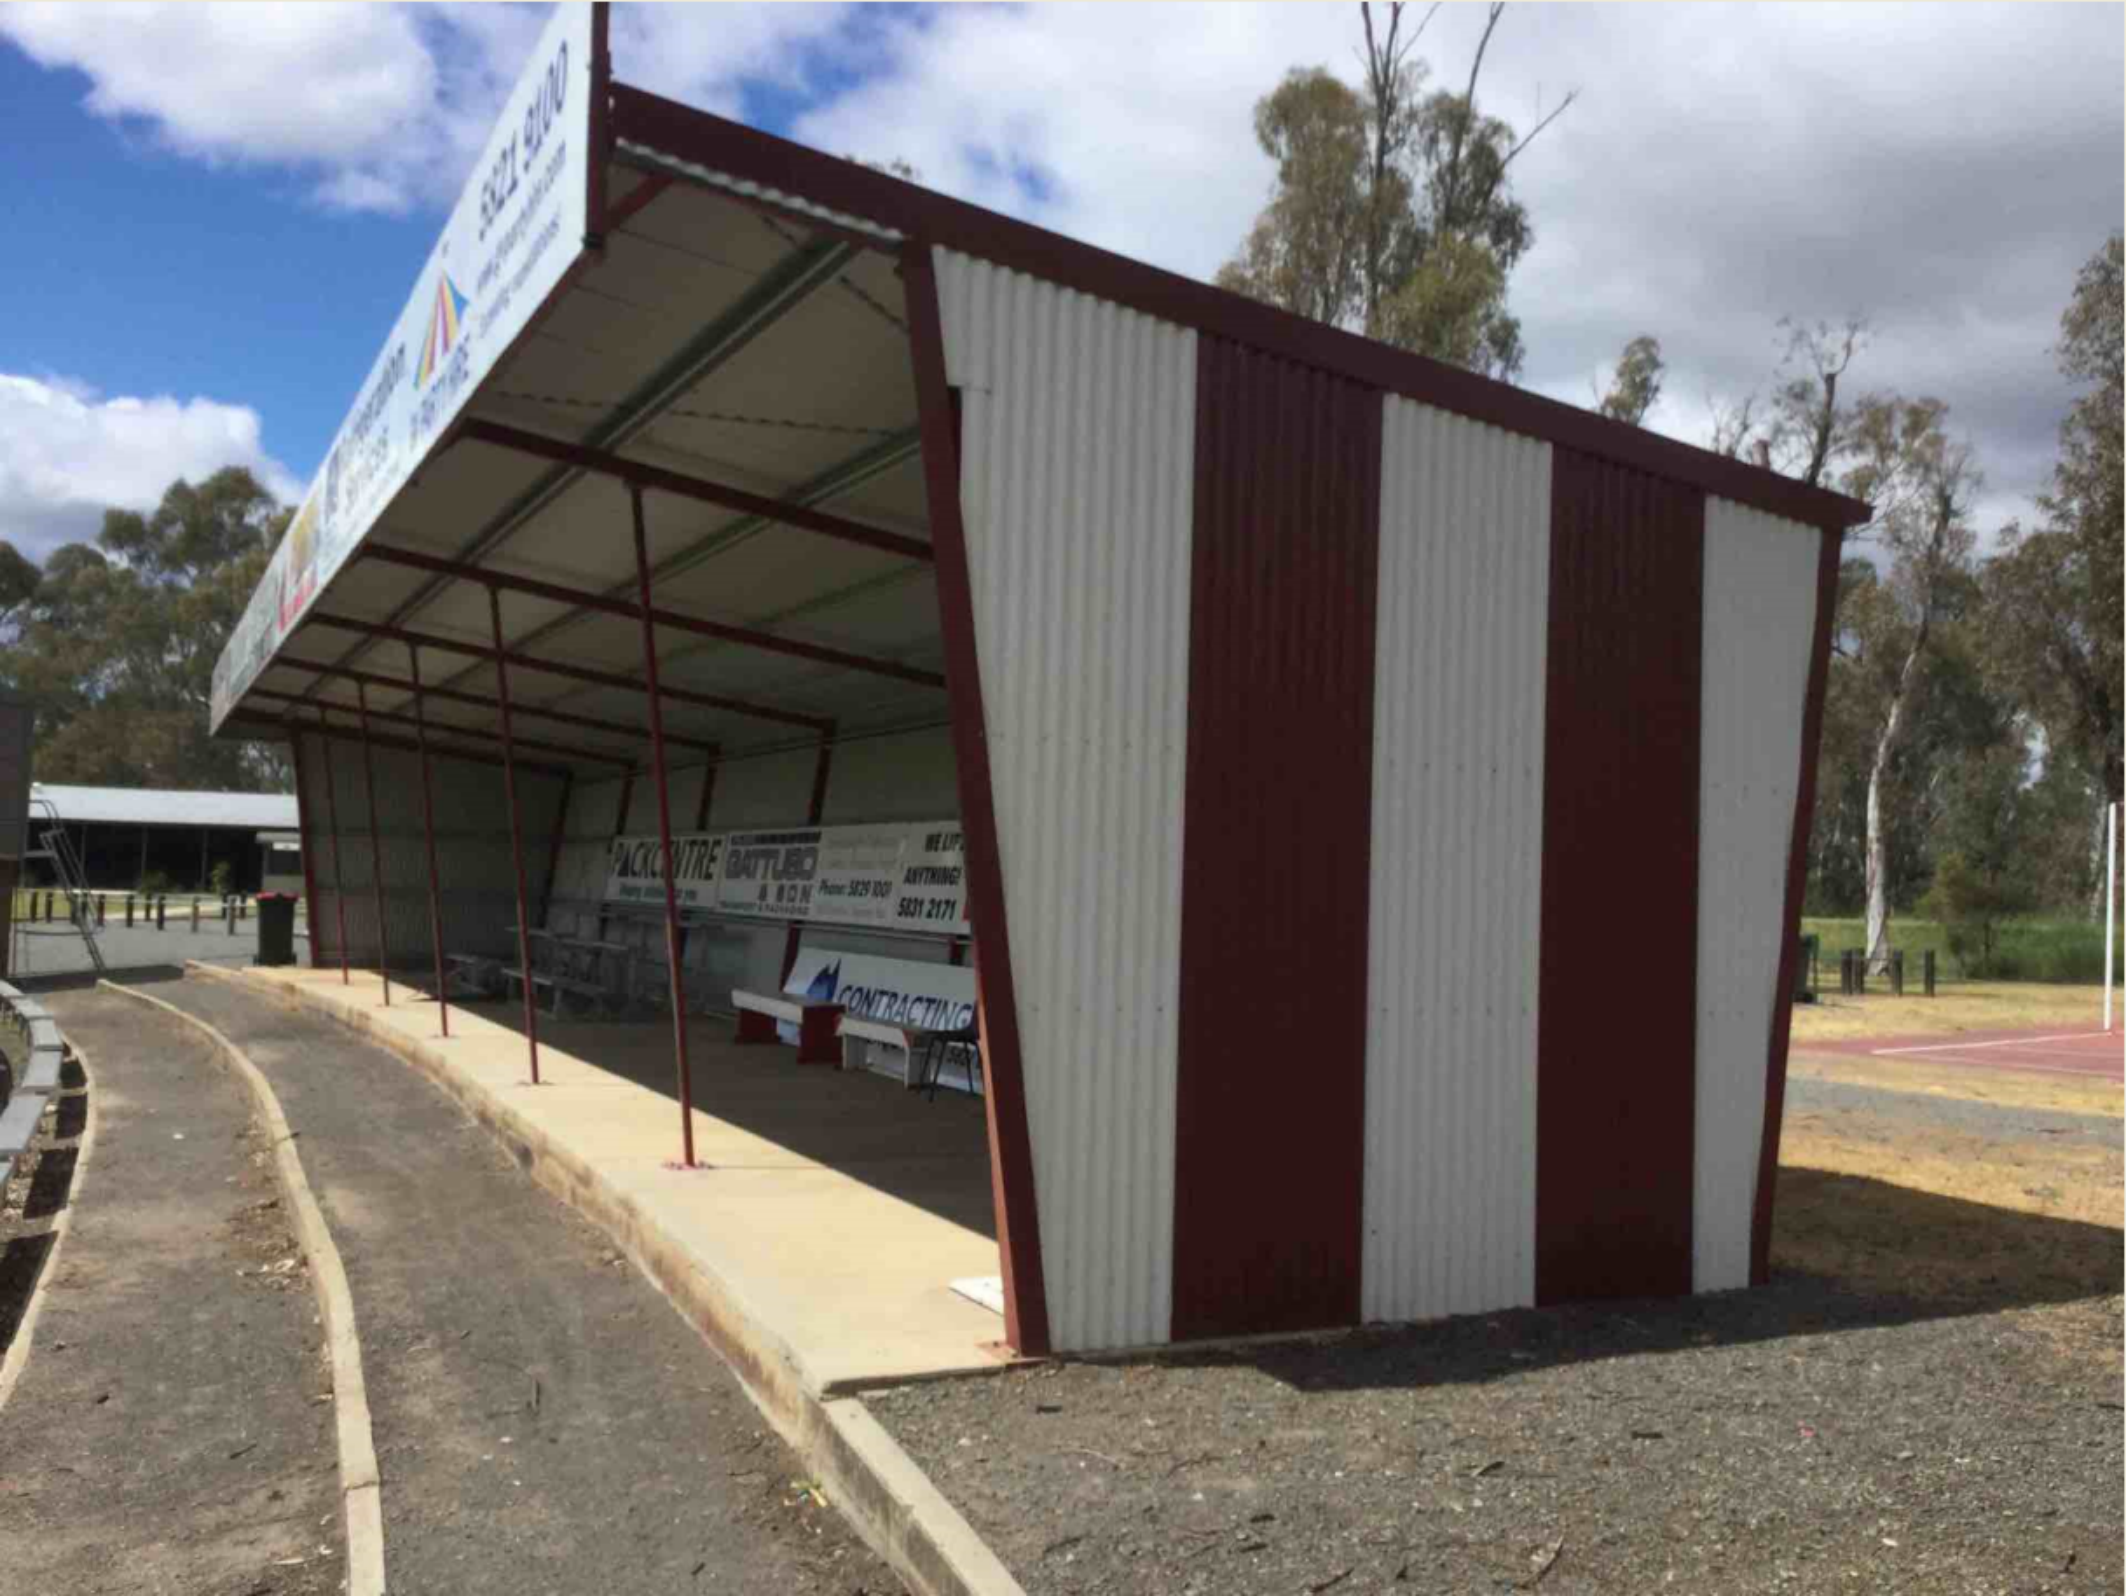
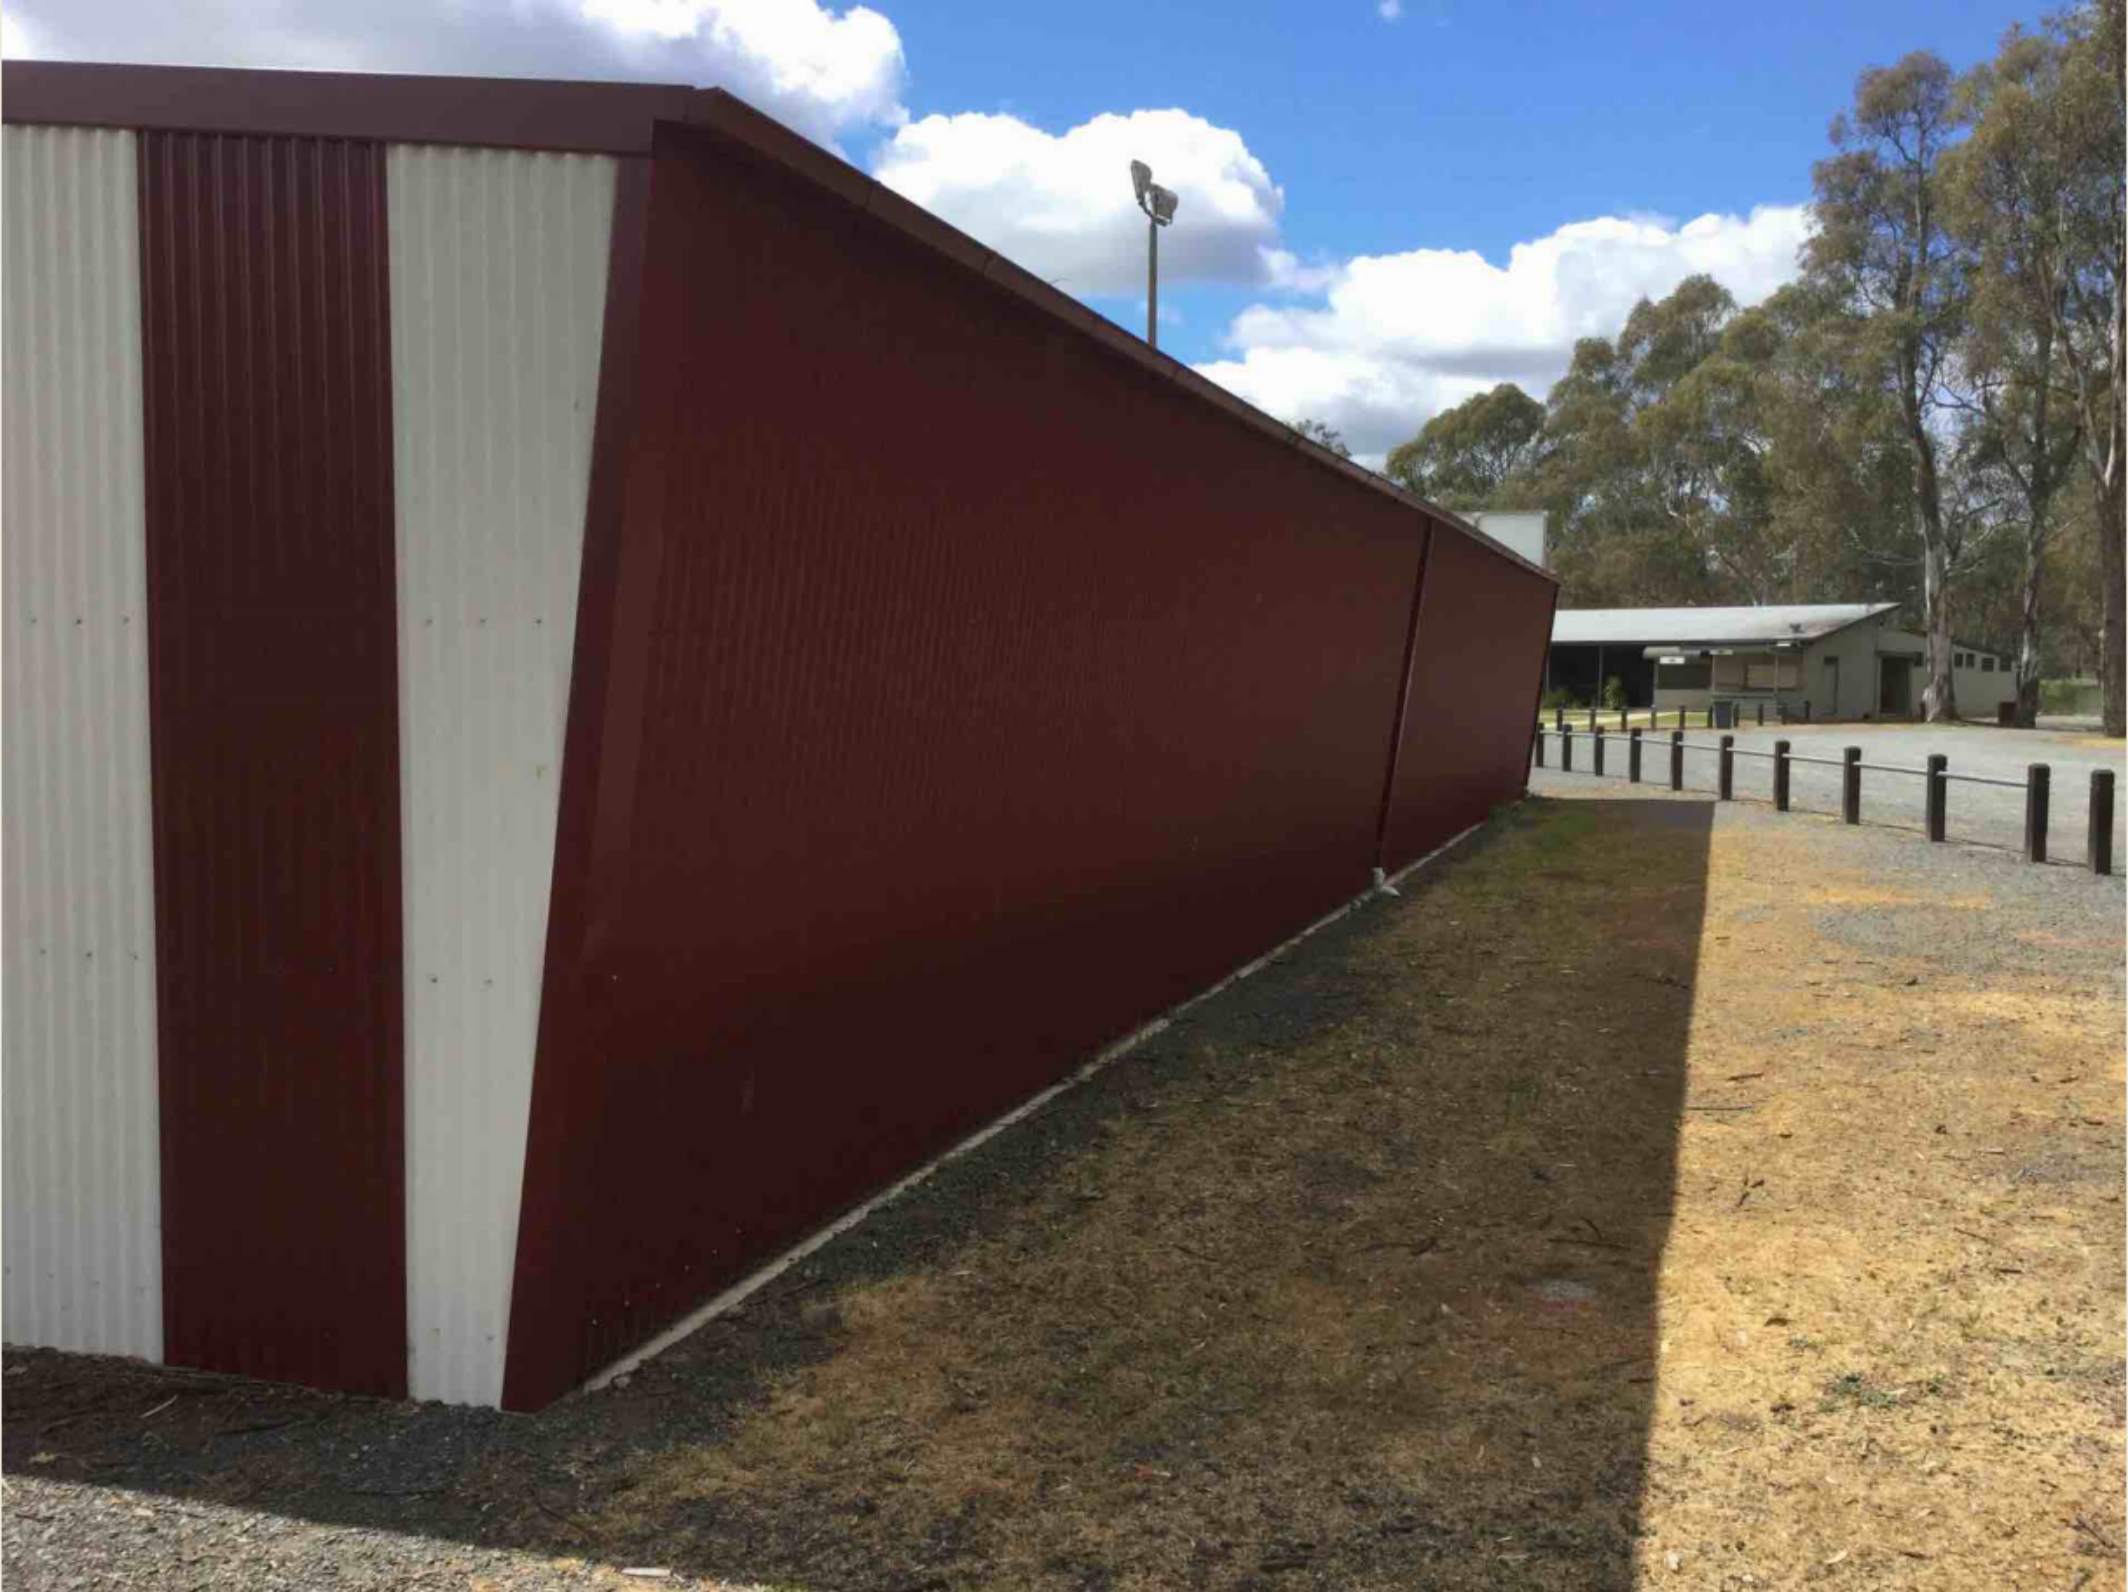
Observation Type	Code	Grade	Score	Notes
BU-Building Overall Condition	BUOC	Good	3.0000	Reasonably new structure in very good condition.
BU-Ceiling Condition	BUCE	Excellent	.0000	N/A
BU-Fitout Condition	BUFI	Good	3.0000	New seating inside
BU-Floor Condition	BUFC	Good	3.0000	Concrete floor
BU-Internal Wall Condition	BUIC	Excellent	.0000	N/A
BU-Mechanical Condition	BUMC	Excellent	.0000	N/A
BU-Roof Cladding Condition	BURC	Excellent	2.0000	As new iron roof.
BU-Roof Structure Condition	BURT	Good	3.0000	As new steel structure, with some minor painting needed.
BU-Wall Condition	BUWC	Excellent	2.0000	As new corrugated iron walls.

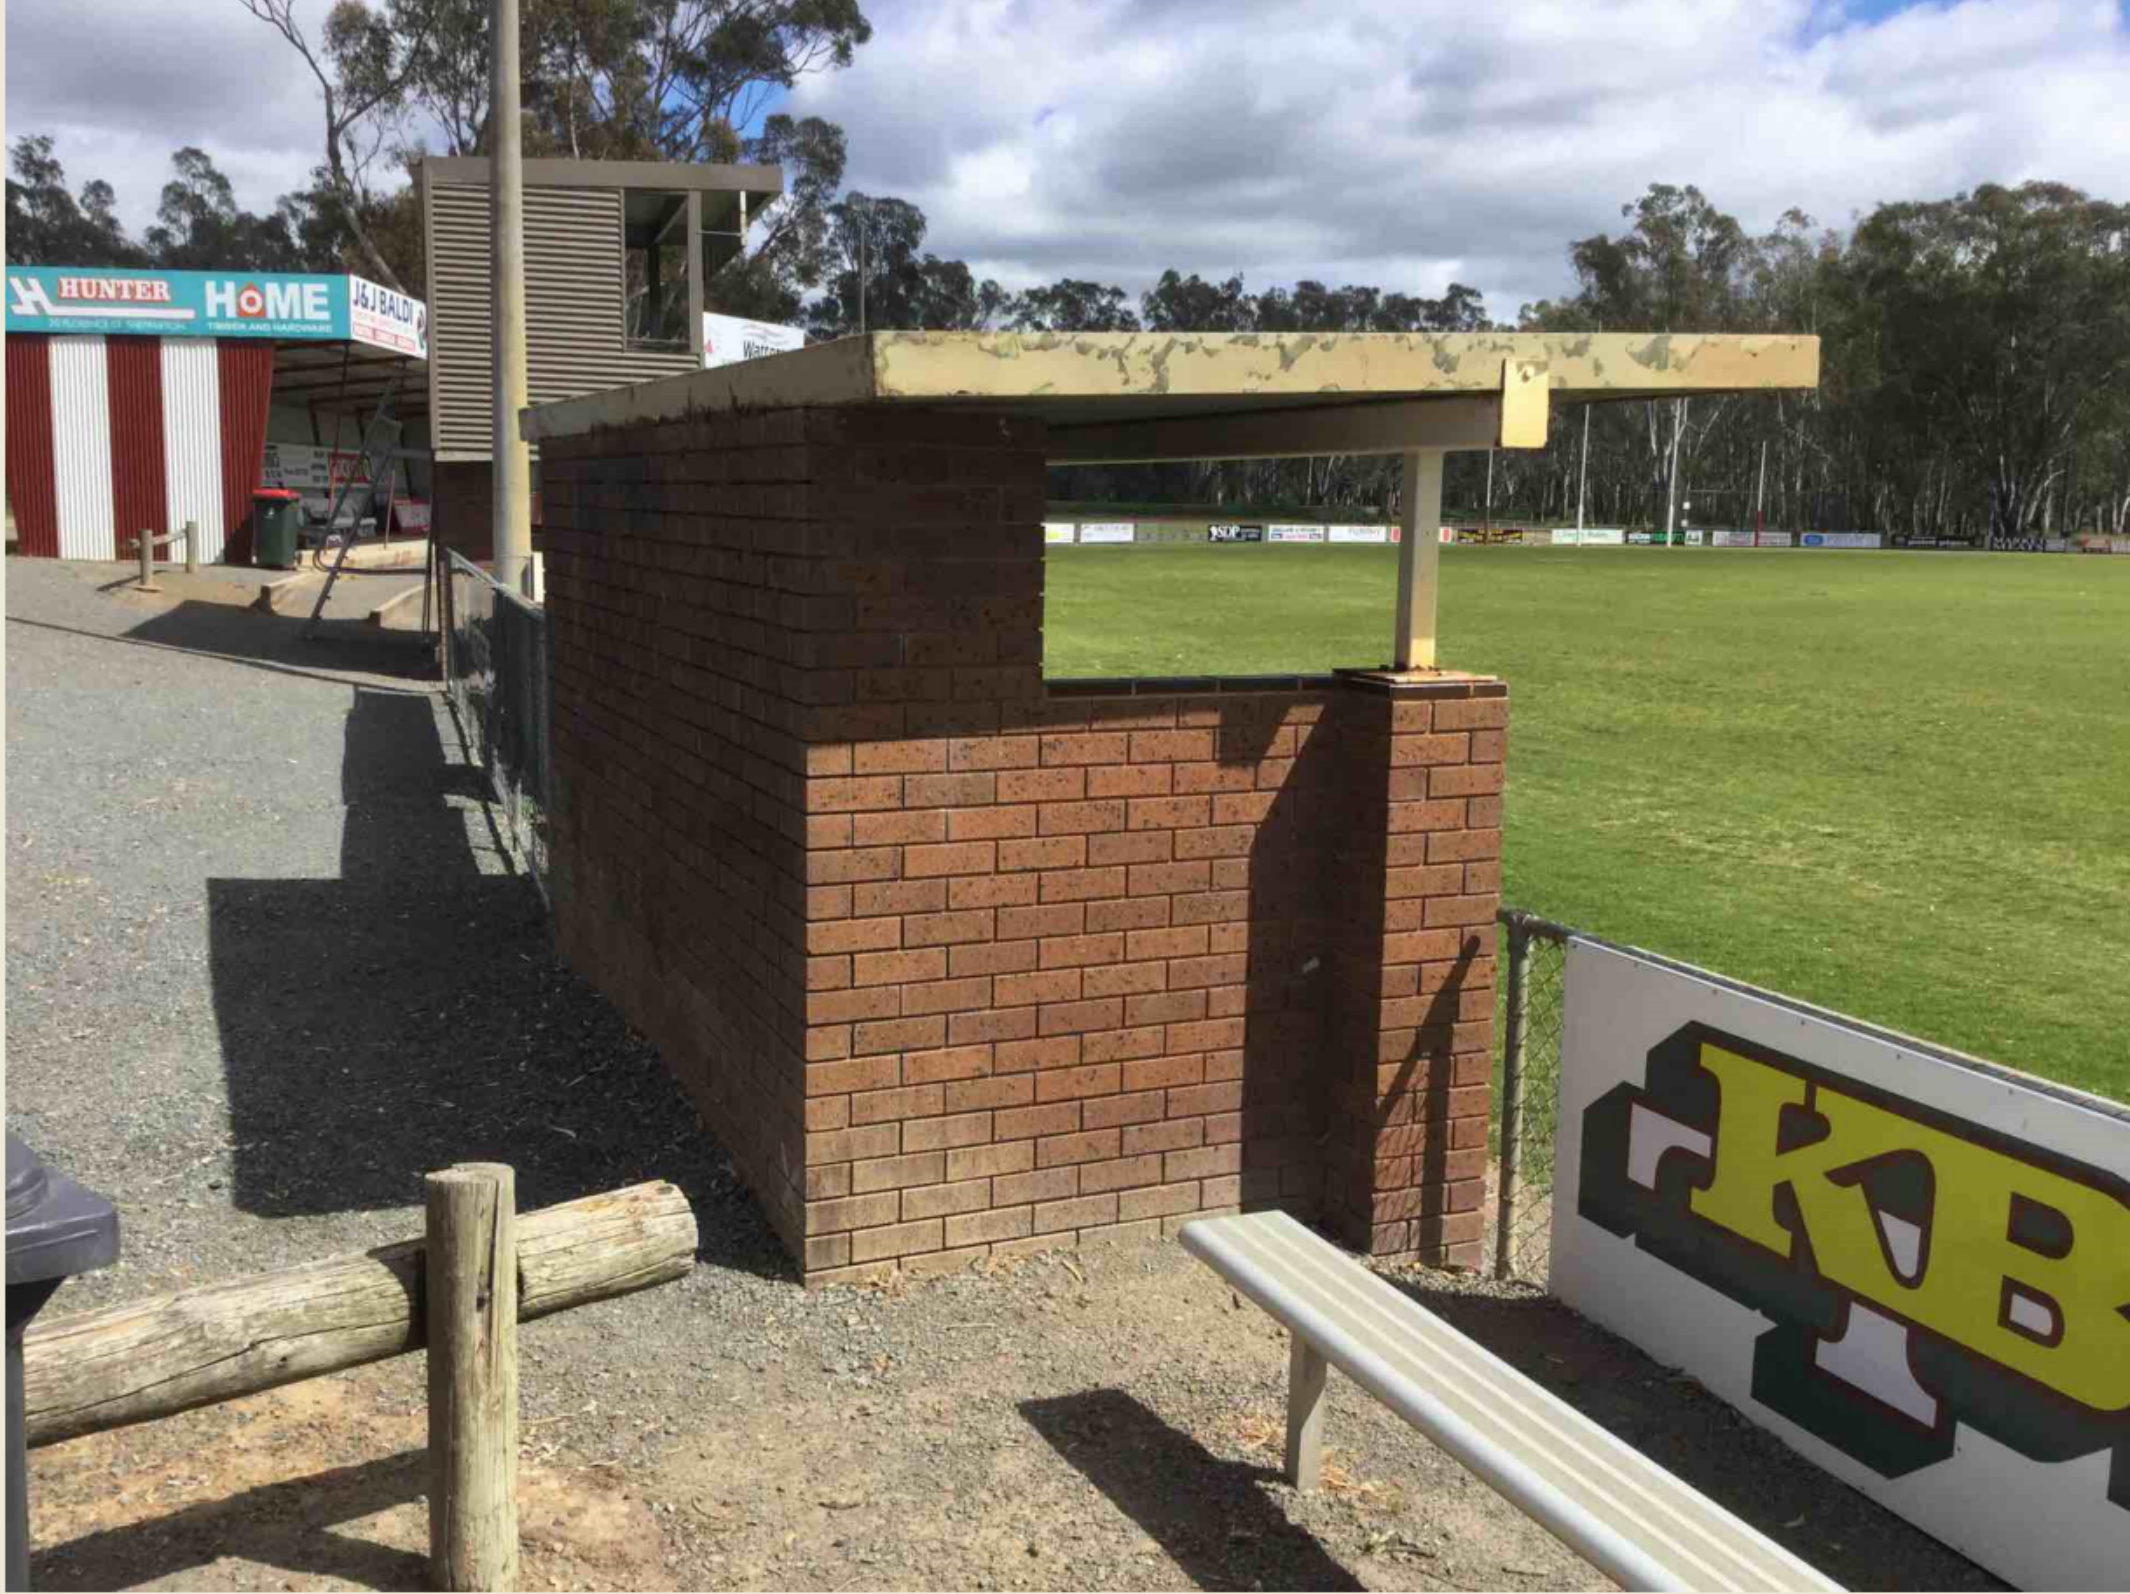
Observation Type	Code	Grade	Score	Notes
BU-Building Overall Condition	BUOC	Moderate	5.0000	Building is generally in good condition, but some structural steel posts need to be painted to prevent further rusting.
BU-Ceiling Condition	BUCE	Excellent	.0000	N/A ((Galvanised ironj)
BU-Fitout Condition	BUFI	Good	4.0000	Fixed galvanised and timber seating.
BU-Floor Condition	BUFC	Good	3.0000	Concrete.
BU-Internal Wall Condition	BUIC	Excellent	.0000	N/A
BU-Mechanical Condition	BUMC	Excellent	.0000	N/A
BU-Roof Cladding Condition	BURC	Good	3.0000	Concrete roof in good condition.
BU-Roof Structure Condition	BURT	Moderate	6.0000	Iron posts are starting to rust.
BU-Wall Condition	BUWC	Excellent	2.0000	Brick walls in very good condition.
