**Officer:** John Gribben (JEG)  
**Route:** BU-Cond Surv Princess Park (BU29)  
**Report Type:** Assessment

**Site:** Princess Park (Shepparton) (F0062)

**Date:** 13/10/2017

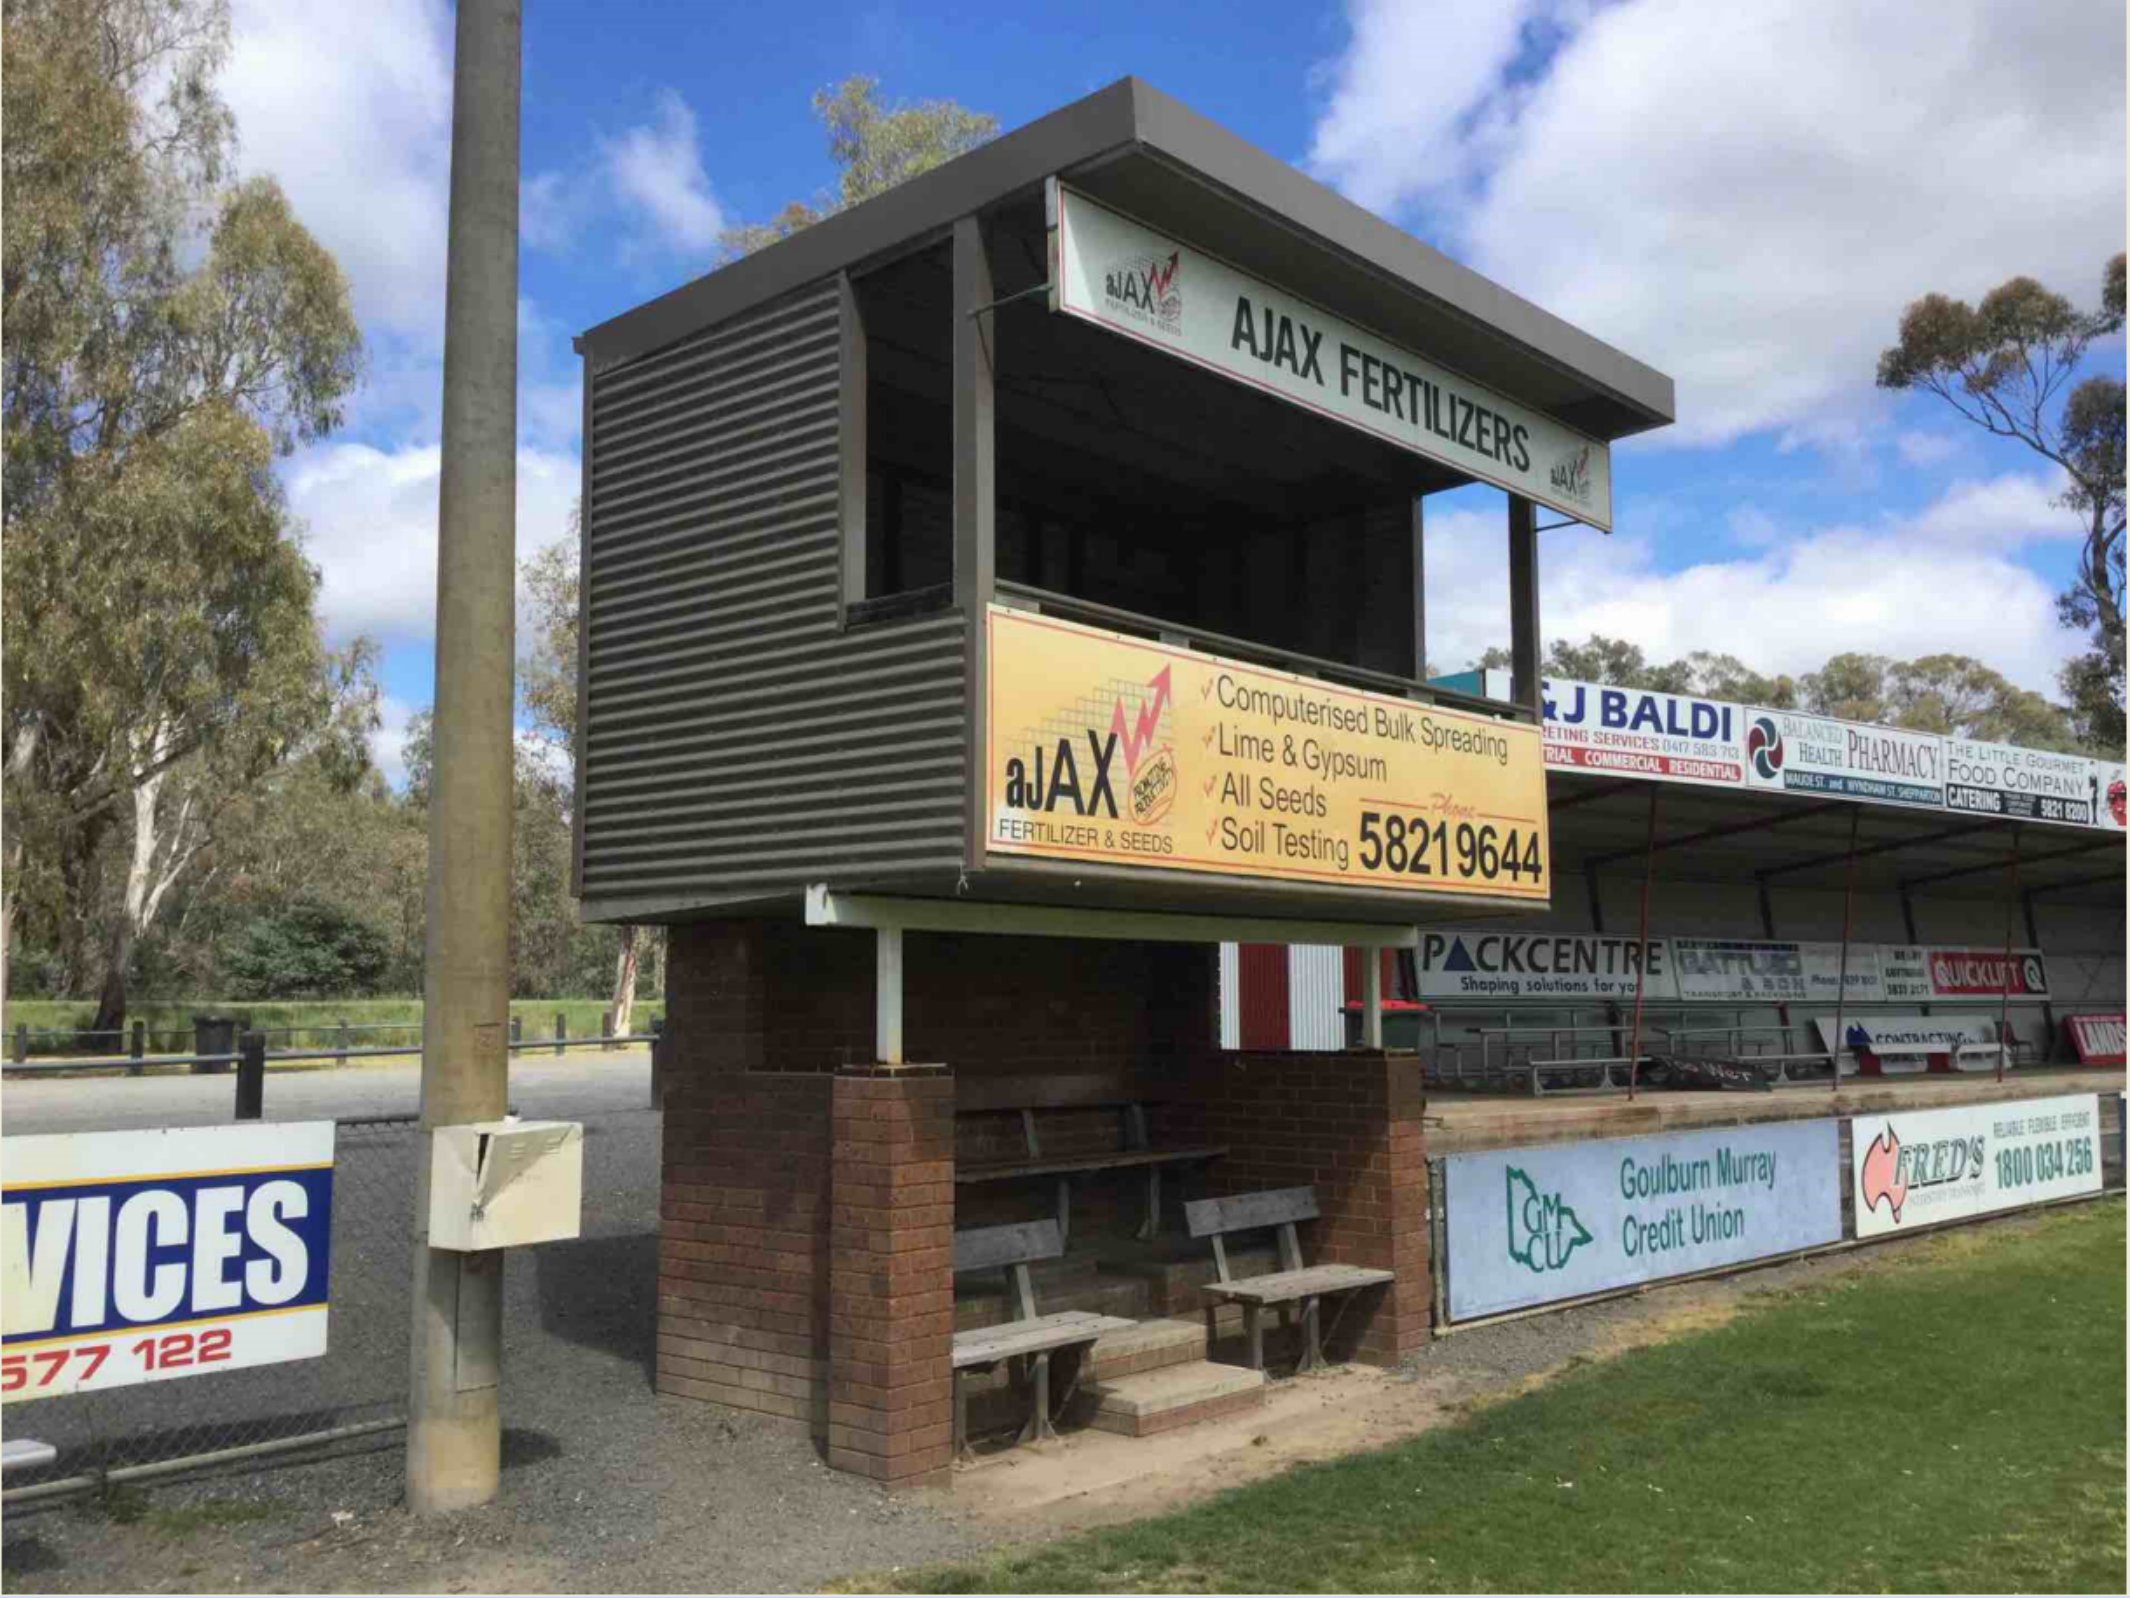
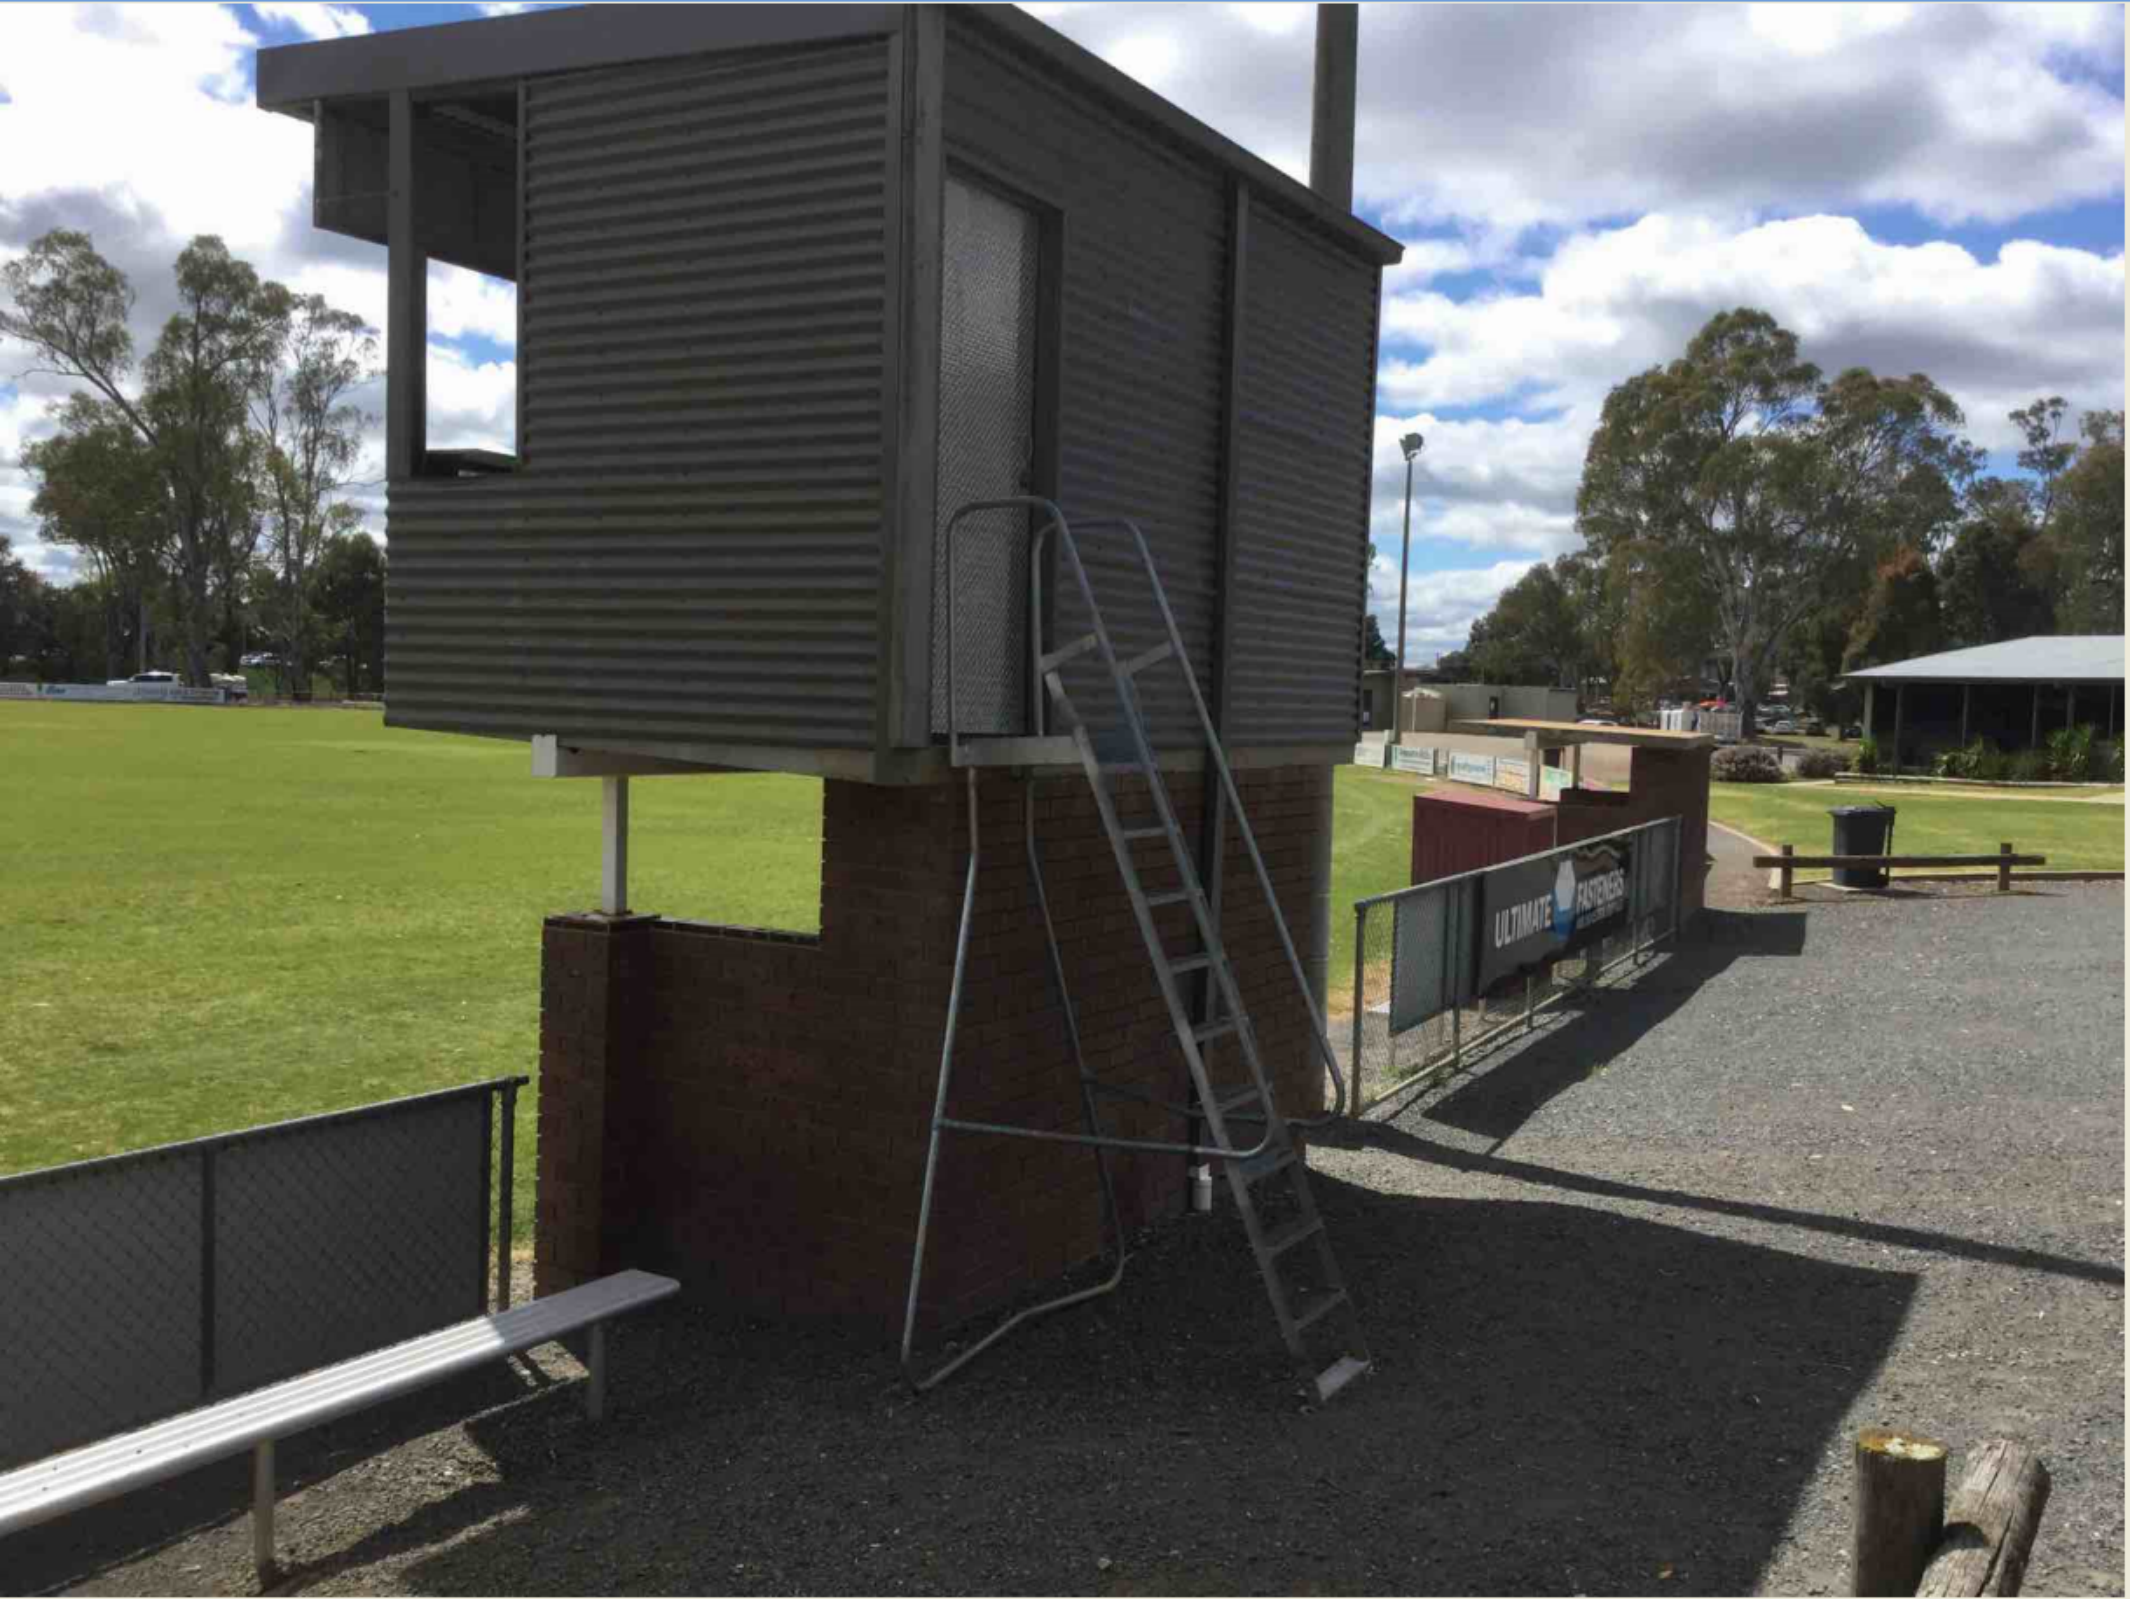
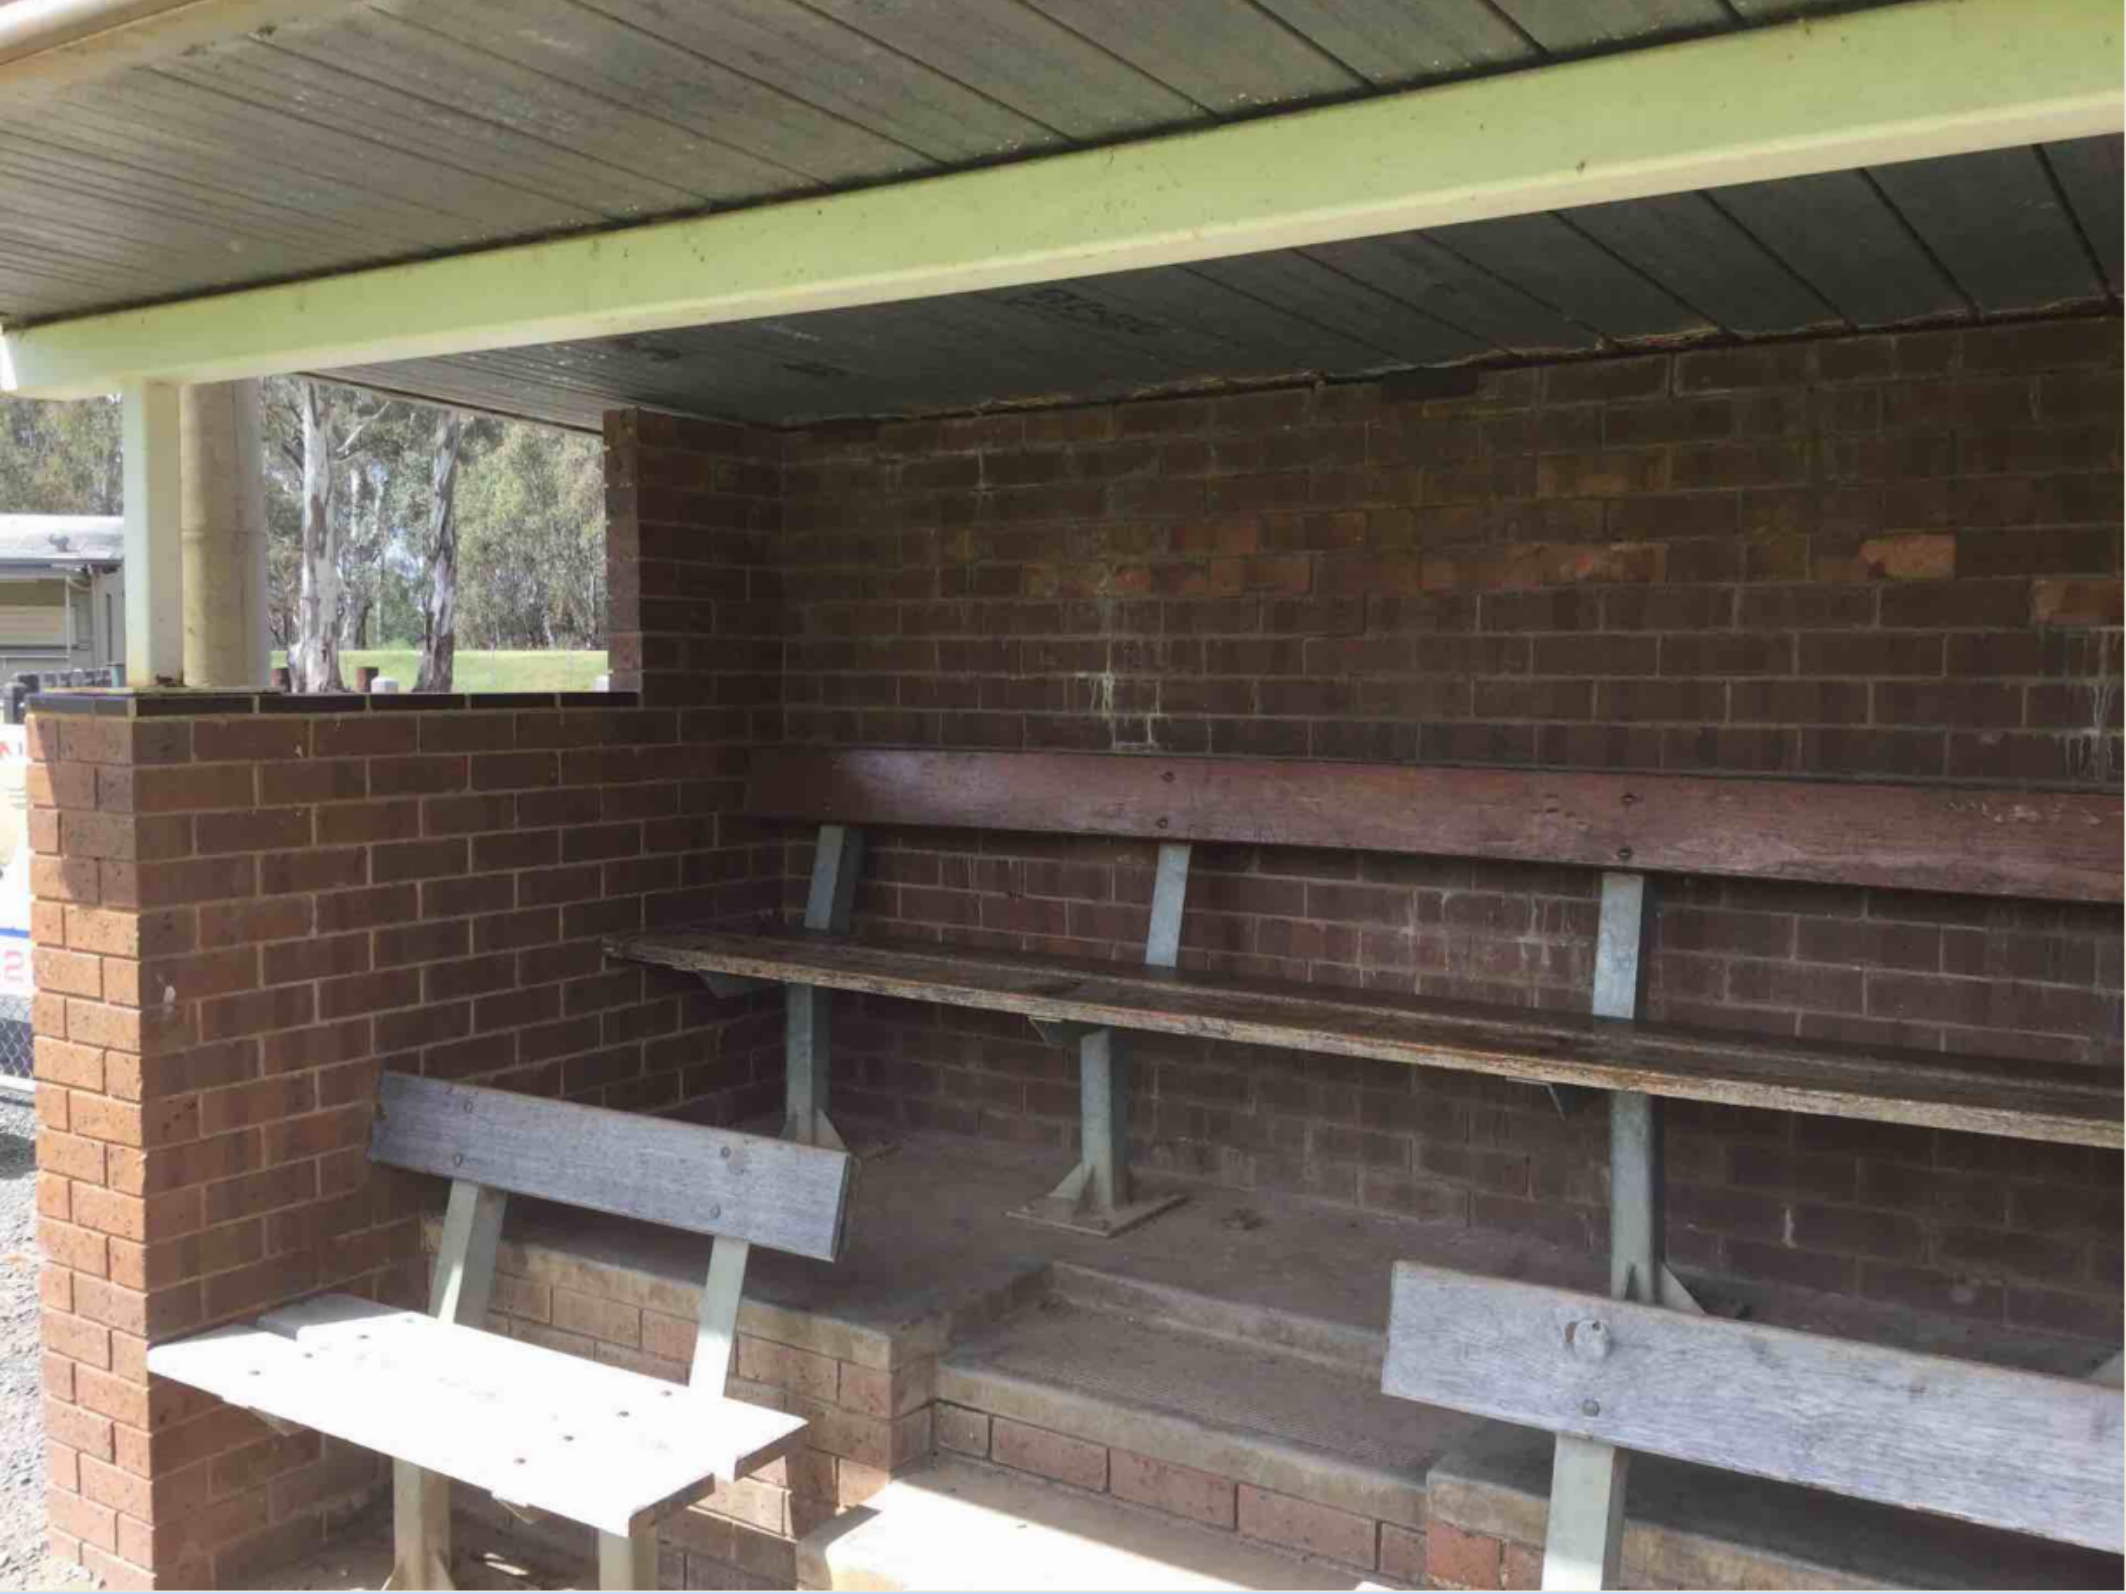
Observation Type	Code	Grade	Score	Notes
BU-Building Overall Condition	BUOC	Moderate	5.0000	Building is in good condition, but rust is starting to show on some of the structural steel posts on the lower level.
BU-Ceiling Condition	BUCE	Good	3.0000	Galvanised iron in good condition.
BU-Fitout Condition	BUFI	Good	4.0000	Fixed galvanised iron and timber seating in good condition.
BU-Floor Condition	BUFC	Good	3.0000	Concrete in good condition.
BU-Internal Wall Condition	BUIC	Excellent	.0000	N/A
BU-Mechanical Condition	BUMC	Excellent	.0000	N/A
BU-Roof Cladding Condition	BURC	Good	3.0000	New structure placed on top of the concrete roof of the coaches box. The roof of this structure in colorbond, and in very good condition.
BU-Roof Structure Condition	BURT	Moderate	6.0000	New structure placed on the concrete roof of the coaches bloc is in very good condition, but structural steel posts for the lower structure are in need of painting to prevent further rusting. Given the structure above, this should be addressed in the next few years.

BU-Wall Condition	BUWC	Good	3.0000	Brick and colorbond walls in very good condition,

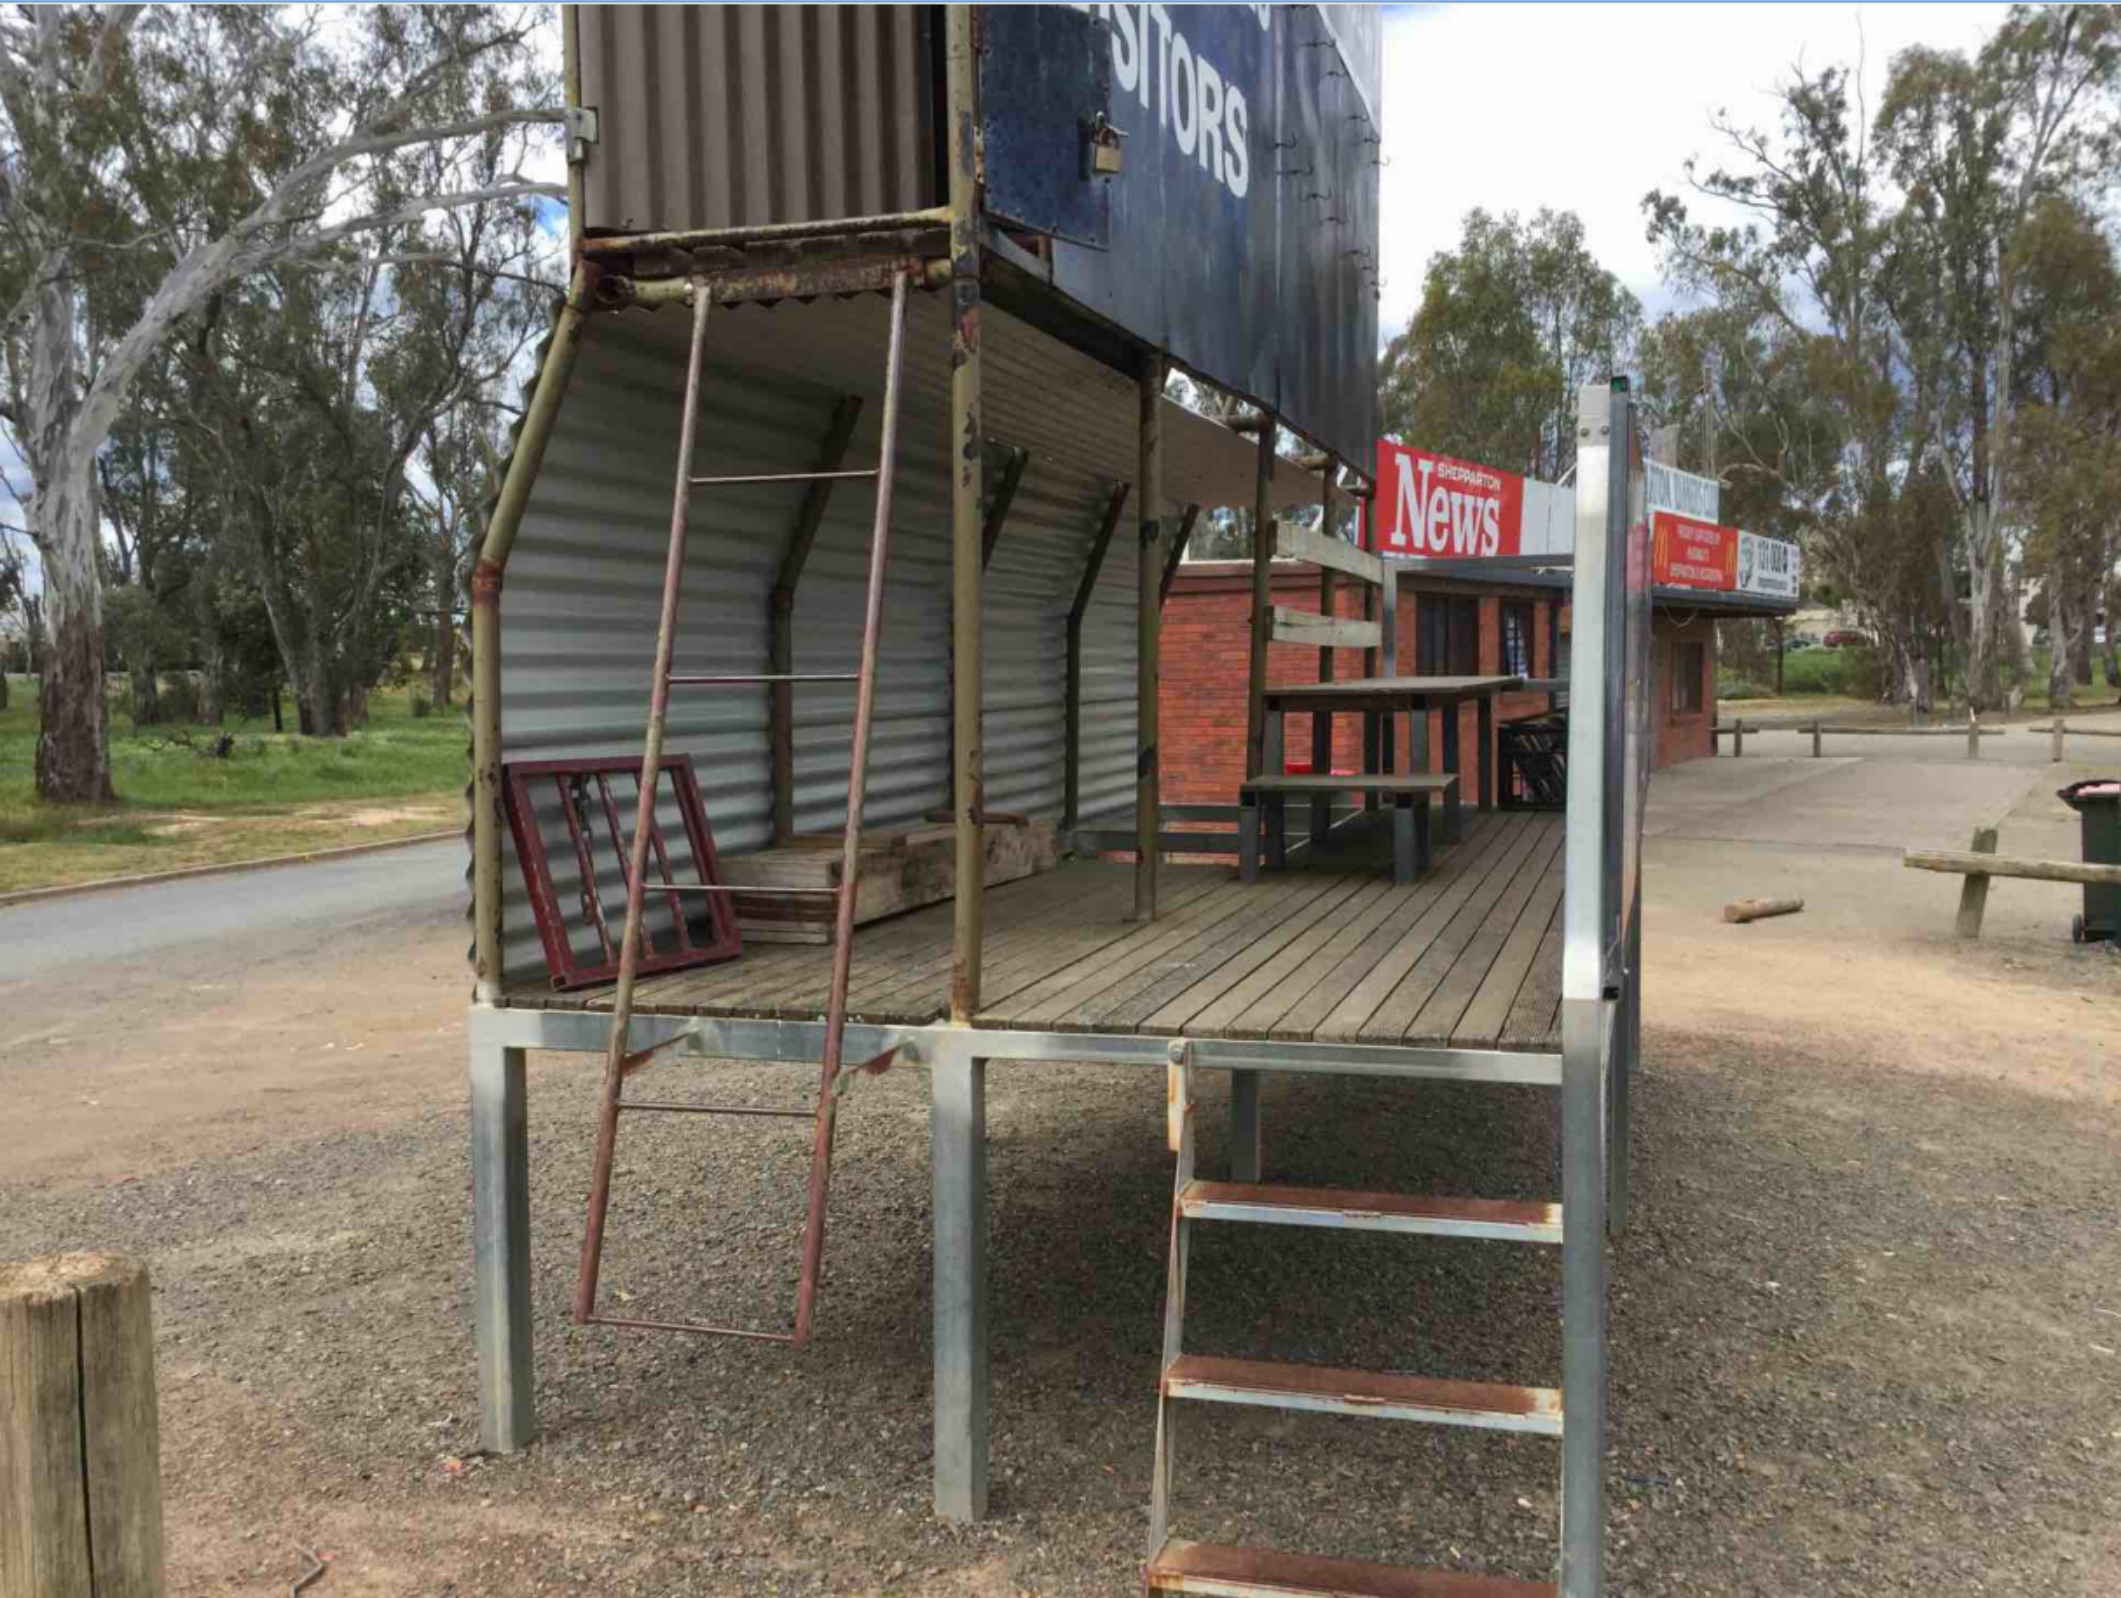
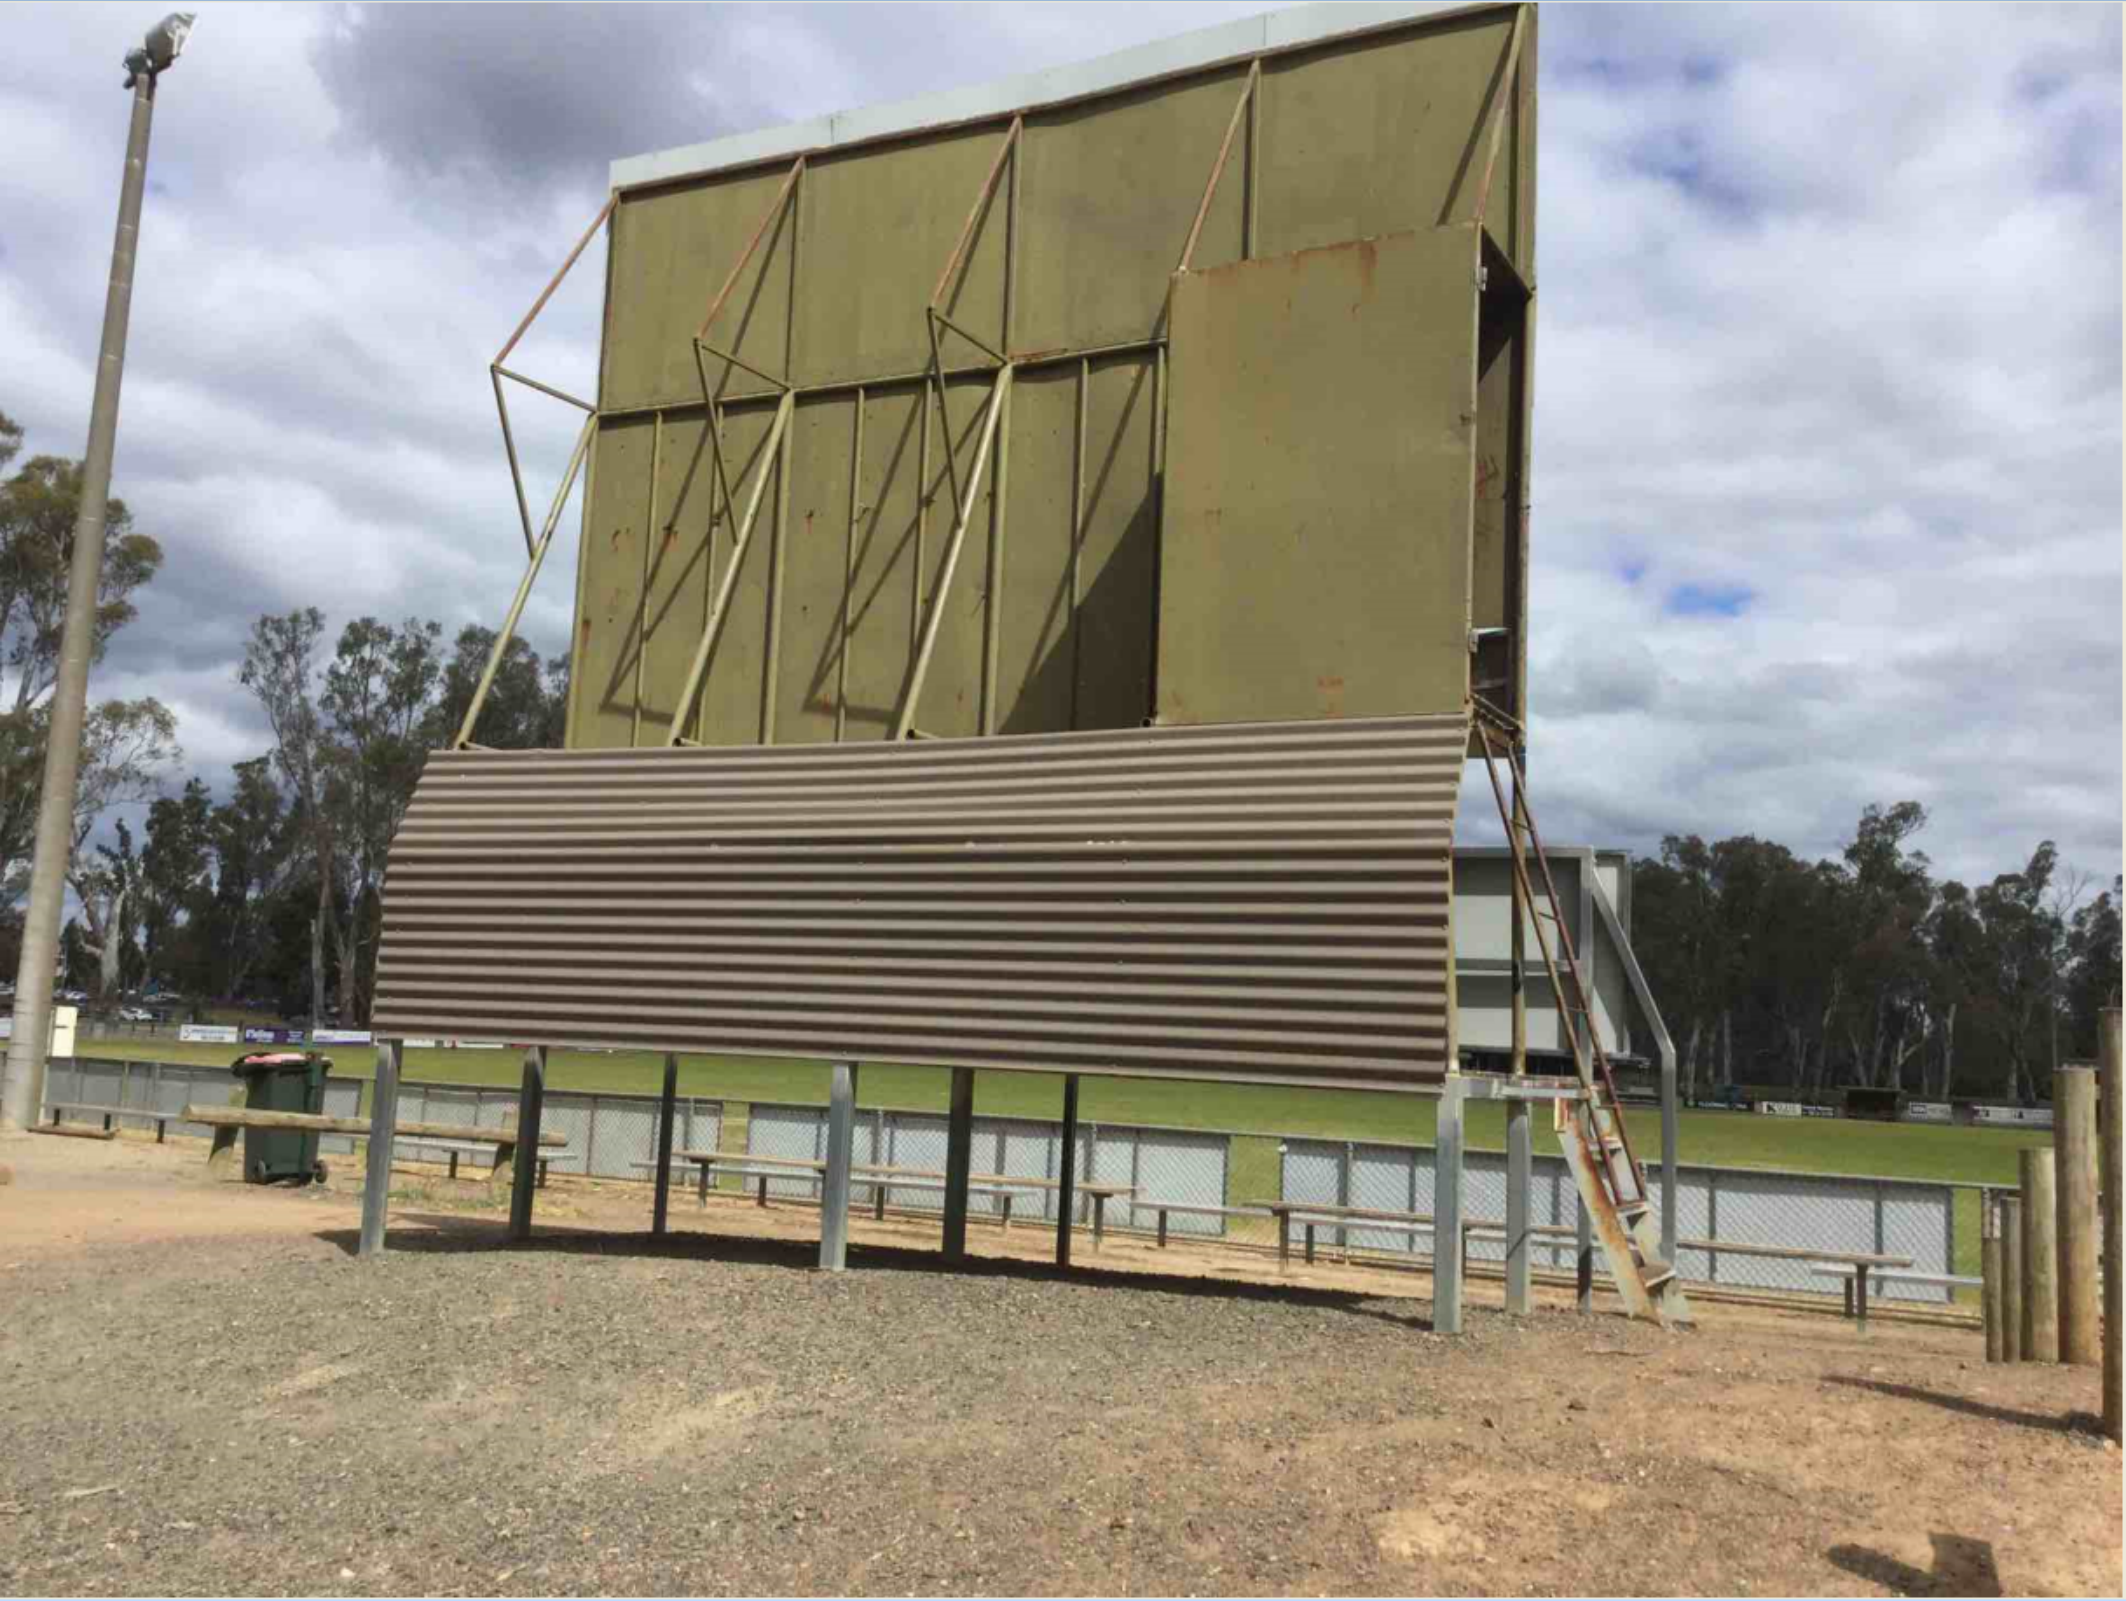
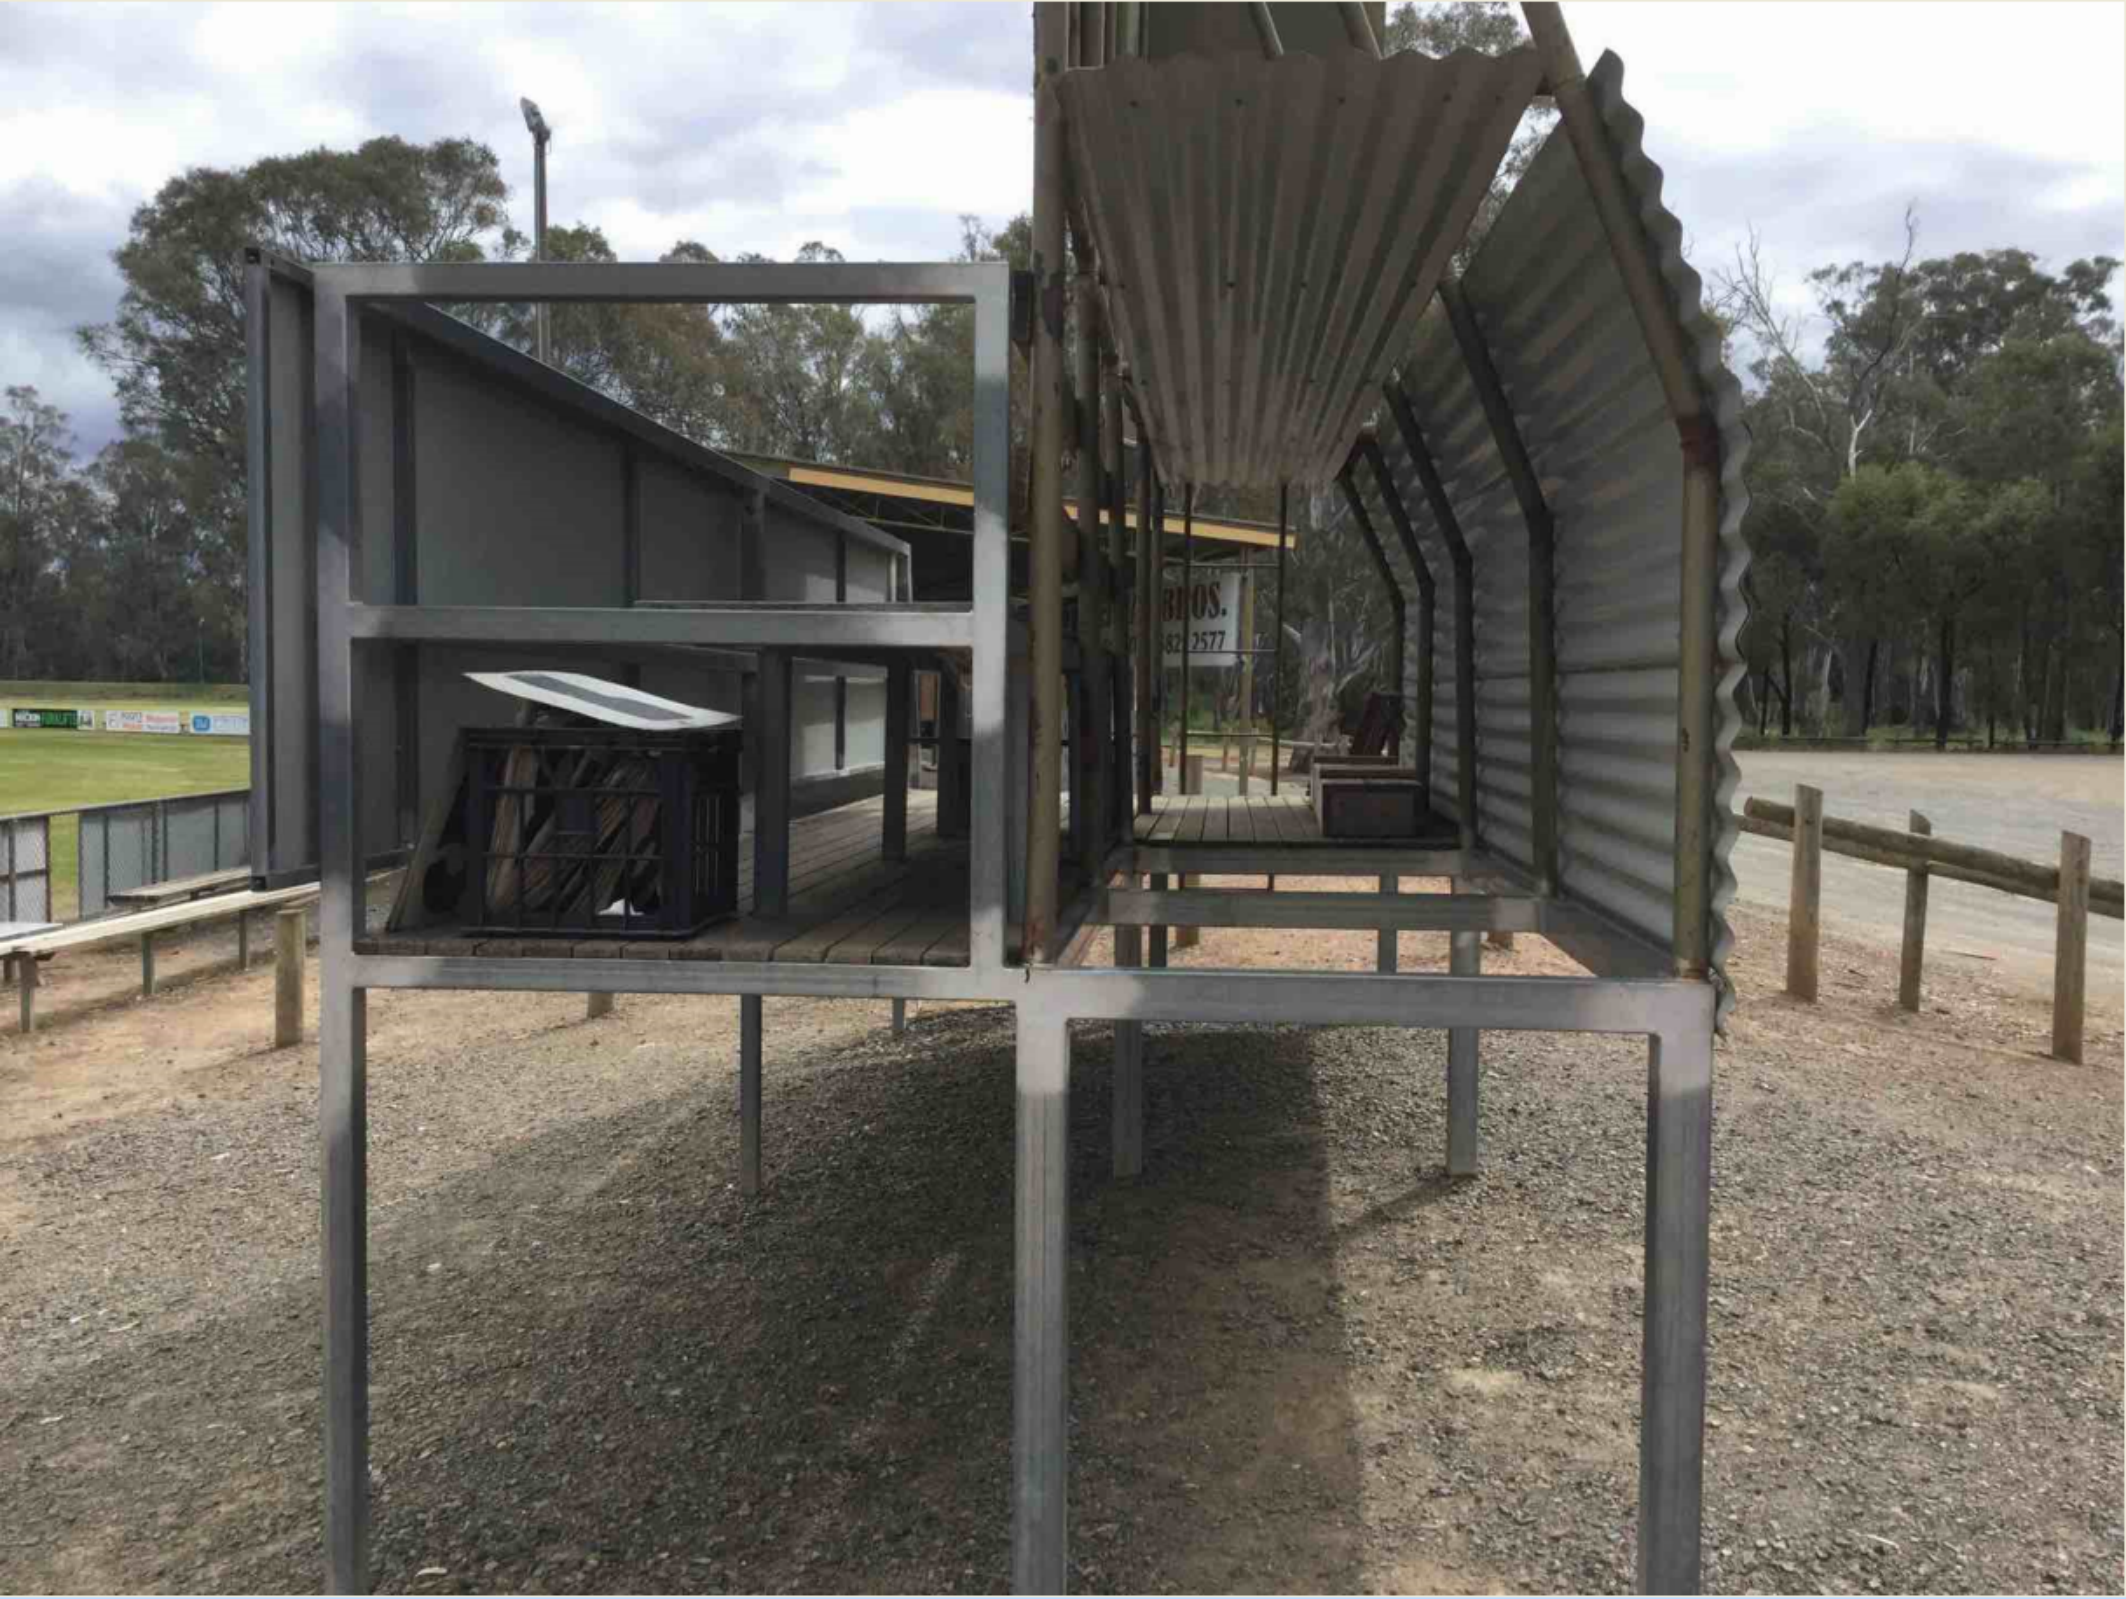
Observation Type	Code	Grade	Score	Notes
BU-Building Overall Condition	BUOC	Good	4.0000	Structure is generally in good condition, but some of the steelwork is showing signs of surface rust.
BU-Ceiling Condition	BUCE	Excellent	.0000	N/A (Steel roofing)
BU-Fitout Condition	BUFI	Excellent	.0000	N/A
BU-Floor Condition	BUFC	Good	4.0000	Timber decking is exposed to weather but appears in good condition.
BU-Internal Wall Condition	BUIC	Excellent	.0000	N/A
BU-Mechanical Condition	BUMC	Not Applicable	.0000	N/A
BU-Roof Cladding Condition	BURC	Good	3.0000	Colorbond and iron roof in good condition.
BU-Roof Structure Condition	BURT	Moderate	5.0000	Steel in good condition, but starting to show signs of surface rust.
BU-Wall Condition	BUWC	Excellent	.0000	N/A
