**Officer:** John Gribben (JEG)  
**Route:** BU-Cond Surv Princess Park (BU29)  
**Report Type:** Assessment

**Site:** Princess Park (Shepparton) (F0062)

**Date:** 13/10/2017

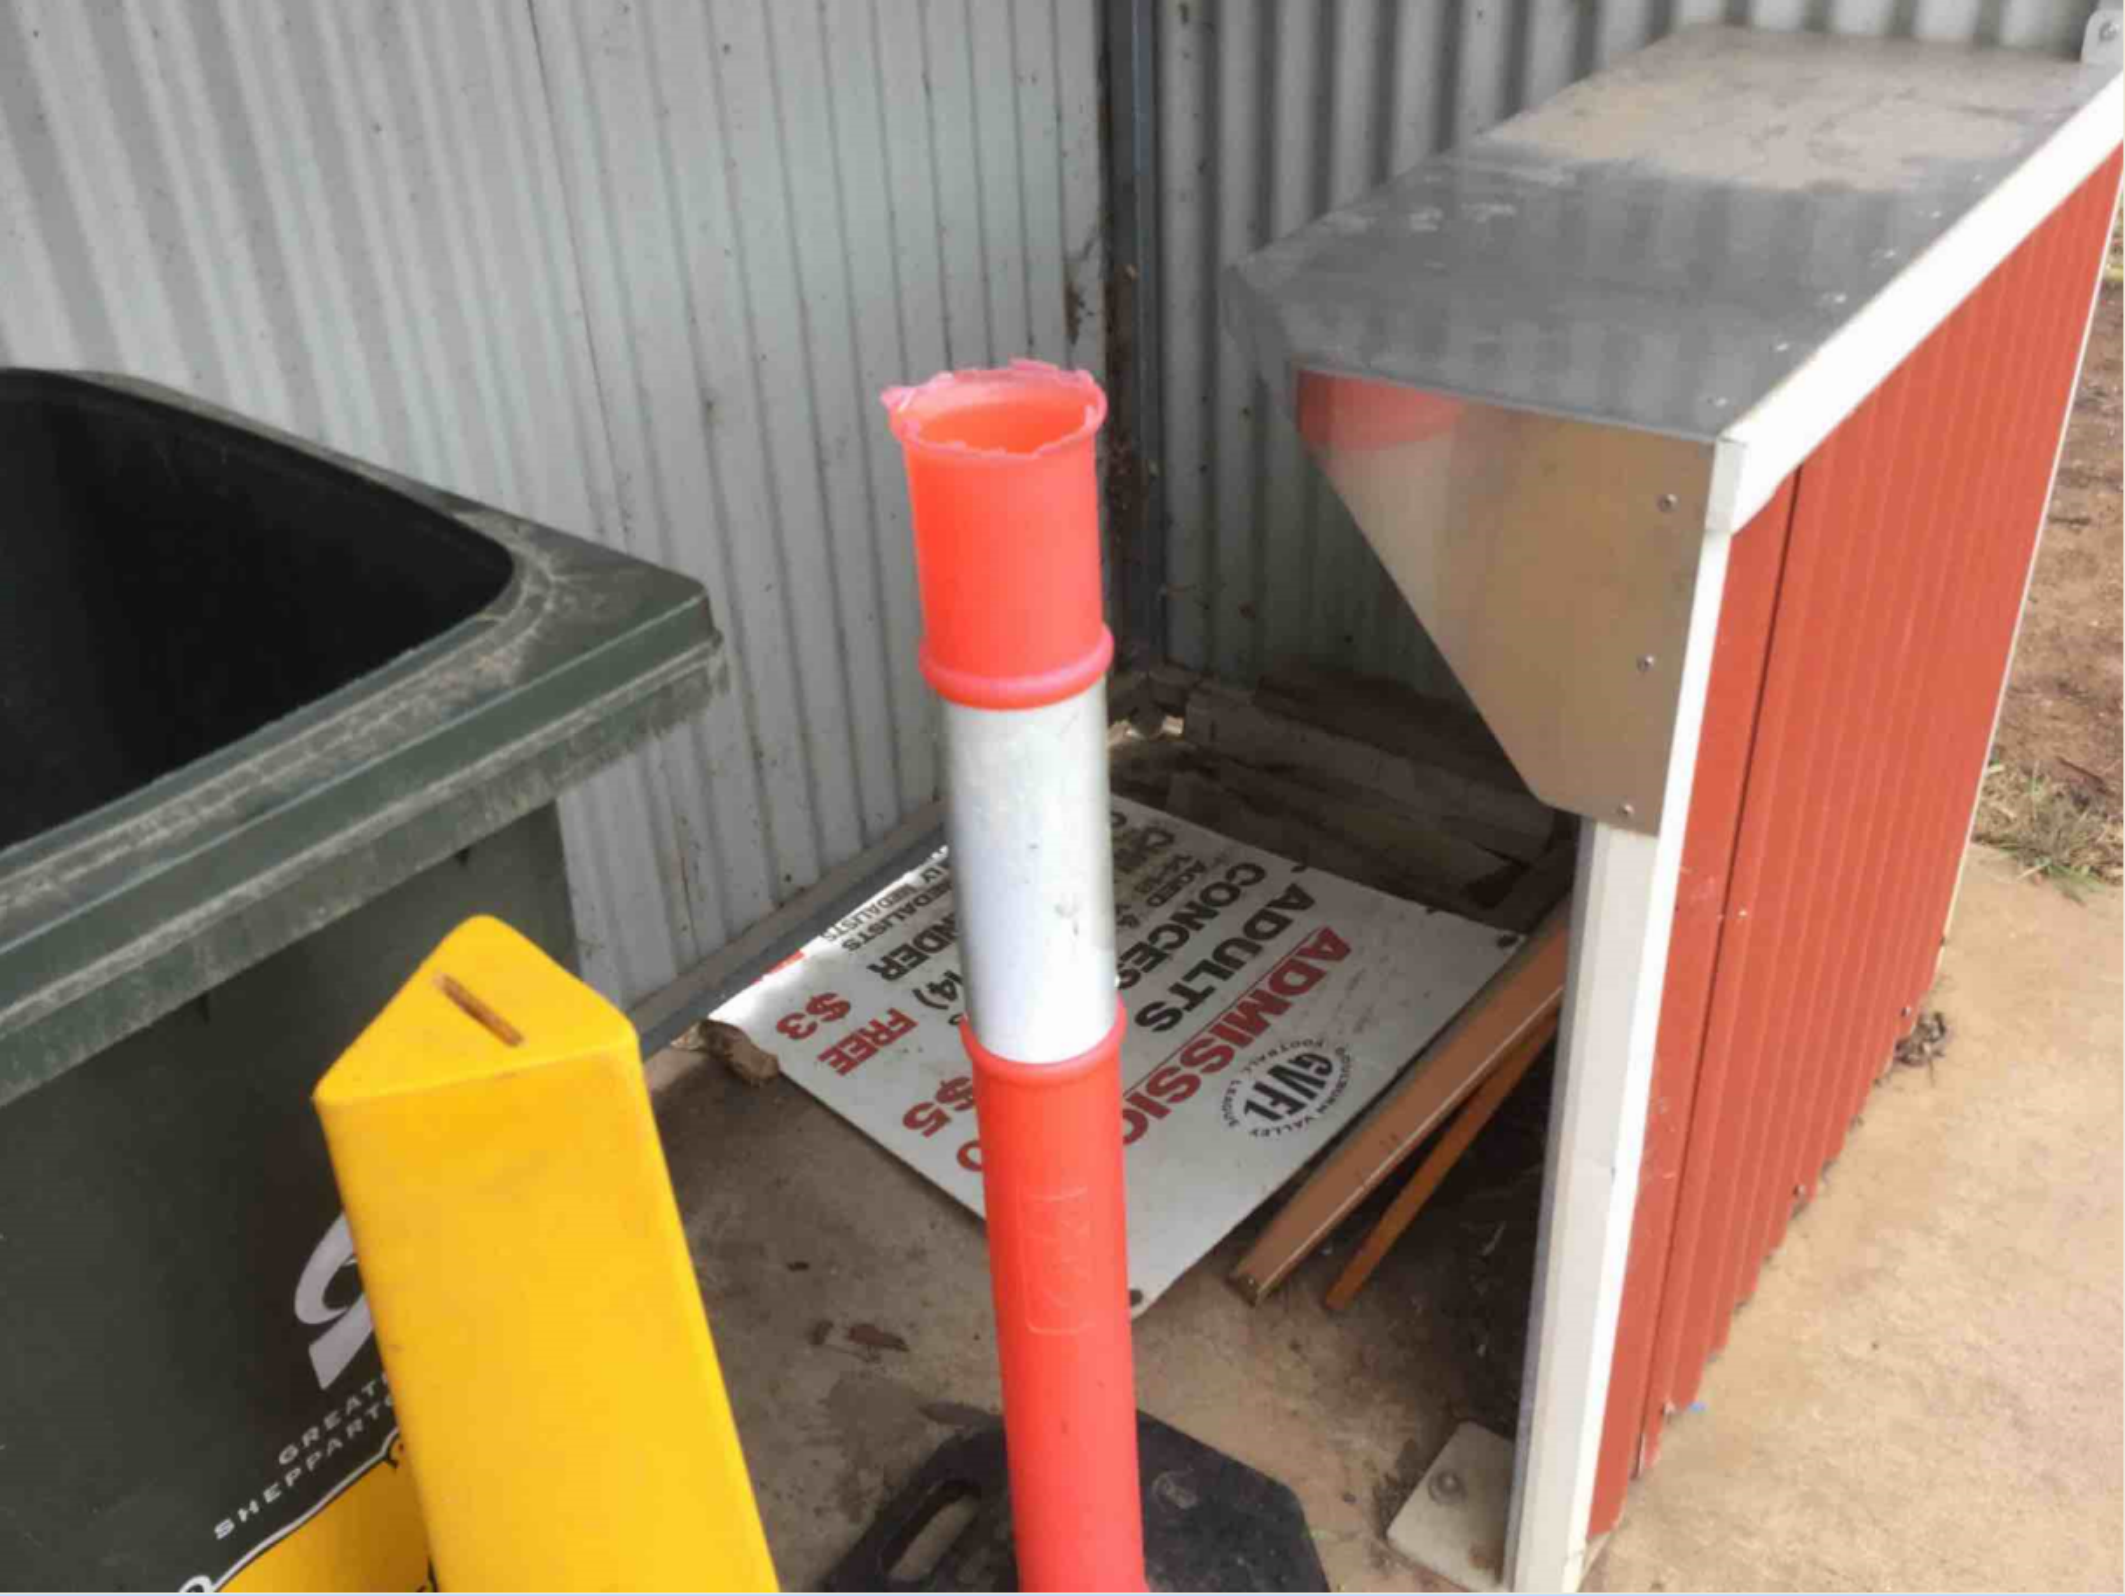
Observation Type	Code	Grade	Score	Notes
BU-Building Overall Condition	BUOC	Good	3.0000	Small building in very good condition.
BU-Ceiling Condition	BUCE	Excellent	.0000	N/A (iron roof)
BU-Fitout Condition	BUFI	Excellent	2.0000	Stainless steel bench in very good condition.
BU-Floor Condition	BUFC	Good	3.0000	Concrete floor in very good condition.
BU-Internal Wall Condition	BUIC	Excellent	.0000	N/A
BU-Mechanical Condition	BUMC	Excellent	.0000	N/A
BU-Roof Cladding Condition	BURC	Good	3.0000	Colorbond roof in very good condition.
BU-Roof Structure Condition	BURT	Good	3.0000	Steel structure in very good condition.
BU-Wall Condition	BUWC	Good	3.0000	Colorbond walls in ver good condition.

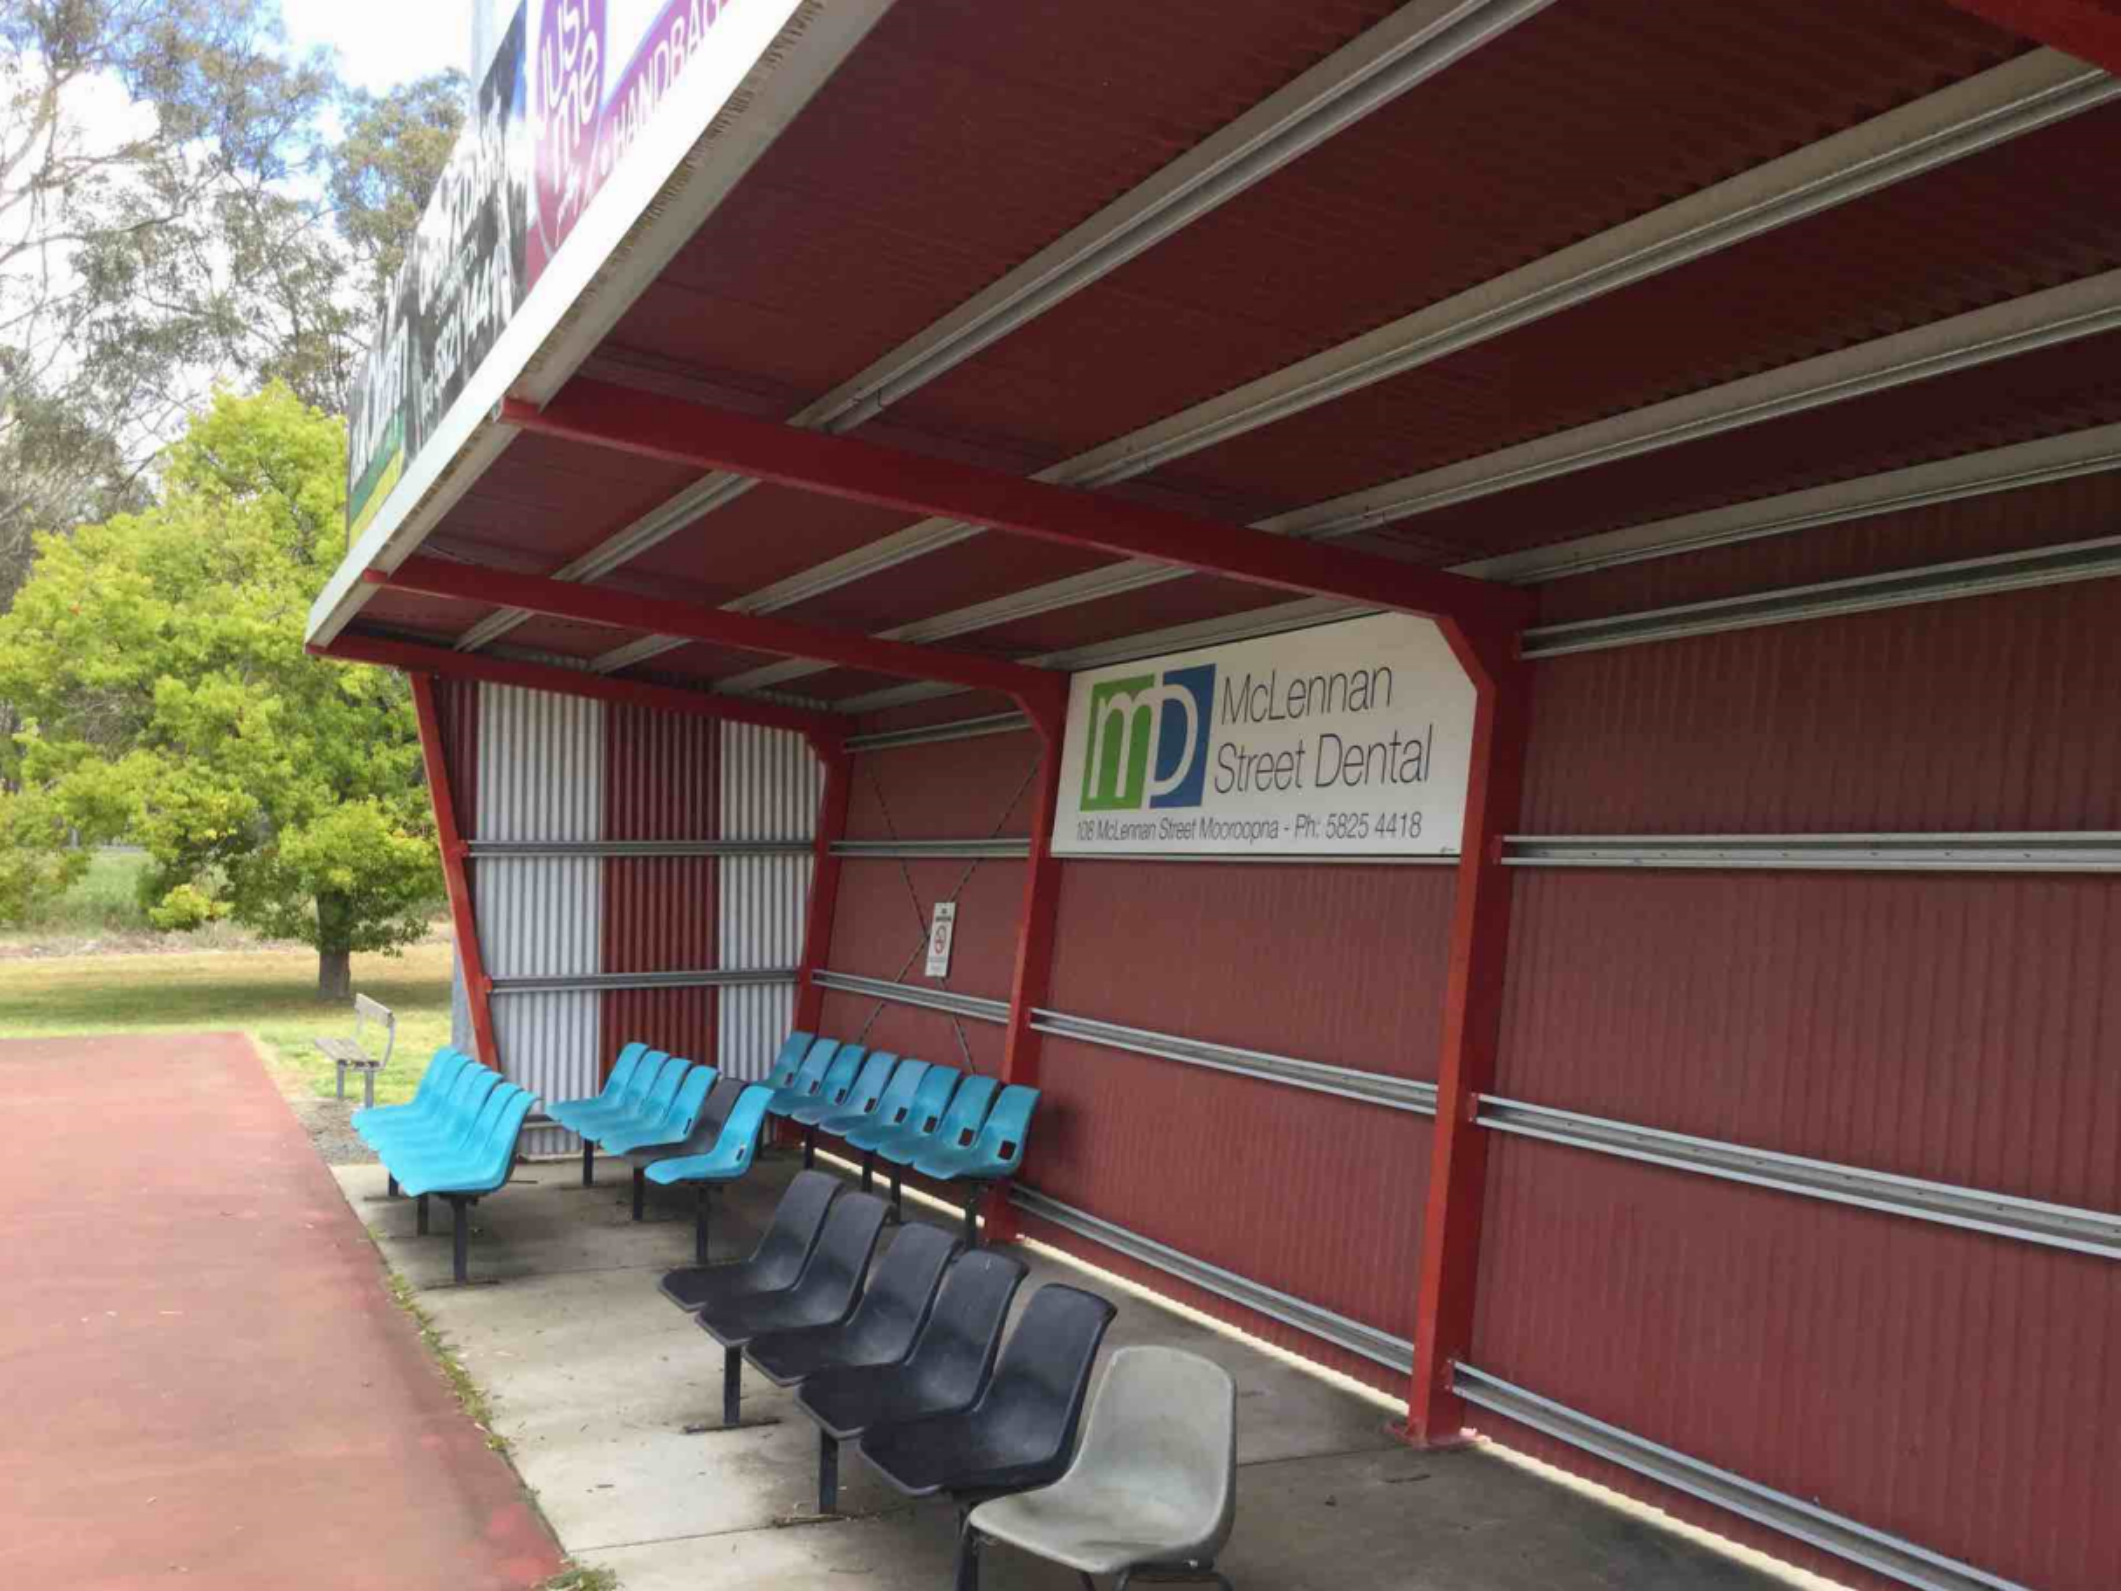
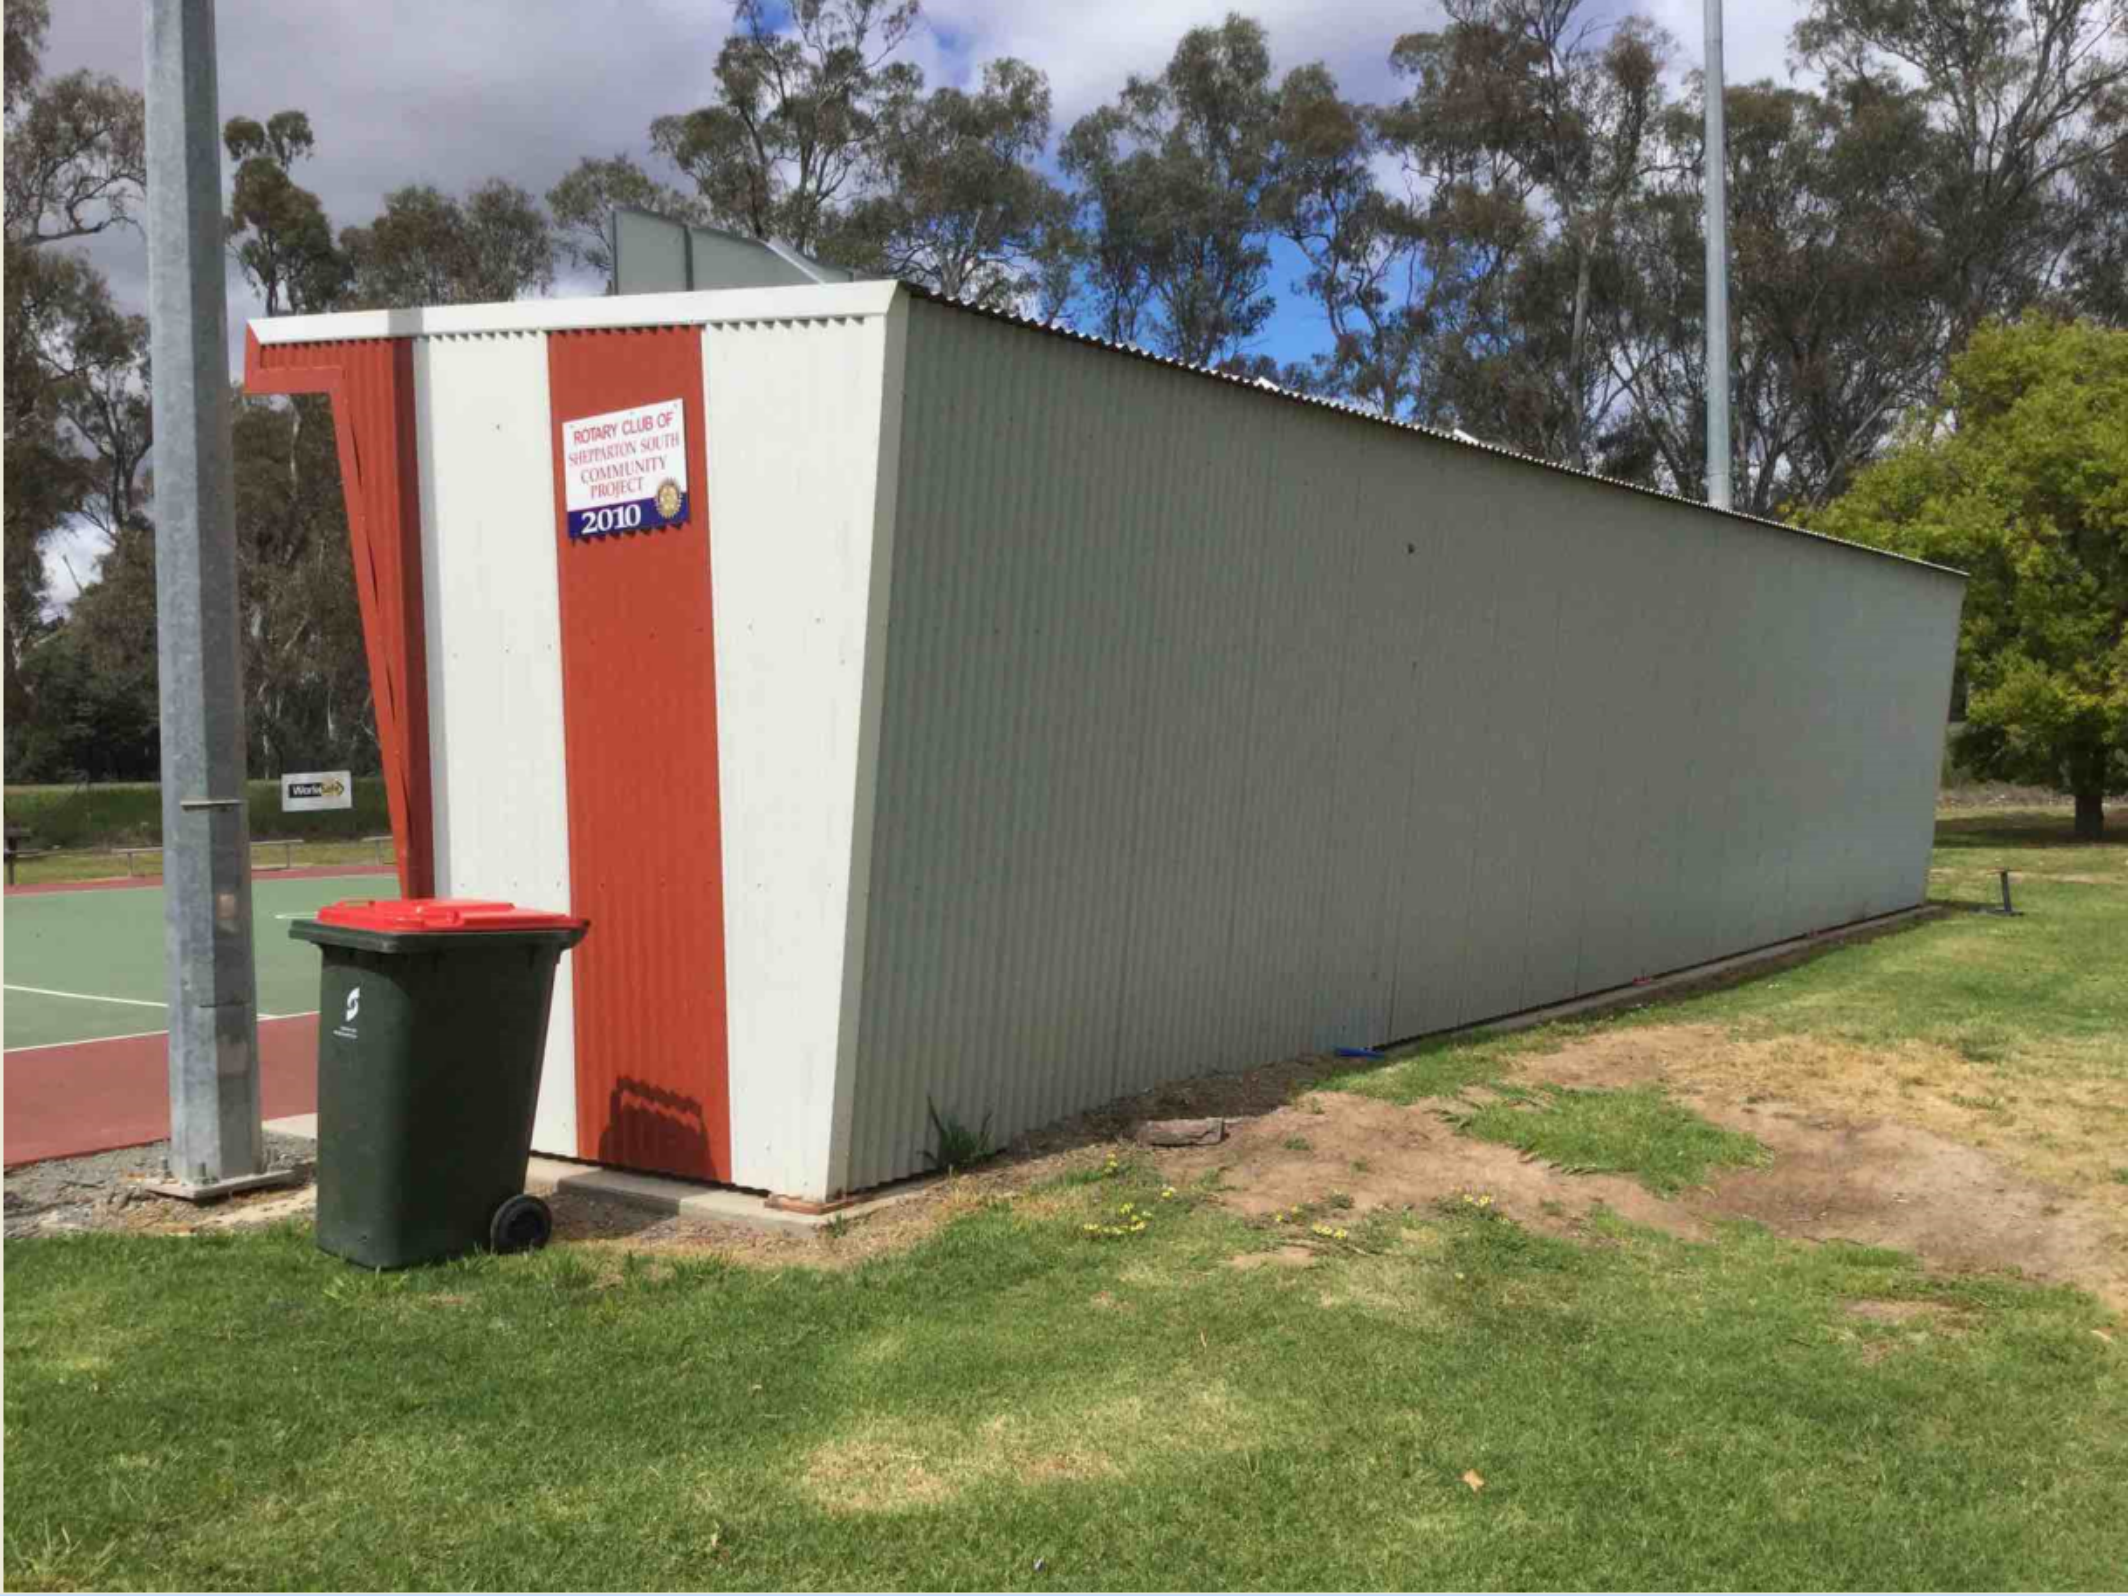
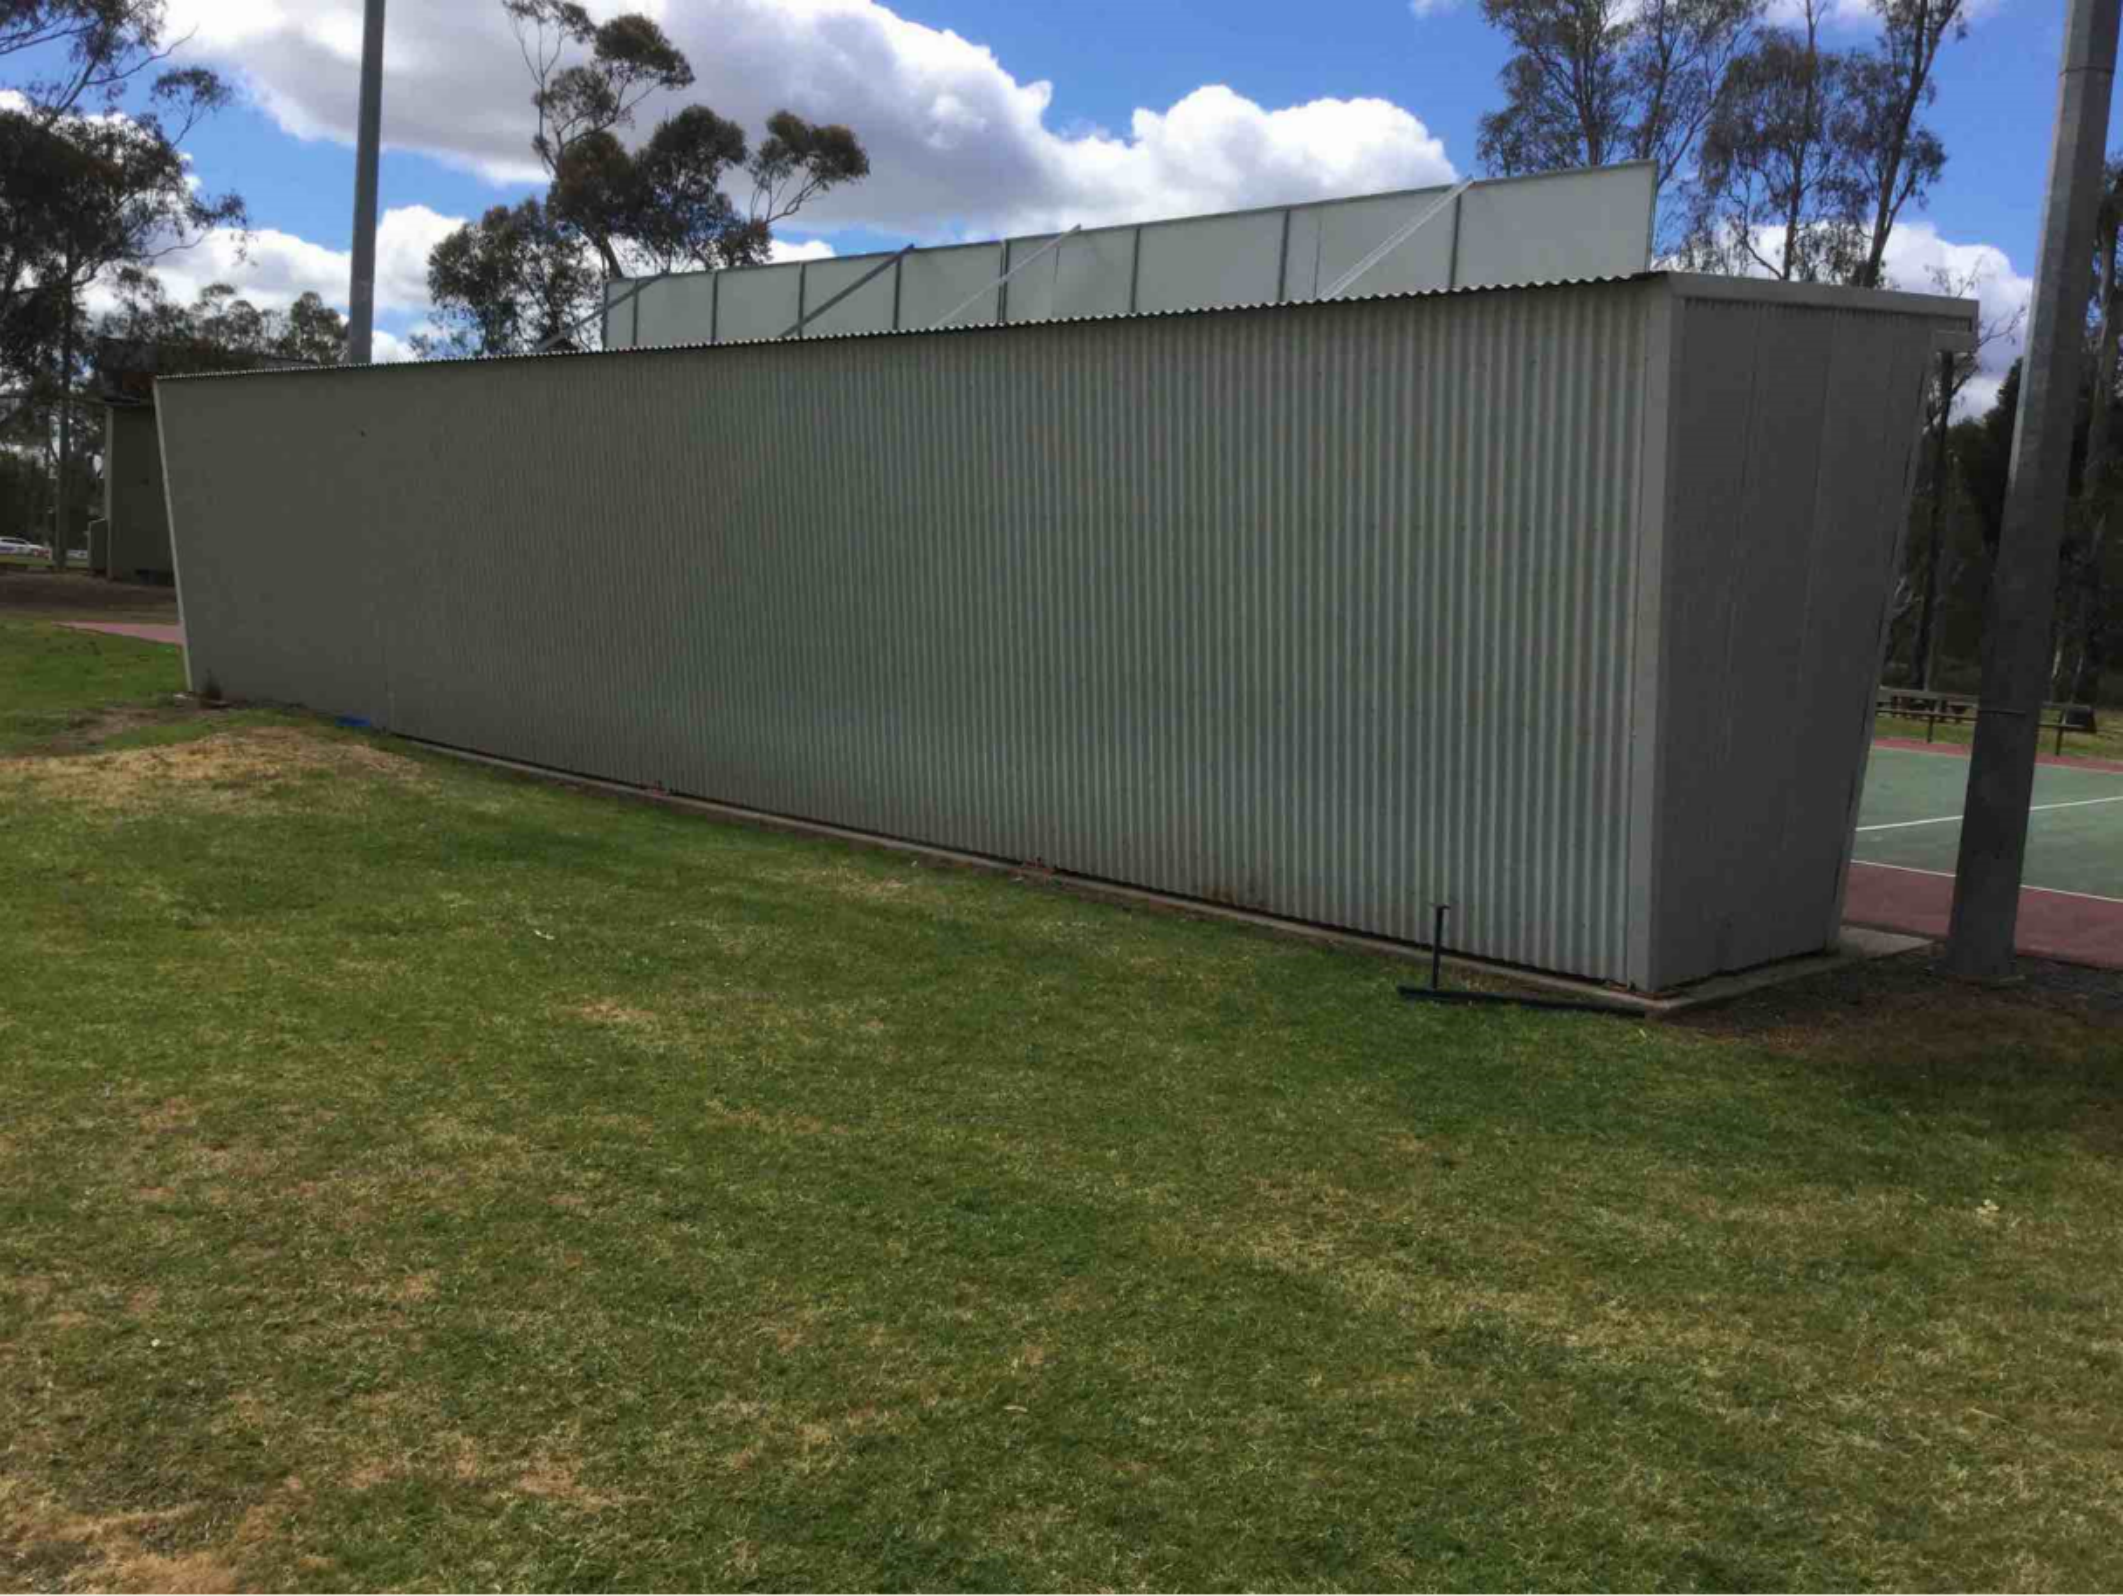
Observation Type	Code	Grade	Score	Notes
BU-Building Overall Condition	BUOC	Good	3.0000	Shelter is in excellent condition.
BU-Ceiling Condition	BUCE	Excellent	.0000	N/A
BU-Fitout Condition	BUFI	Good	4.0000	Secondhand seating installed inside, but in good condition.
BU-Floor Condition	BUFC	Good	3.0000	Concrete floor
BU-Internal Wall Condition	BUIC	Excellent	.0000	N/A
BU-Mechanical Condition	BUMC	Excellent	.0000	N/A
BU-Roof Cladding Condition	BURC	Excellent	2.0000	As new iron roof.
BU-Roof Structure Condition	BURT	Excellent	1.0000	As new steel structure.
BU-Wall Condition	BUWC	Excellent	1.0000	Colorbond walls are as new.

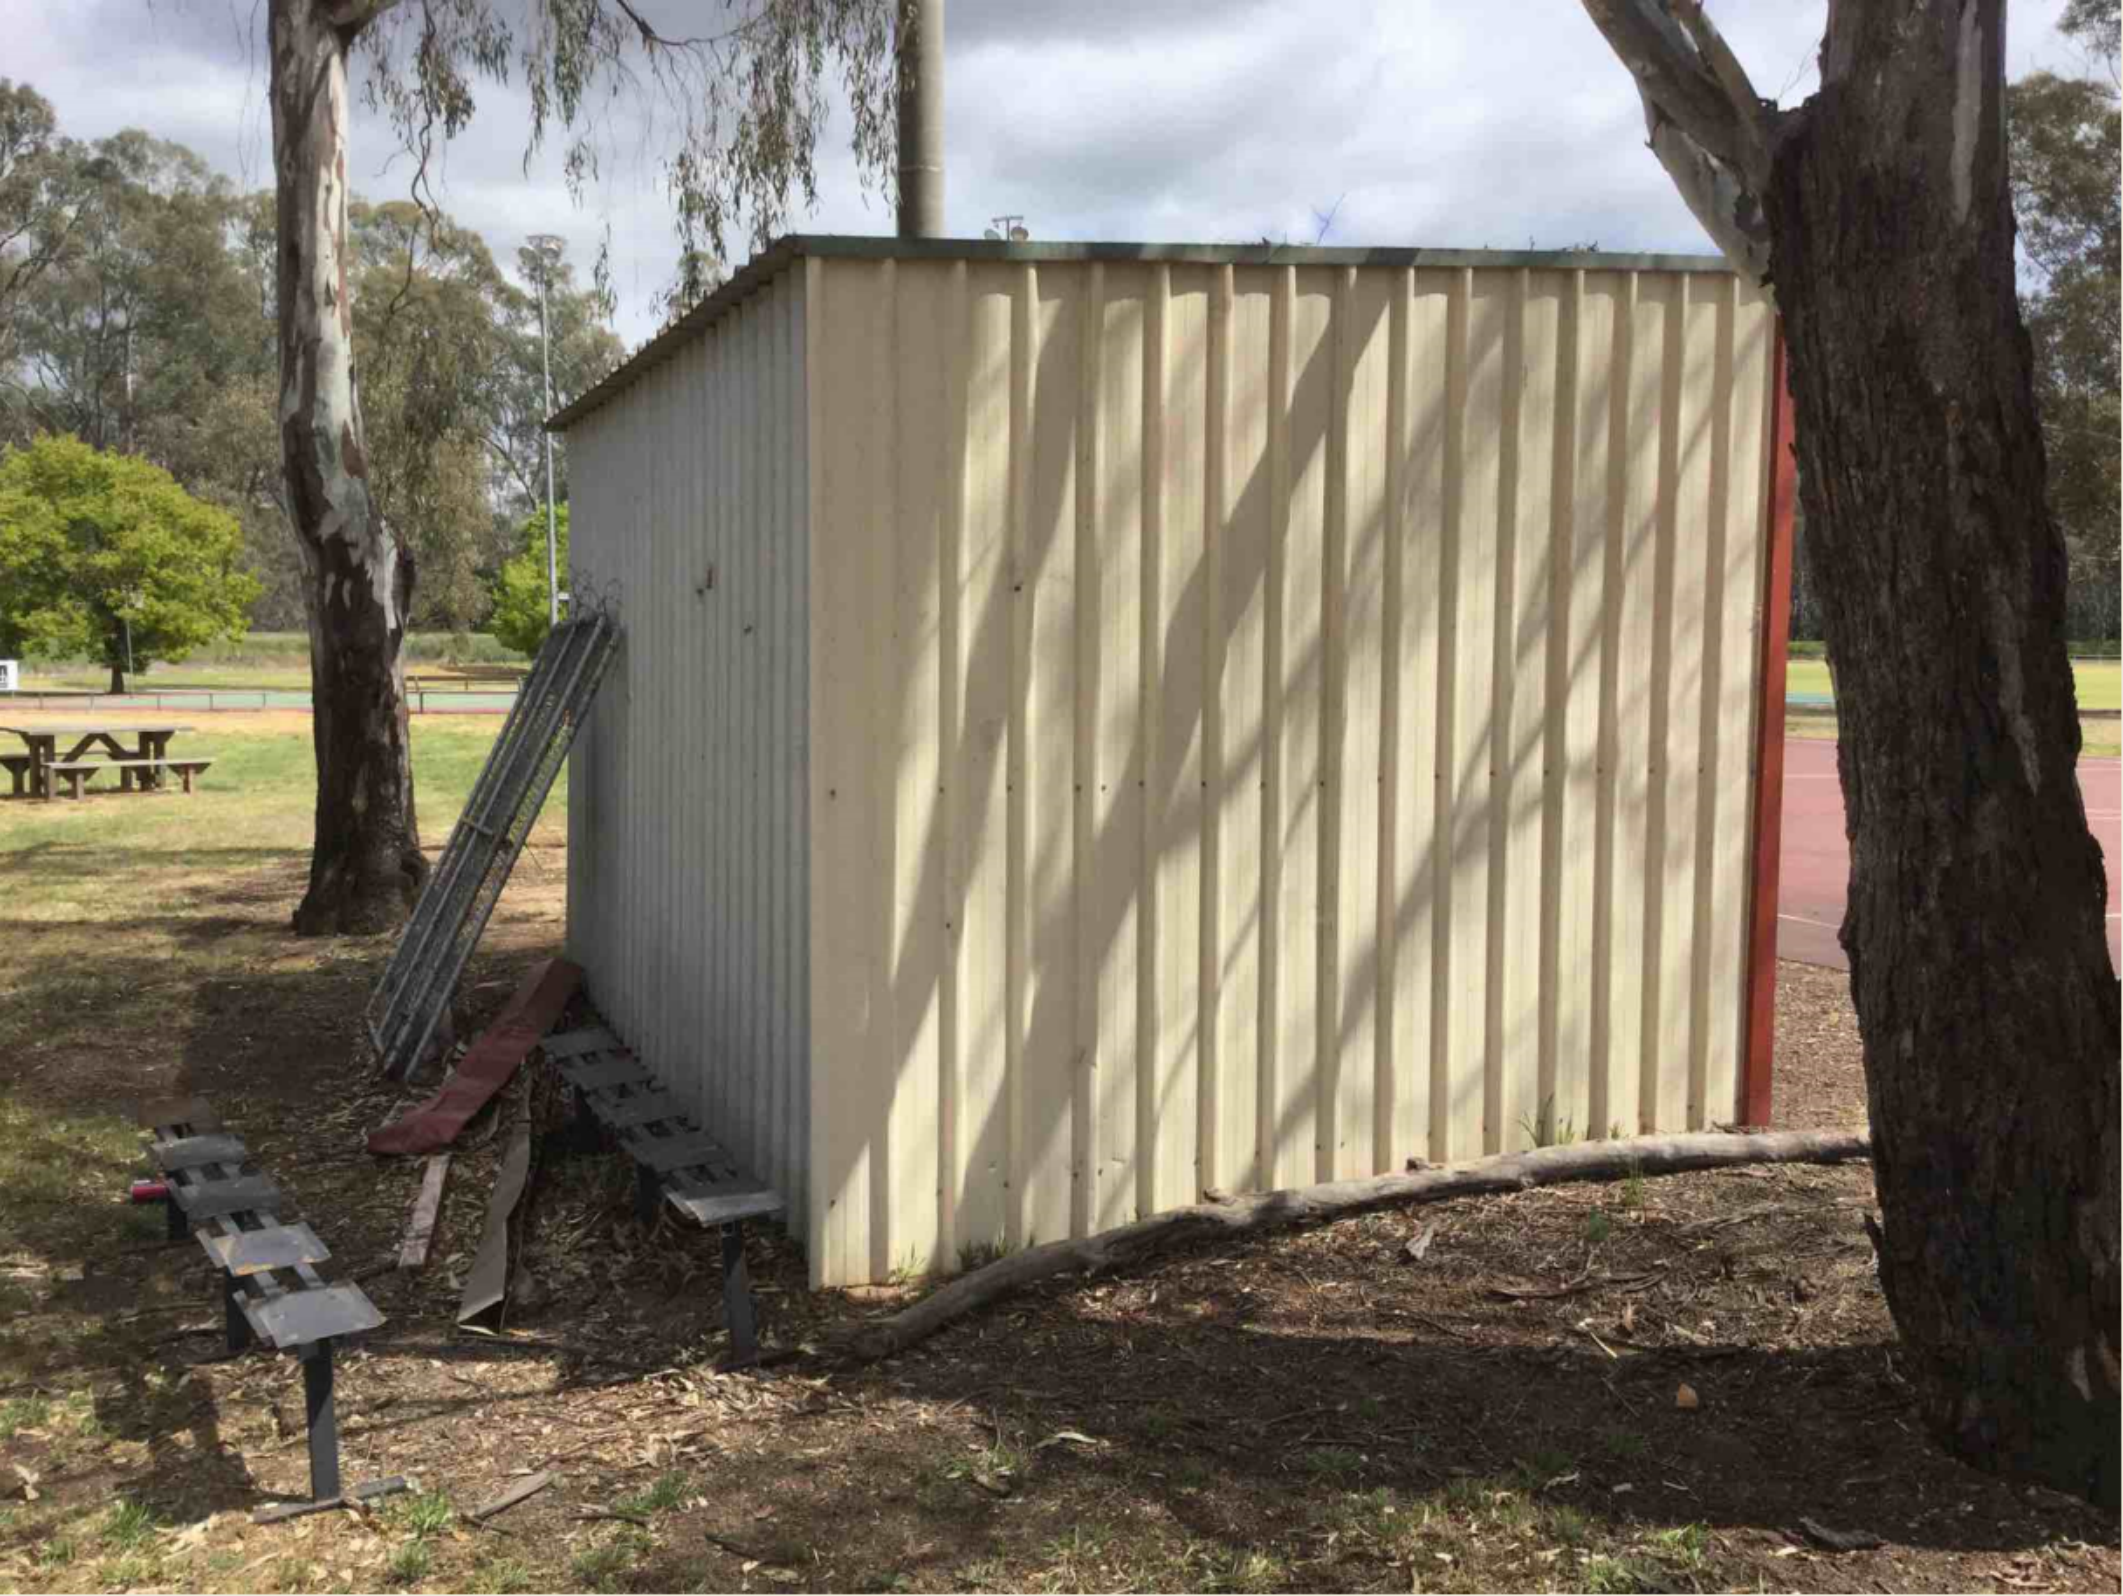
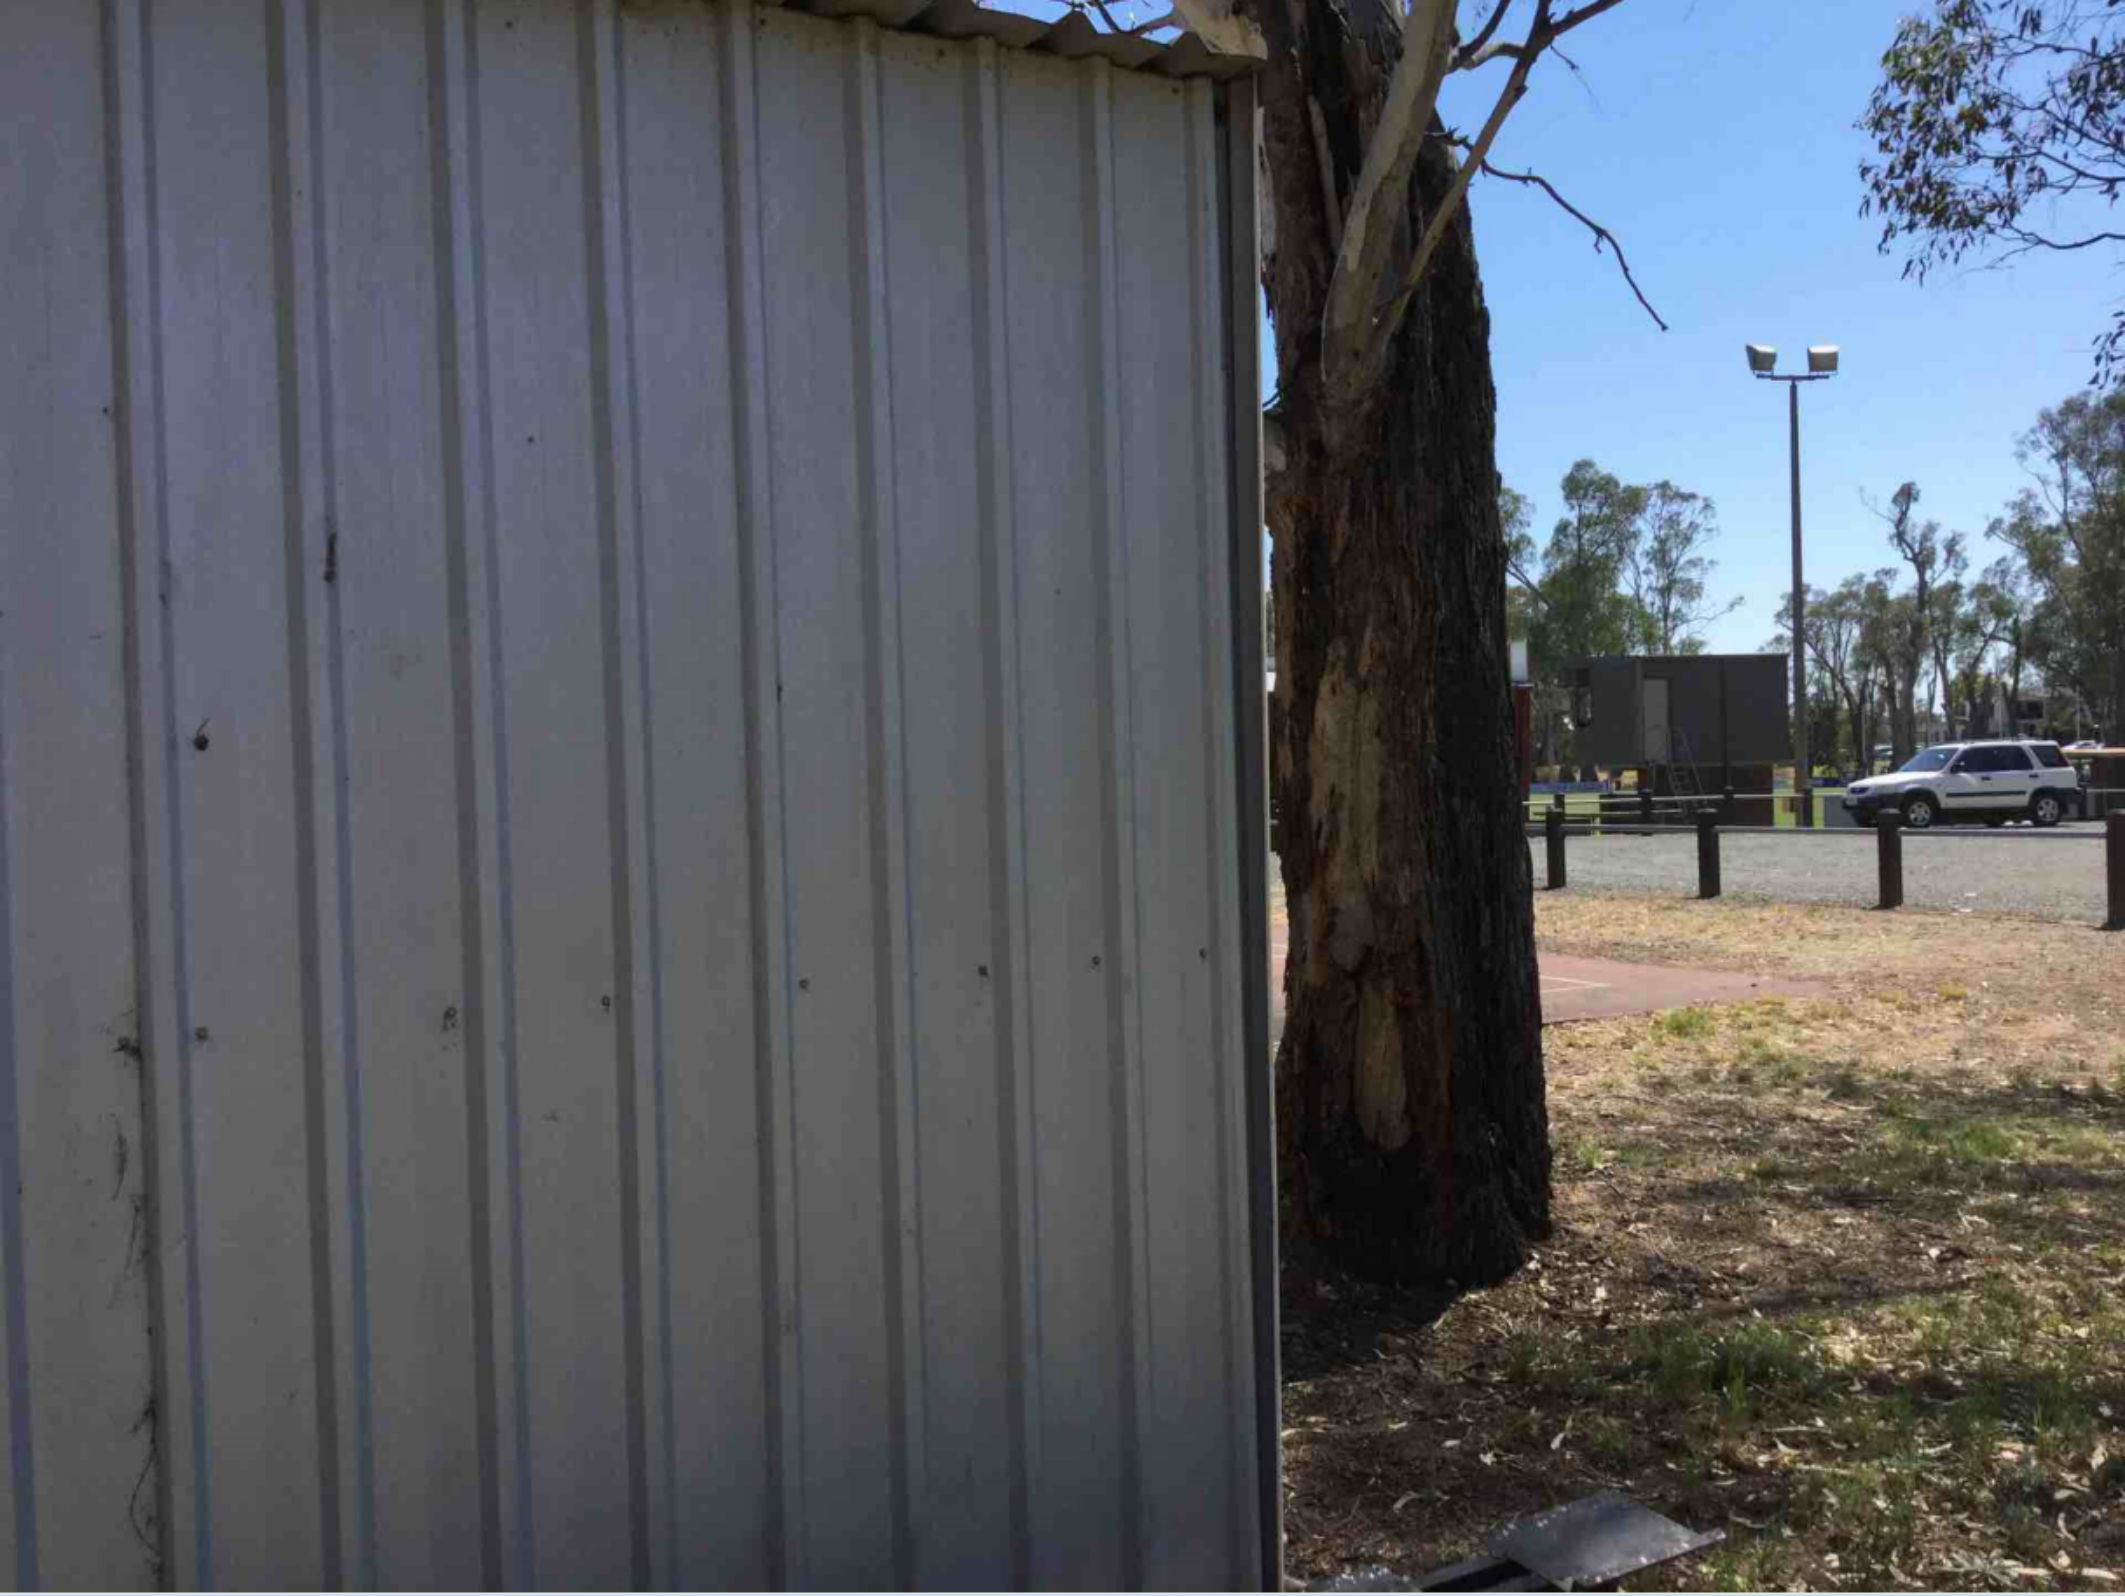
Observation Type	Code	Grade	Score	Notes
BU-Building Overall Condition	BUOC	Moderate	5.0000	Shed appears to be in good condition.
BU-Ceiling Condition	BUCE	Excellent	.0000	N/A
BU-Fitout Condition	BUFI	Excellent	.0000	N/A
BU-Floor Condition	BUFC	Good	3.0000	Concrete floor.
BU-Internal Wall Condition	BUIC	Excellent	.0000	N/A
BU-Mechanical Condition	BUMC	Excellent	.0000	N/A
BU-Roof Cladding Condition	BURC	Moderate	5.0000	Iron roof with no roof gutter.
BU-Roof Structure Condition	BURT	Good	4.0000	Appears to be a solid steel structure.
BU-Wall Condition	BUWC	Moderate	5.0000	Colorbond walls are good, but some of the iron installation hasn't been finished off properly.
