**Officer:** John Gribben (JEG)  
**Route:** BU-Cond Surv Princess Park (BU29)  
**Report Type:** Assessment

**Site:** Princess Park (Shepparton) (F0062)

**Date:** 13/10/2017

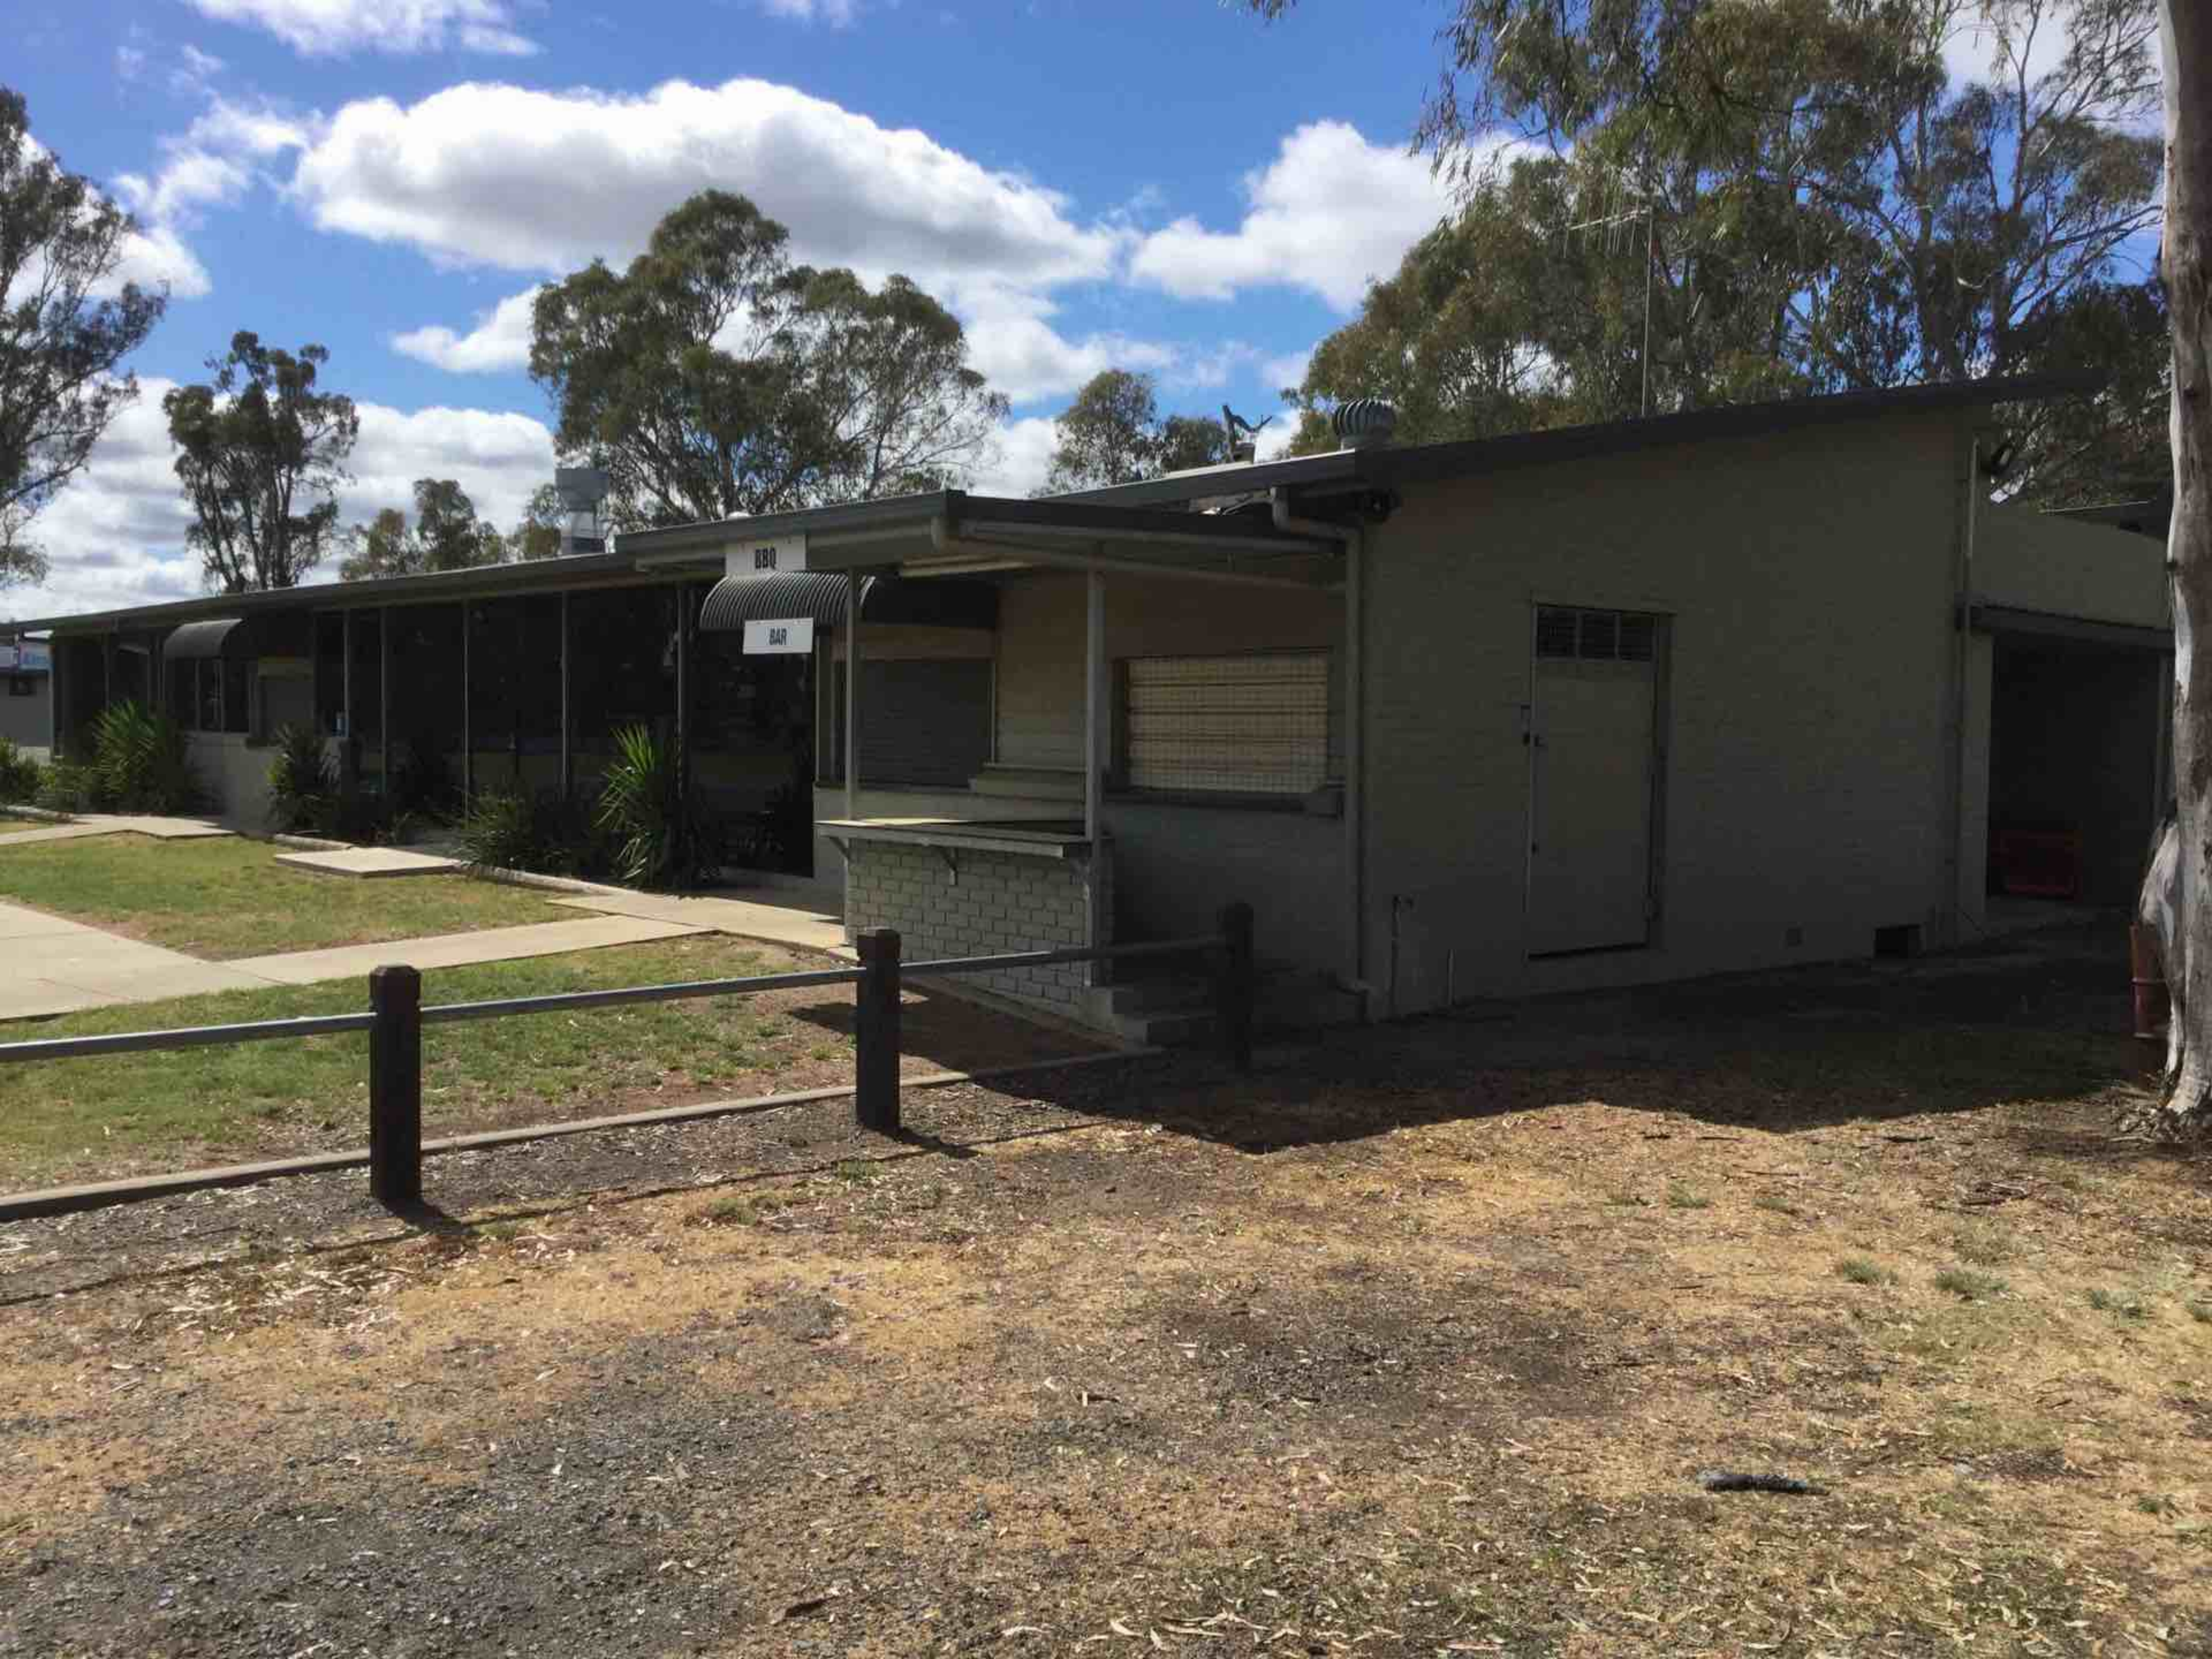
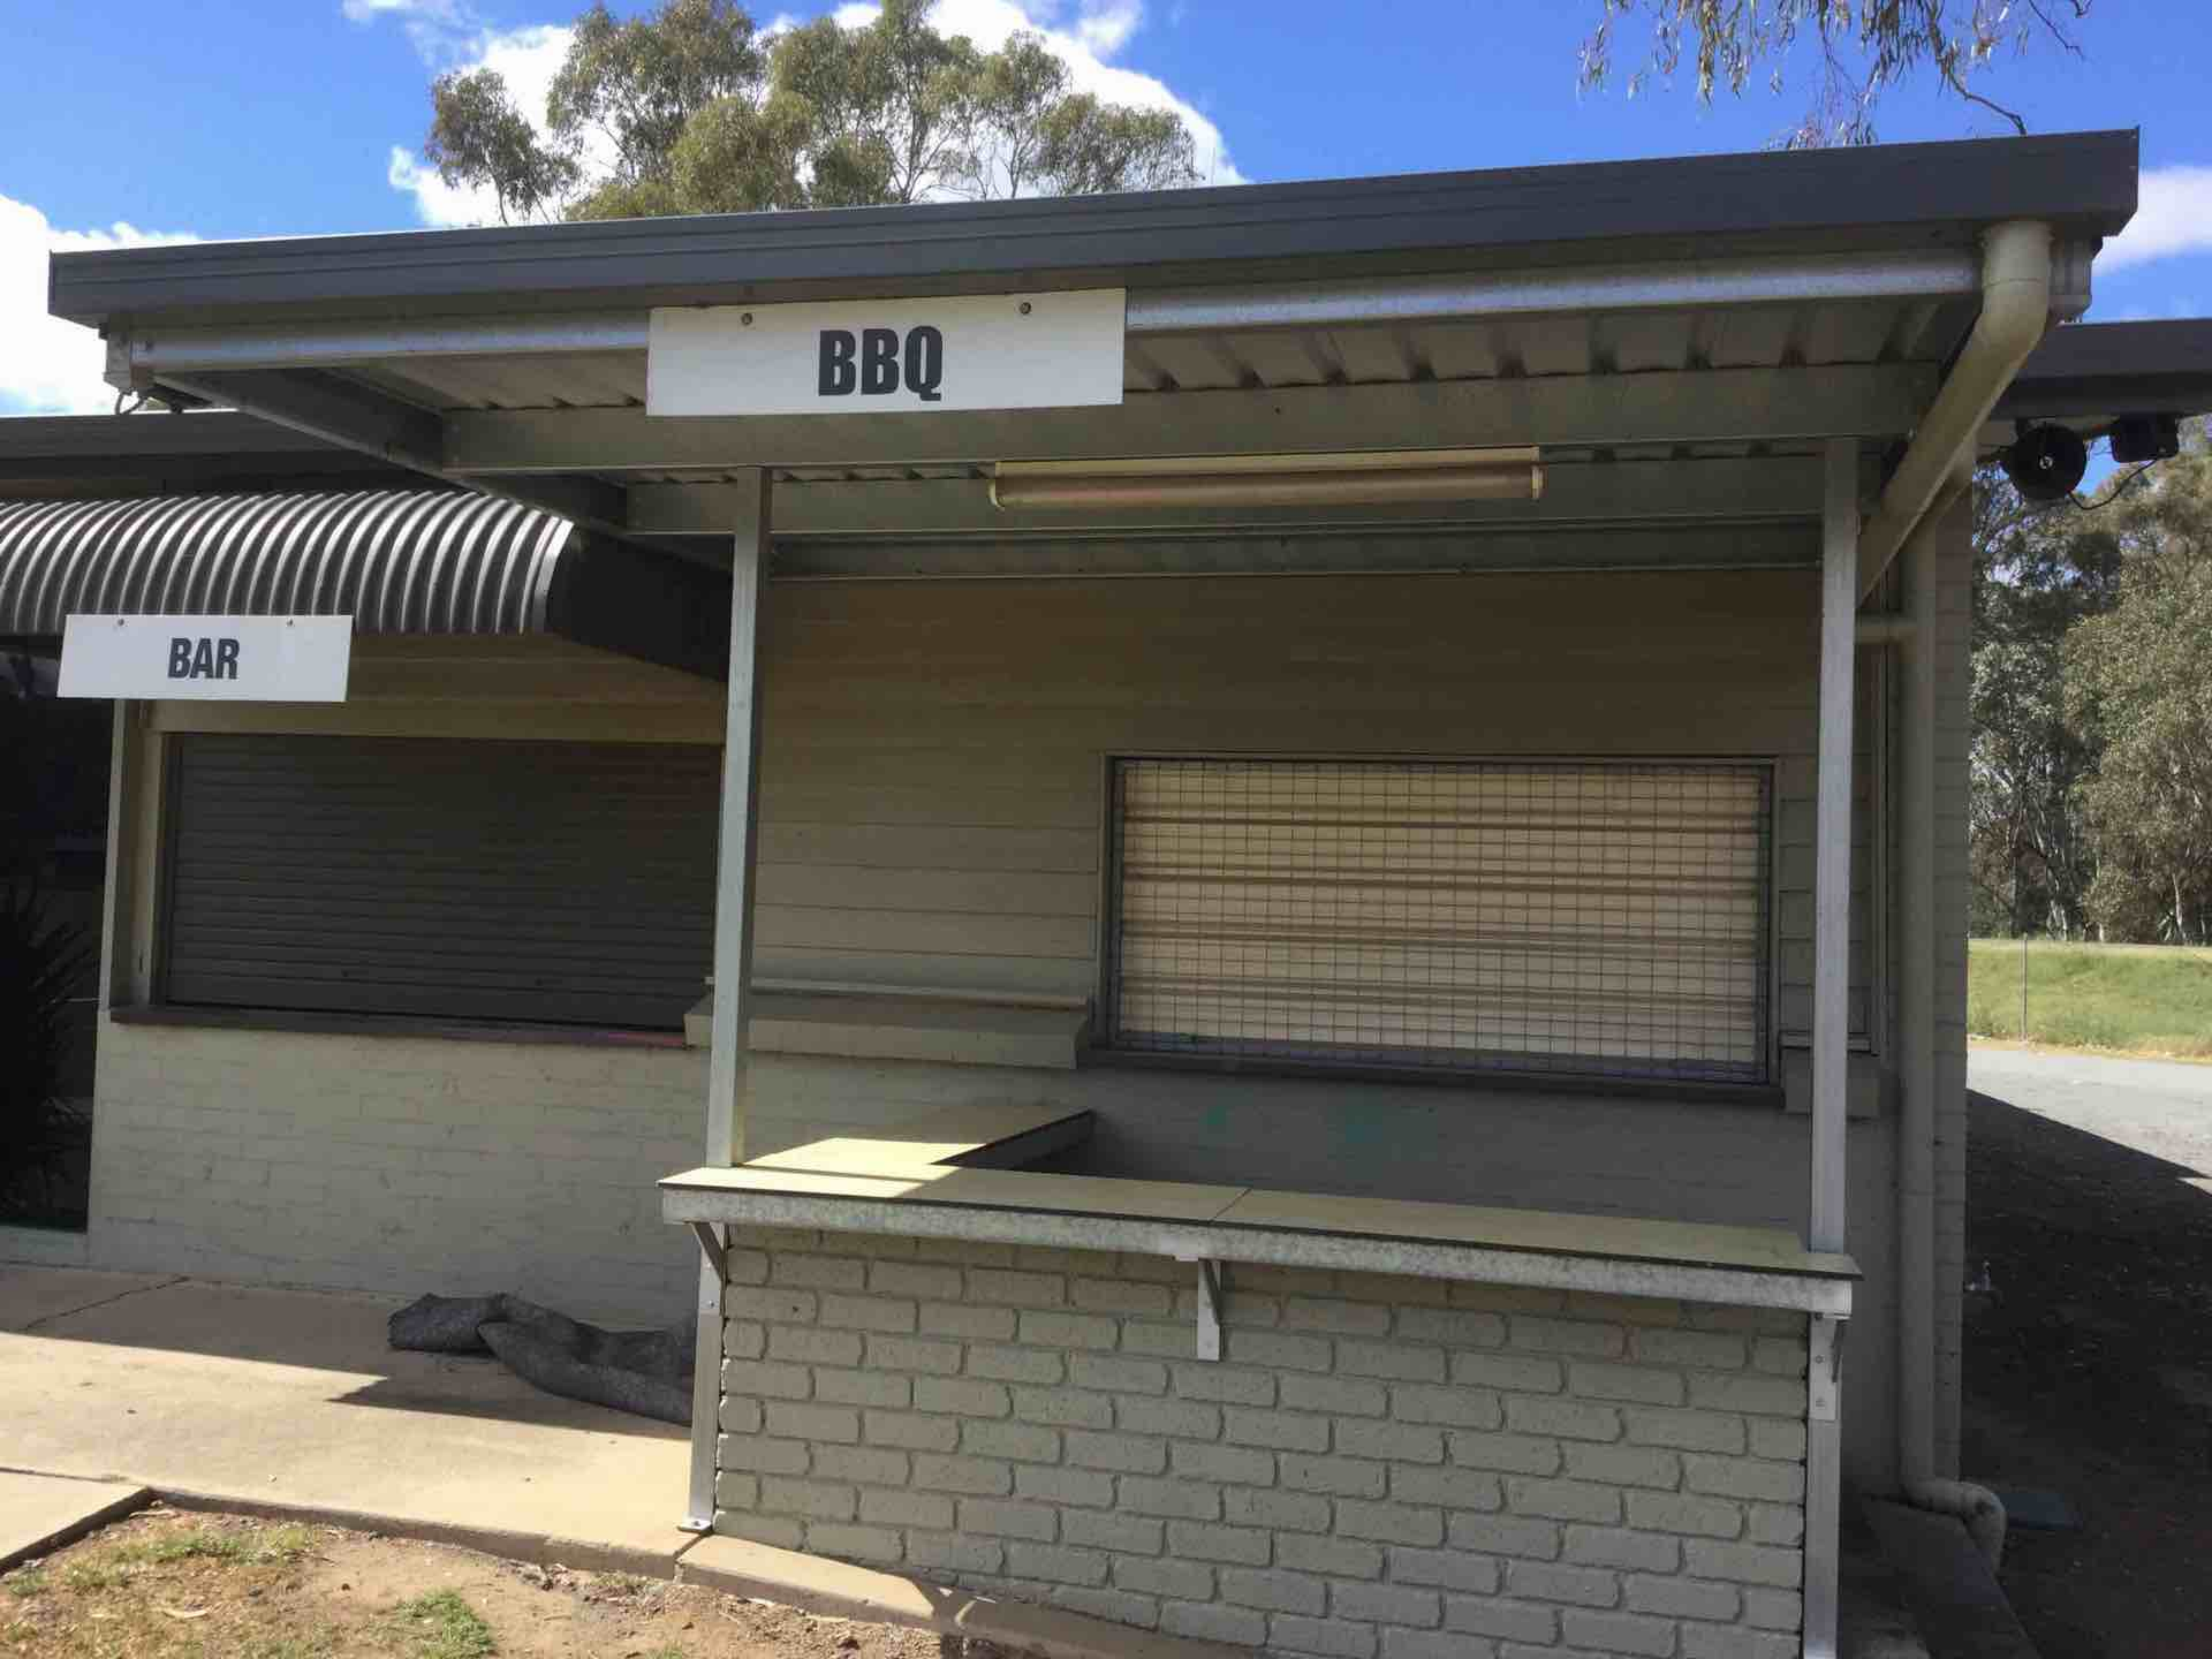
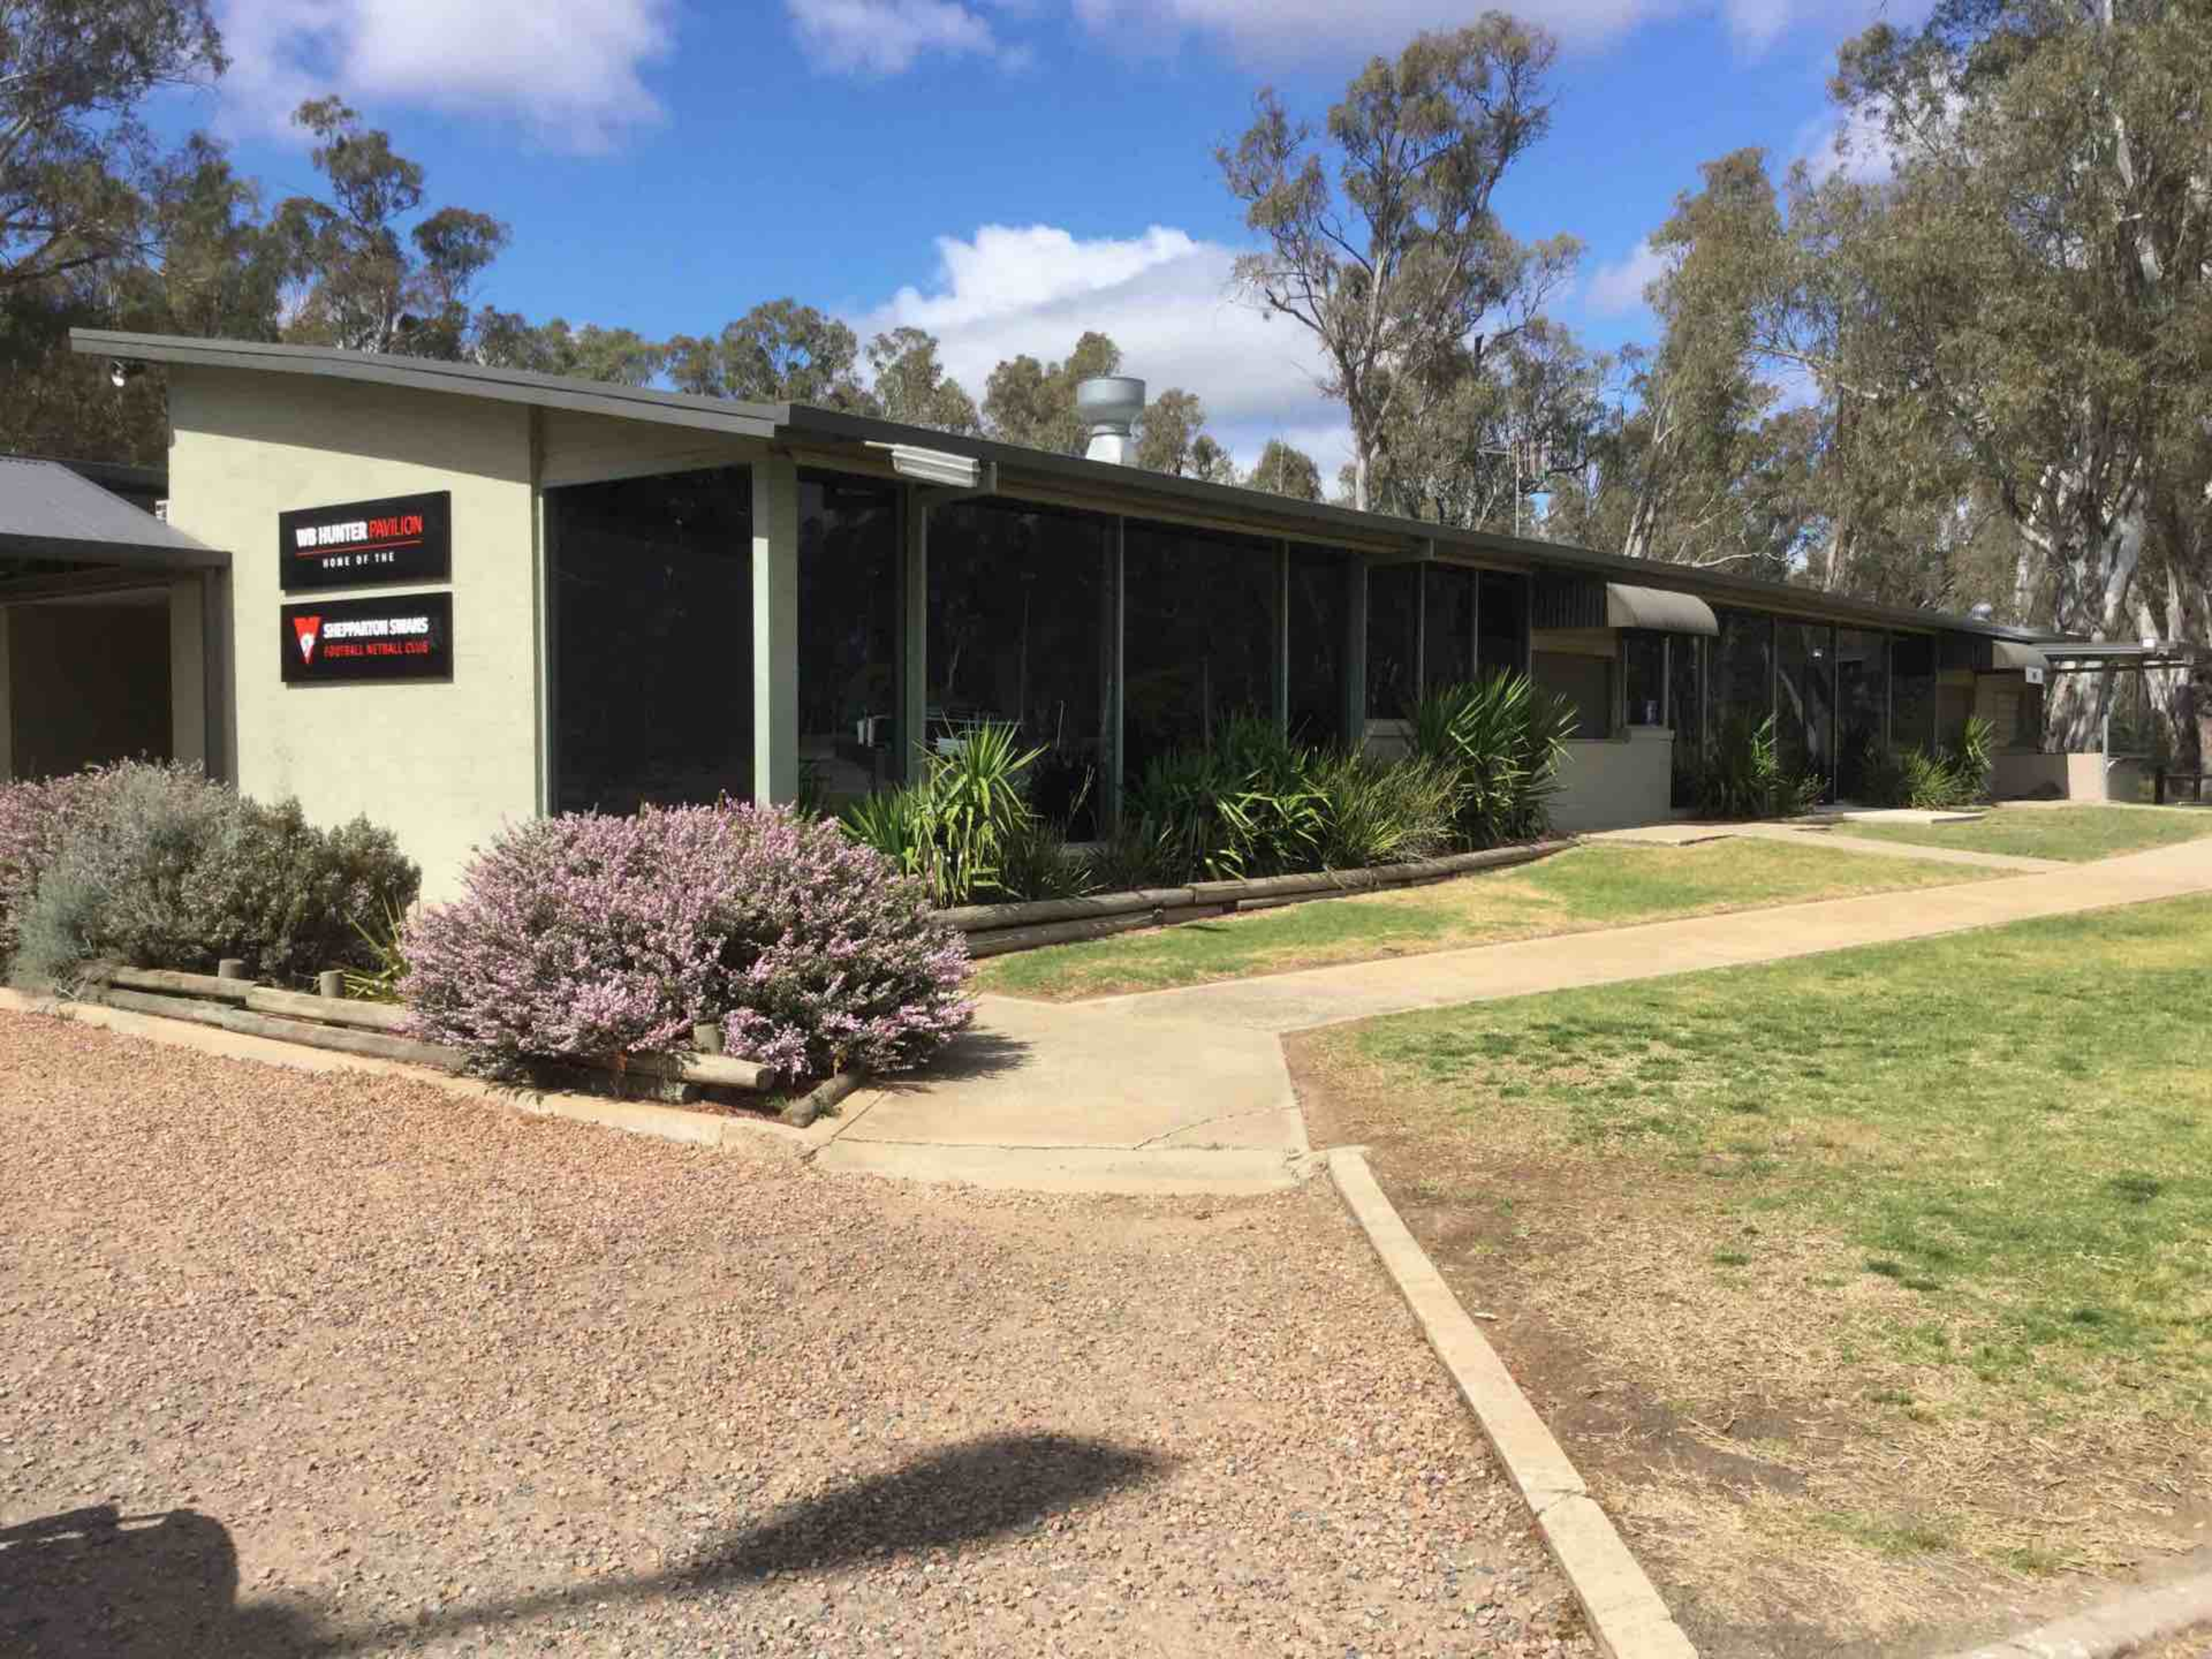
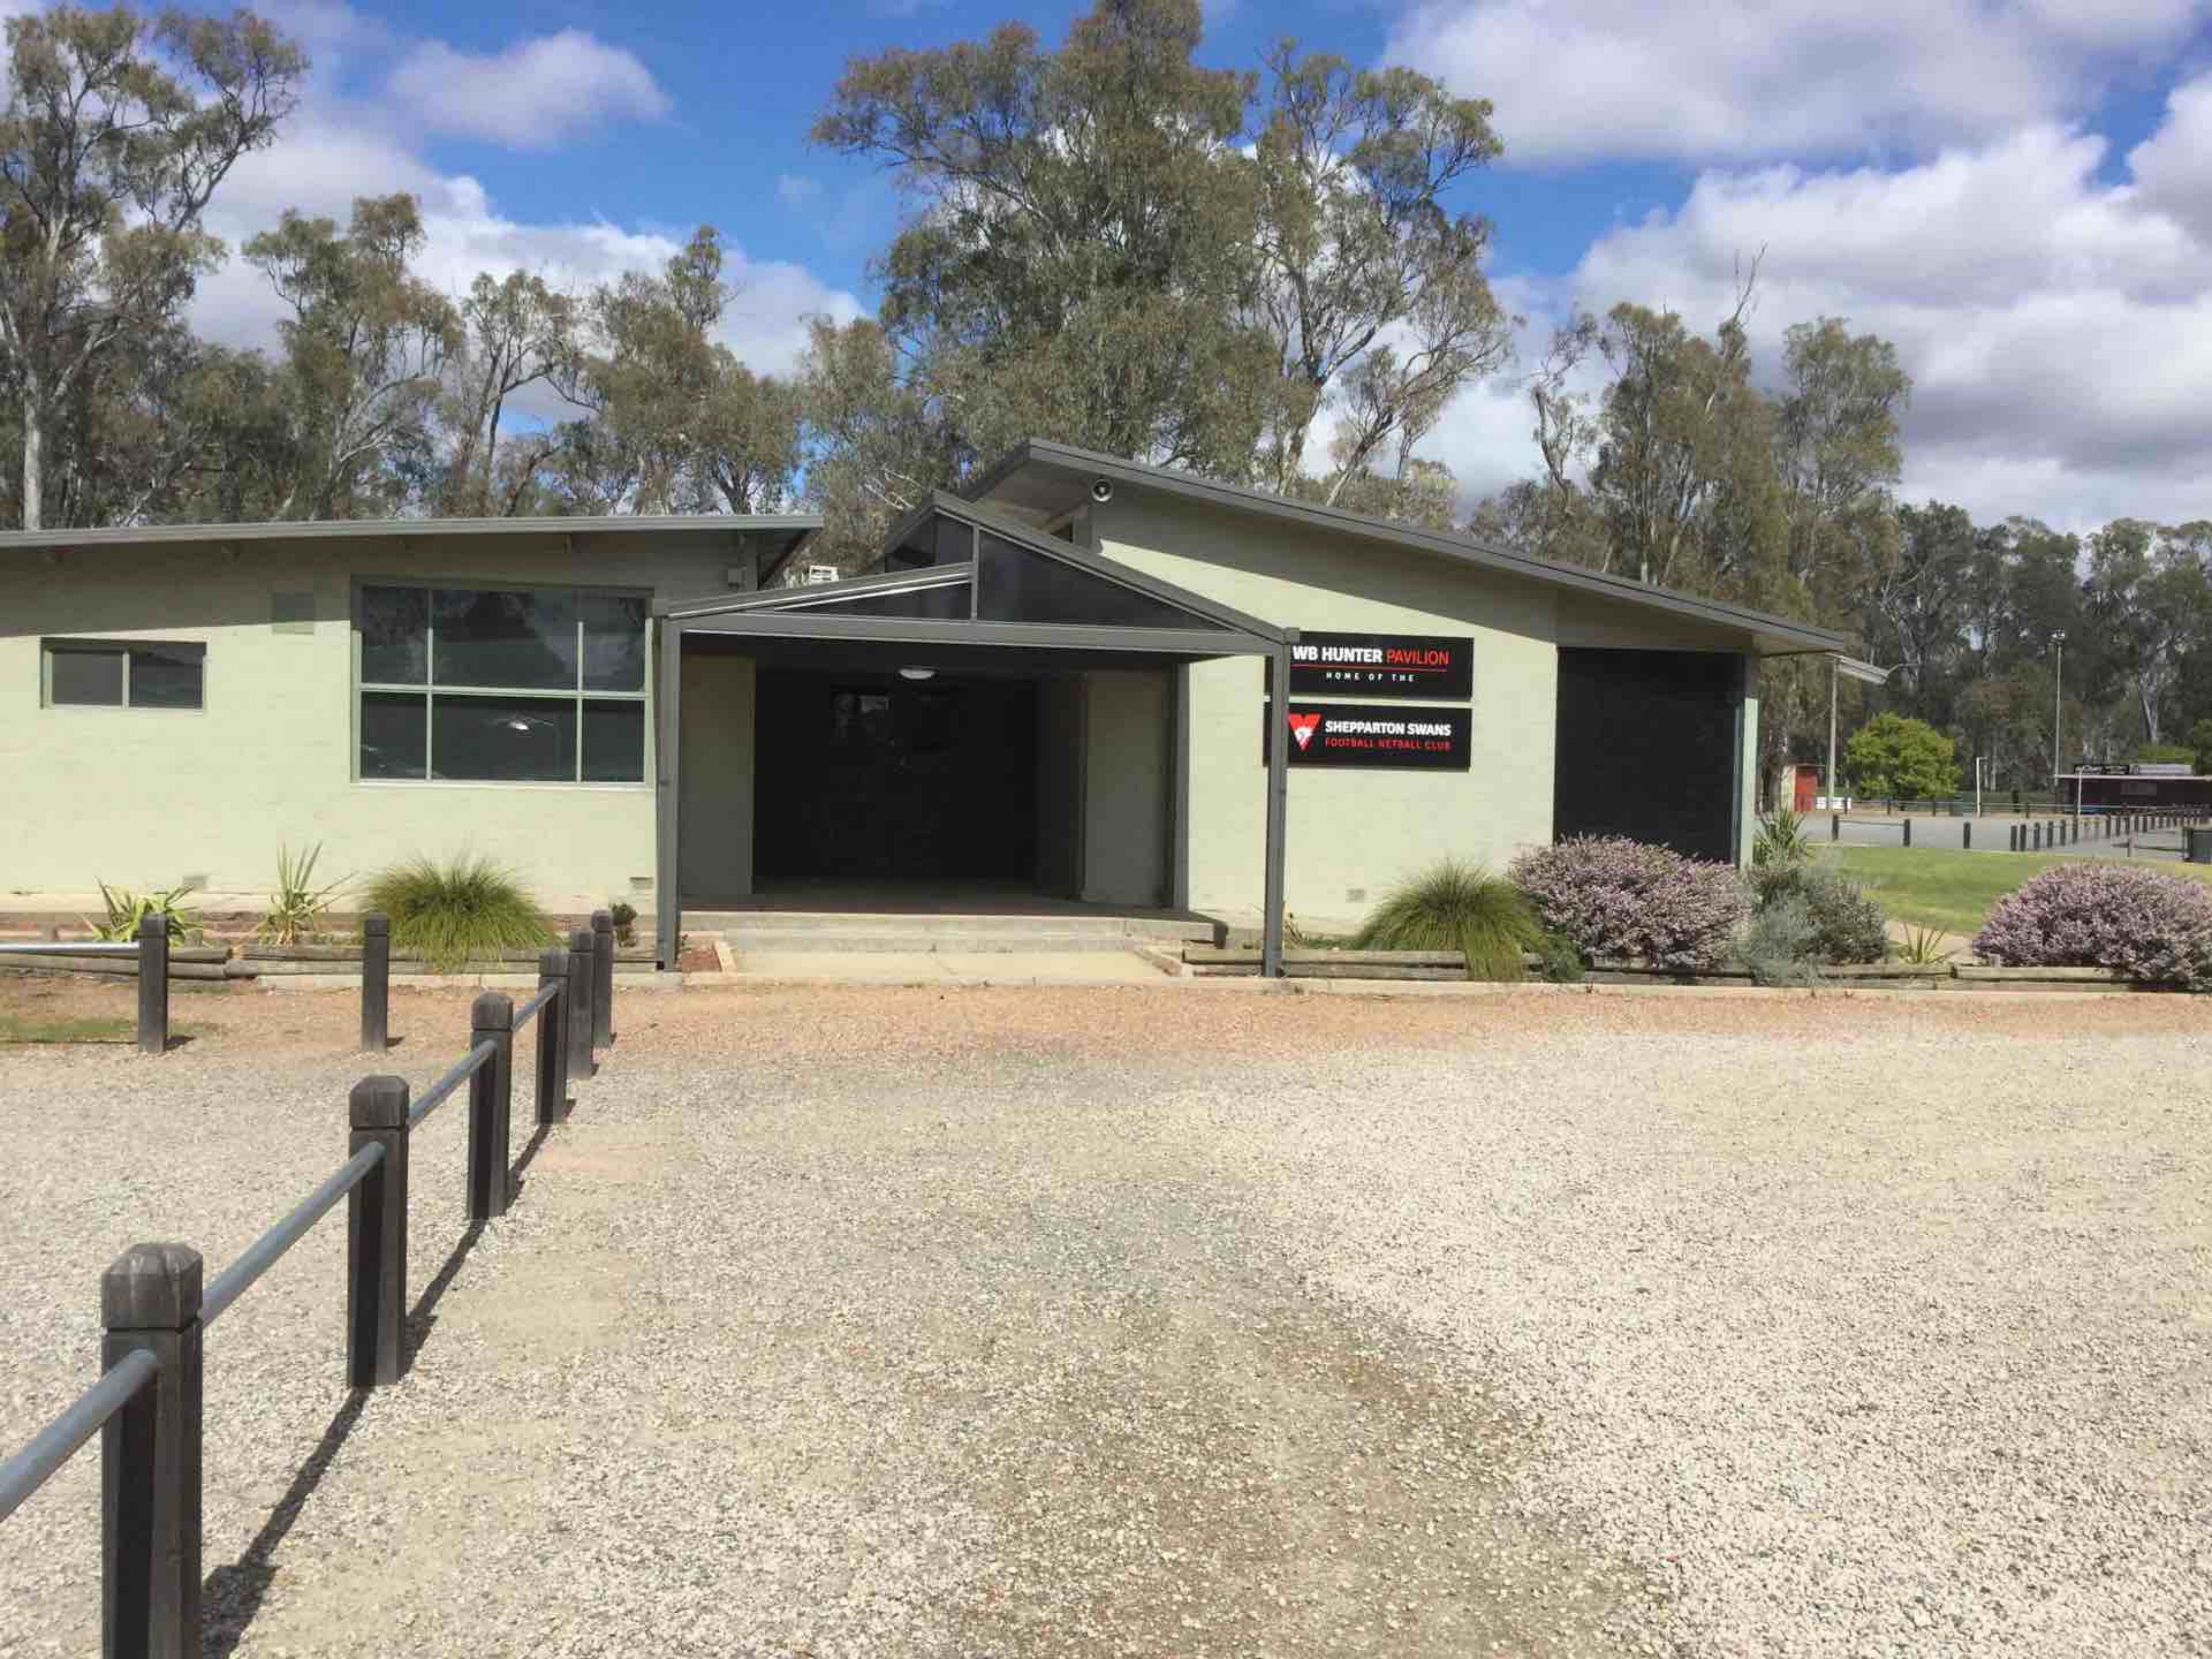
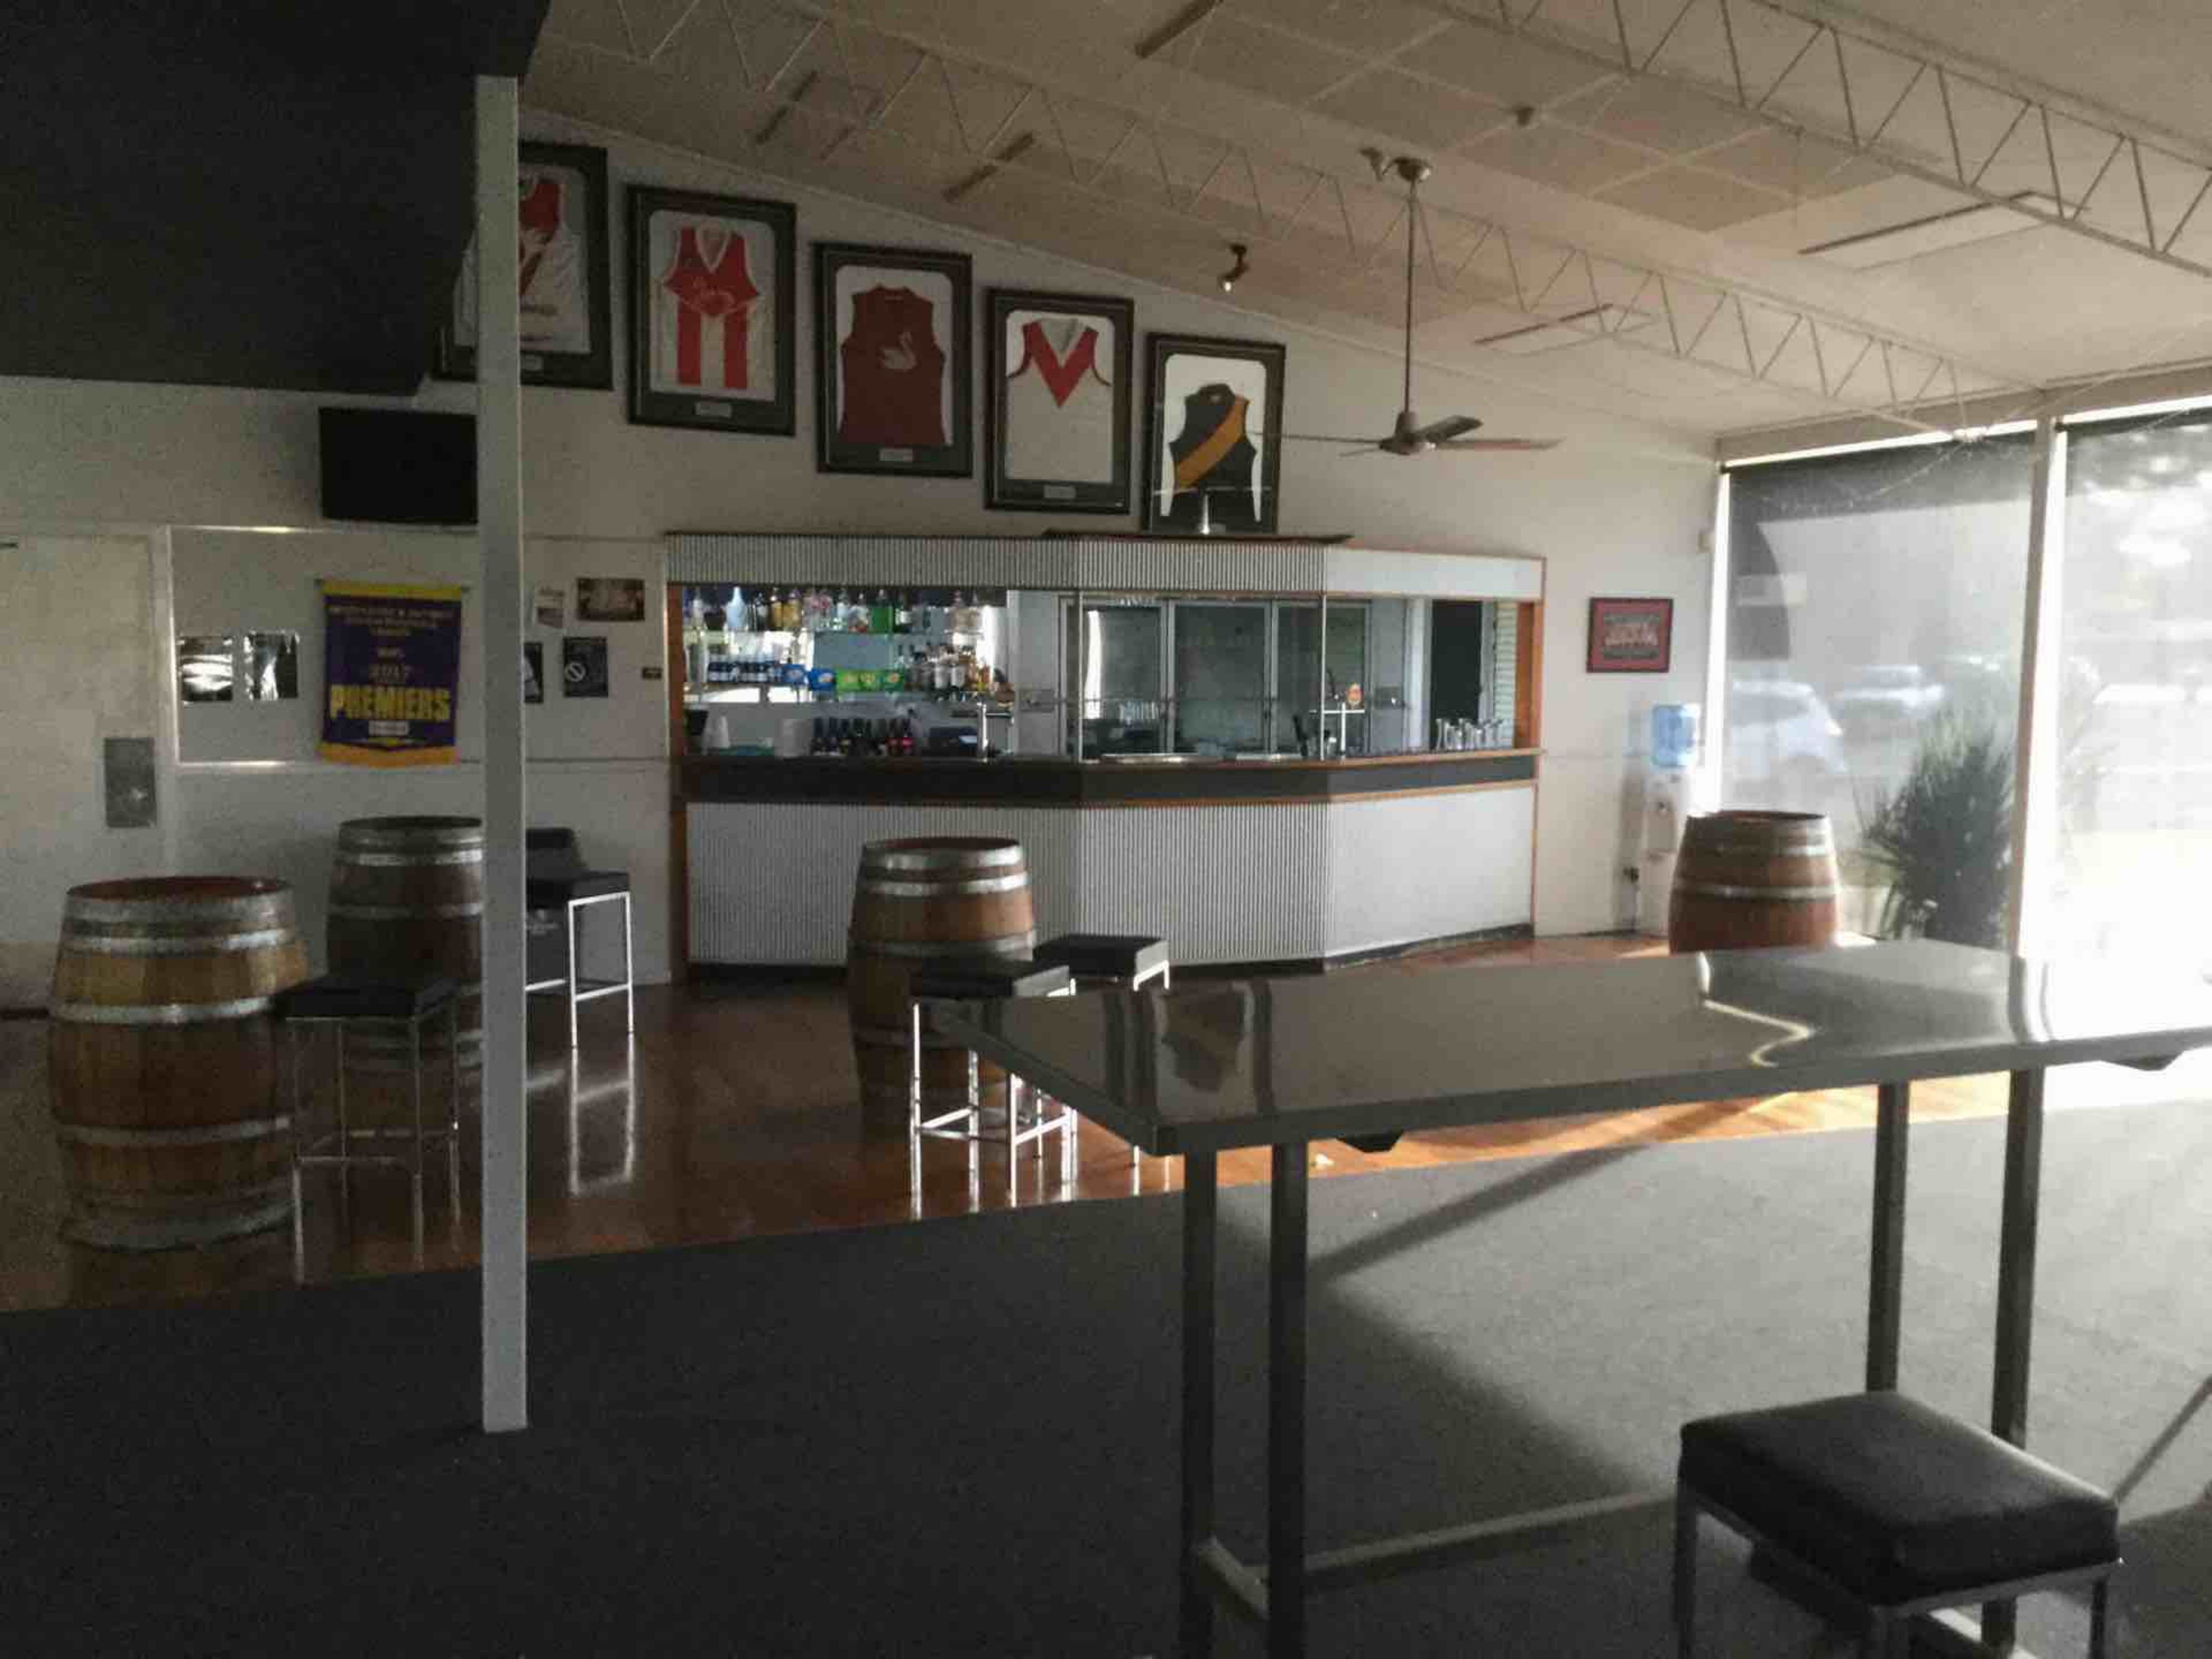
Observation Type	Code	Grade	Score	Notes
BU-Building Overall Condition	BUOC	Good	3.0000	The front/new half of the Pavillion appears to be in an excellent condition and is well maintained.
BU-Ceiling Condition	BUCE	Good	3.0000	Ceiling is in a very good condition.
BU-Fitout Condition	BUFI	Good	3.0000	An excellent fitout for the bar and kitchen. Appears very functional and well used.
BU-Floor Condition	BUFC	Good	3.0000	New carpet, well maintained floor tiles in kitchen etc.
BU-Internal Wall Condition	BUIC	Good	3.0000	Internal walls appear to be in excellent condition.
BU-Mechanical Condition	BUMC	Good	3.0000	New split system in are next to bar.
BU-Roof Cladding Condition	BURC	Good	4.0000	Original roof cladding, but appears to be in excellent condition.
BU-Roof Structure Condition	BURT	Good	3.0000	Original roof structure appears to be in excellent condition.
BU-Wall Condition	BUWC	Good	3.0000	Walls have been externally painted in recent years, with few minor cracks showing.
