**Officer:** John Gribben (JEG)  
**Route:** BU-Cond Surv Princess Park (BU29)  
**Report Type:** Assessment

**Site:** Princess Park (Shepparton) (F0062)

**Date:** 13/10/2017

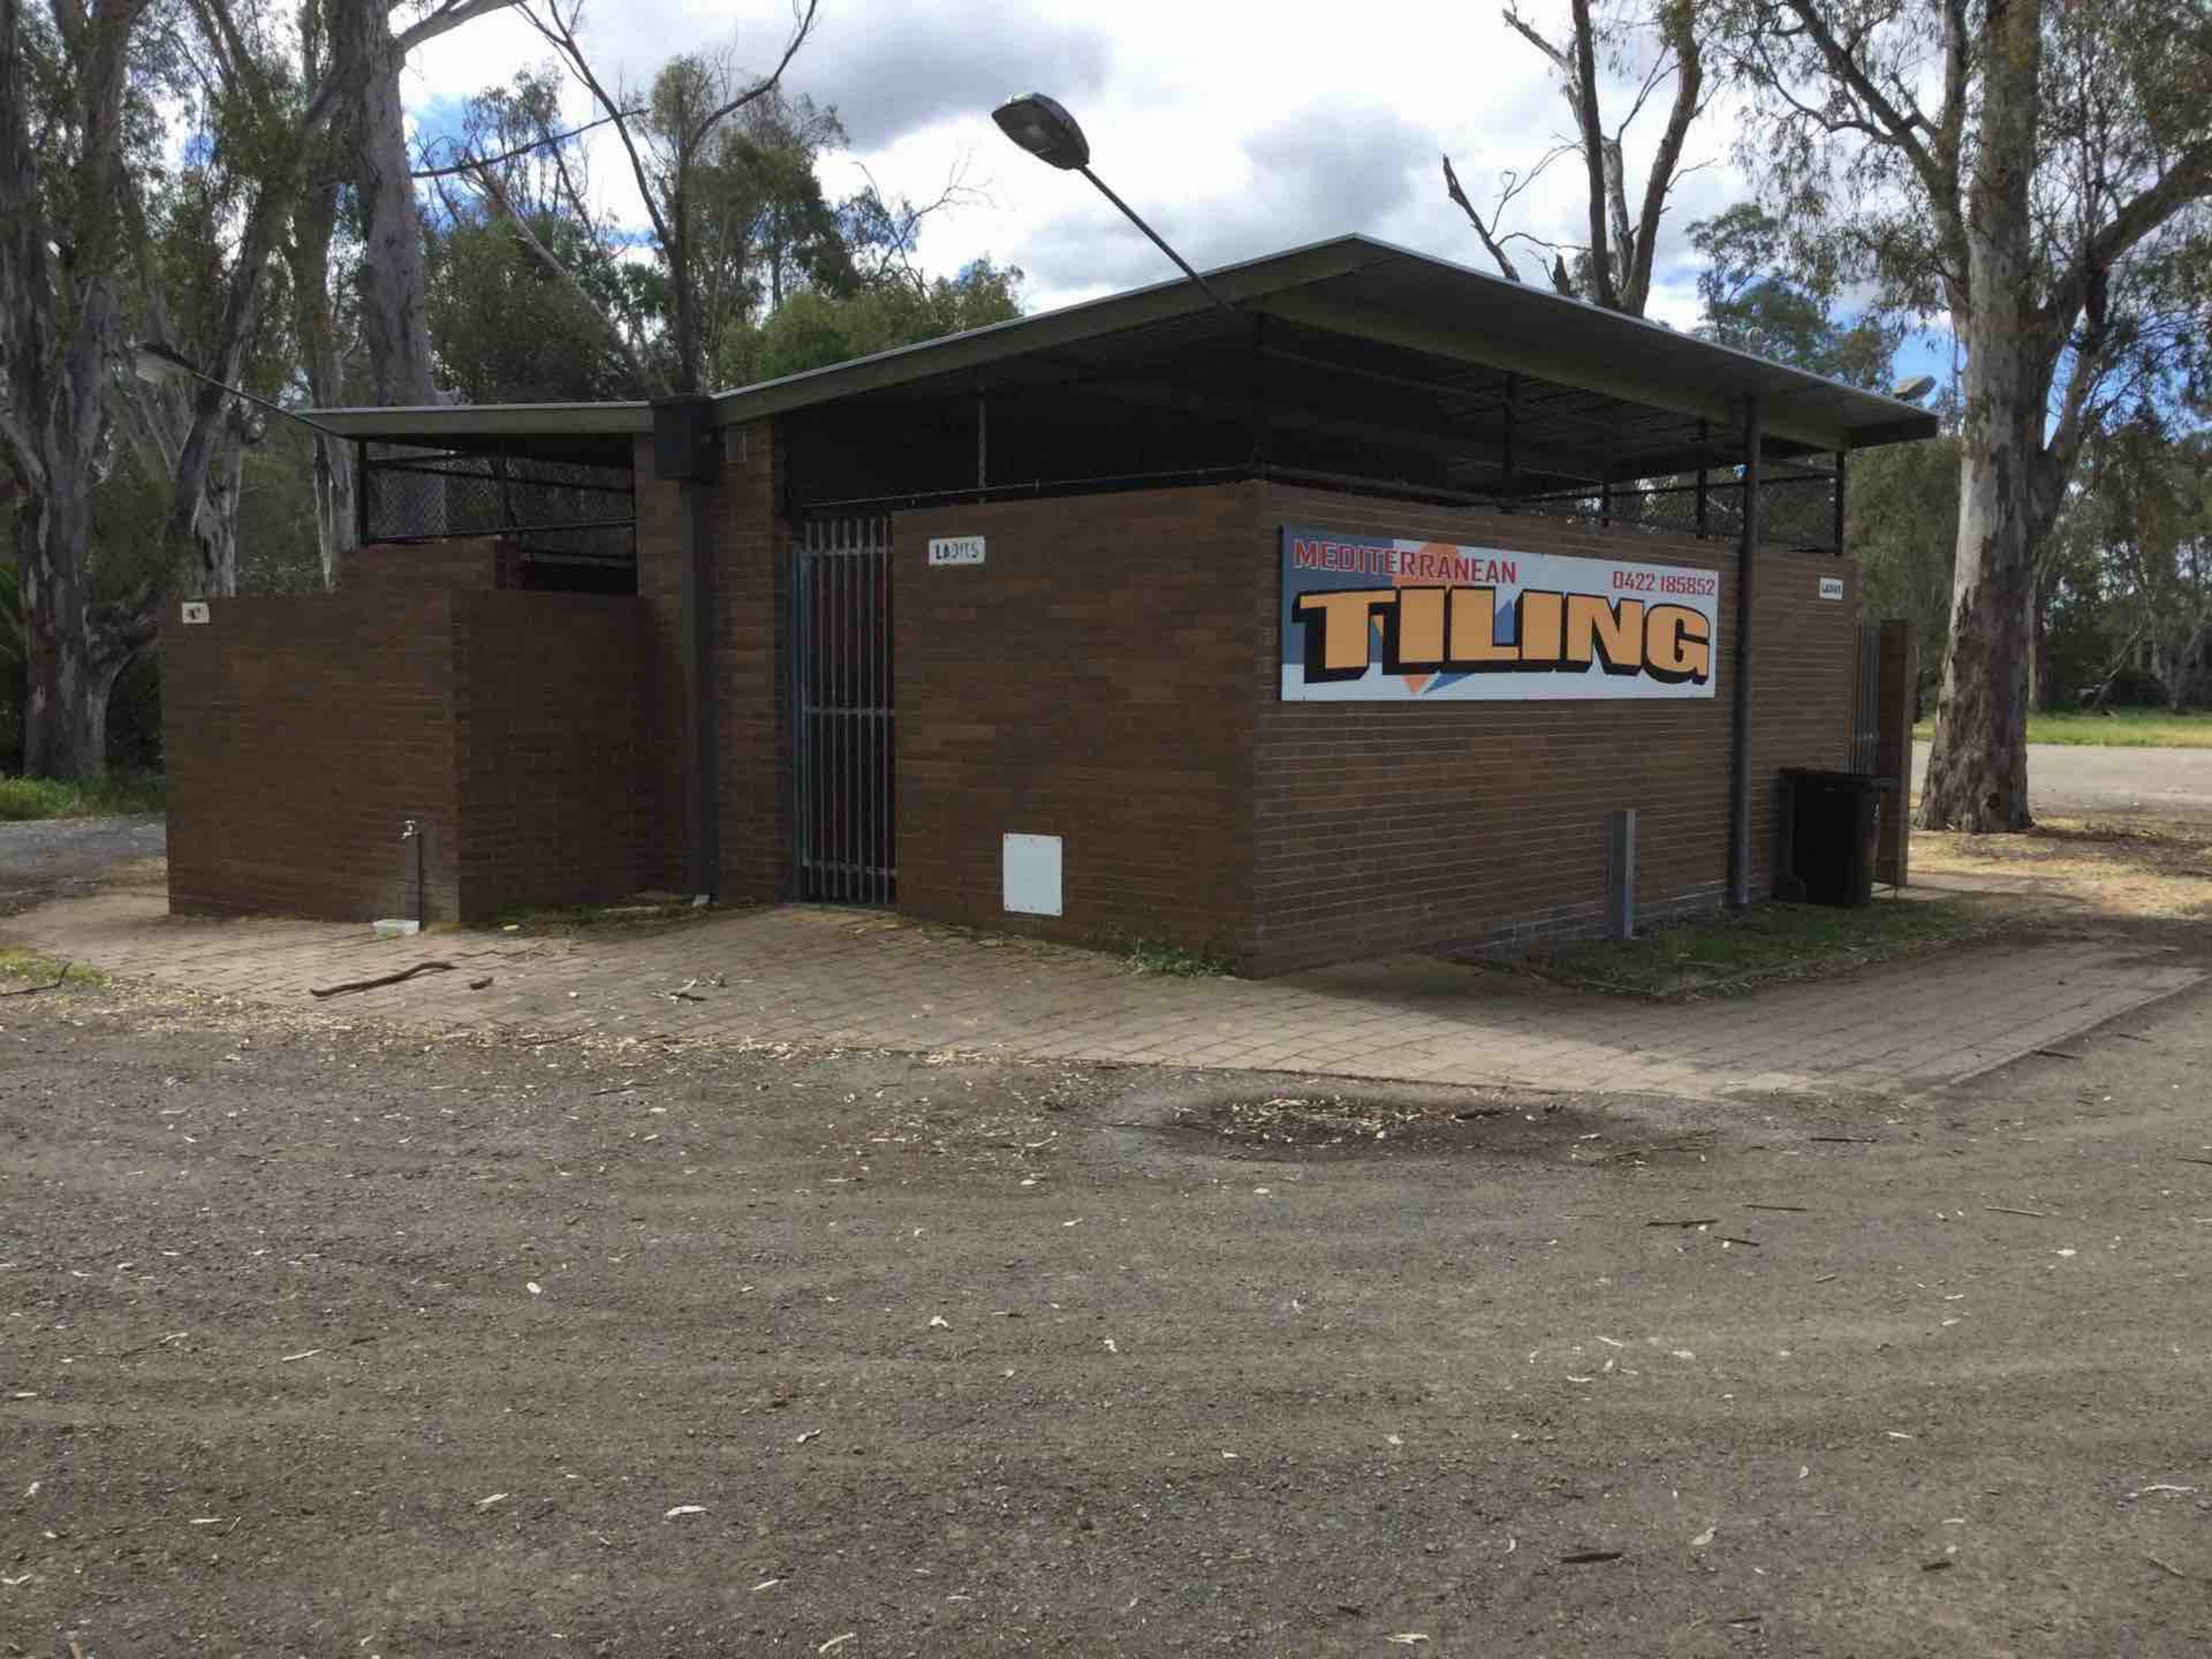
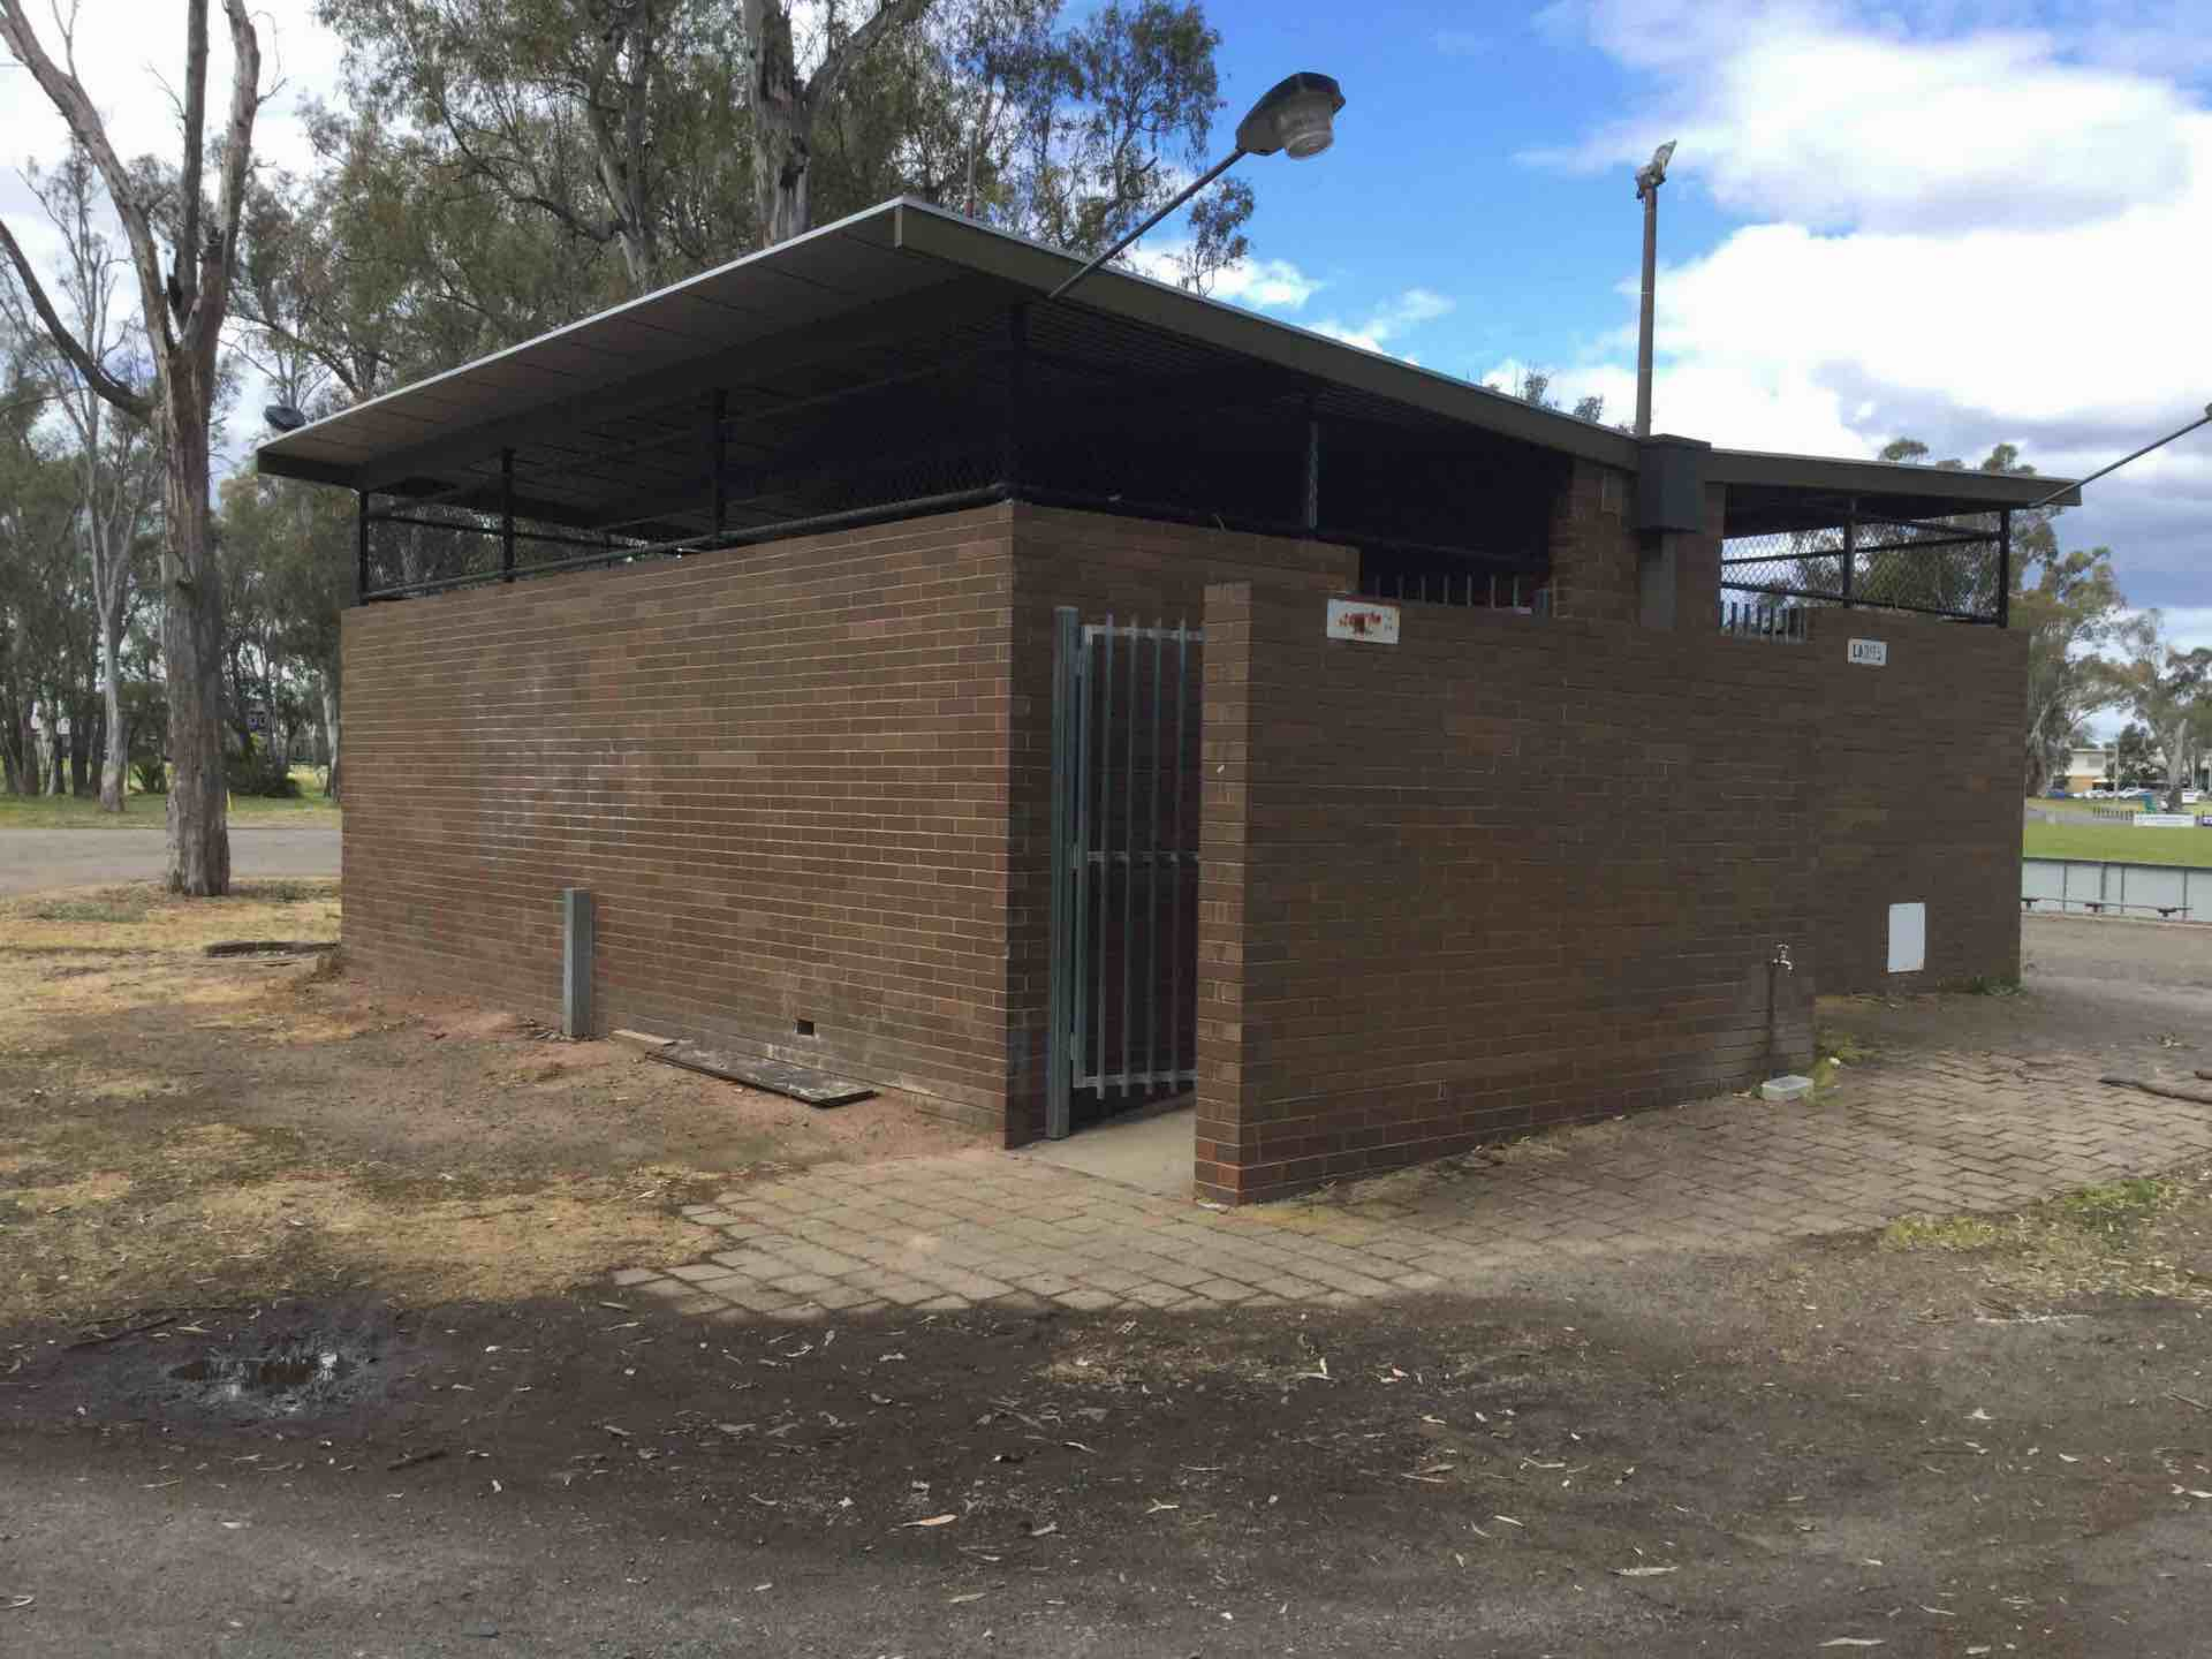
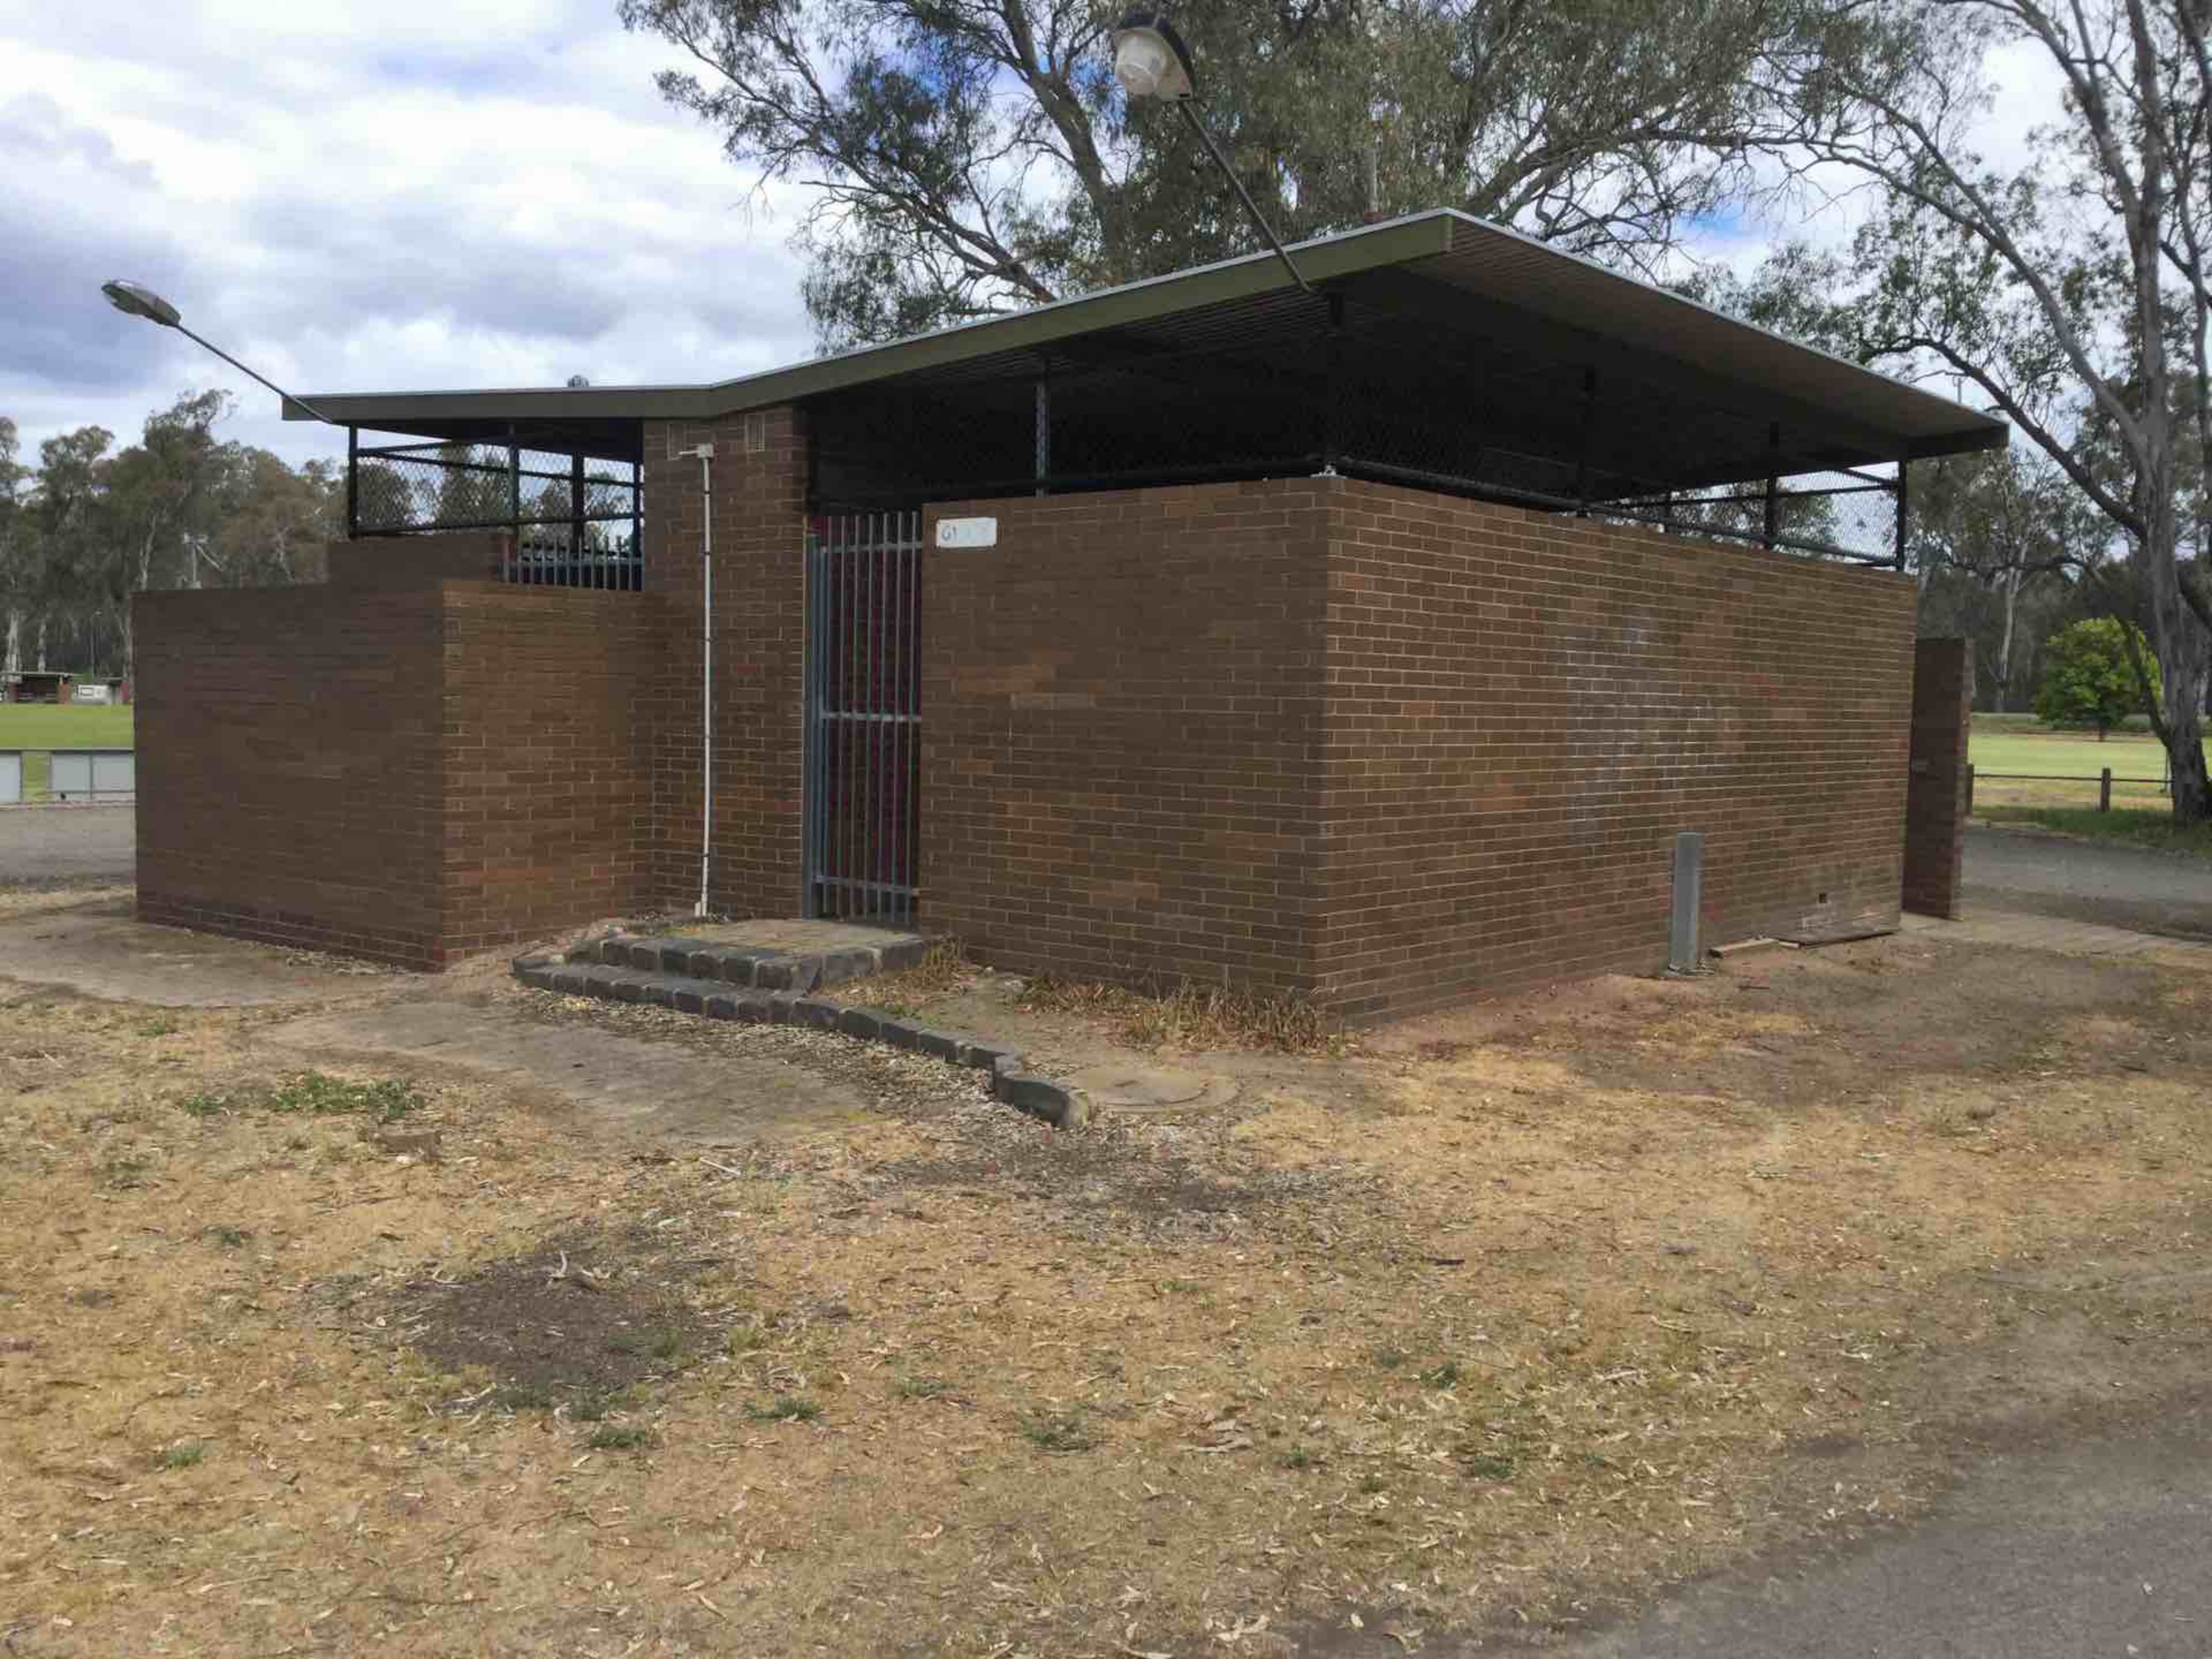
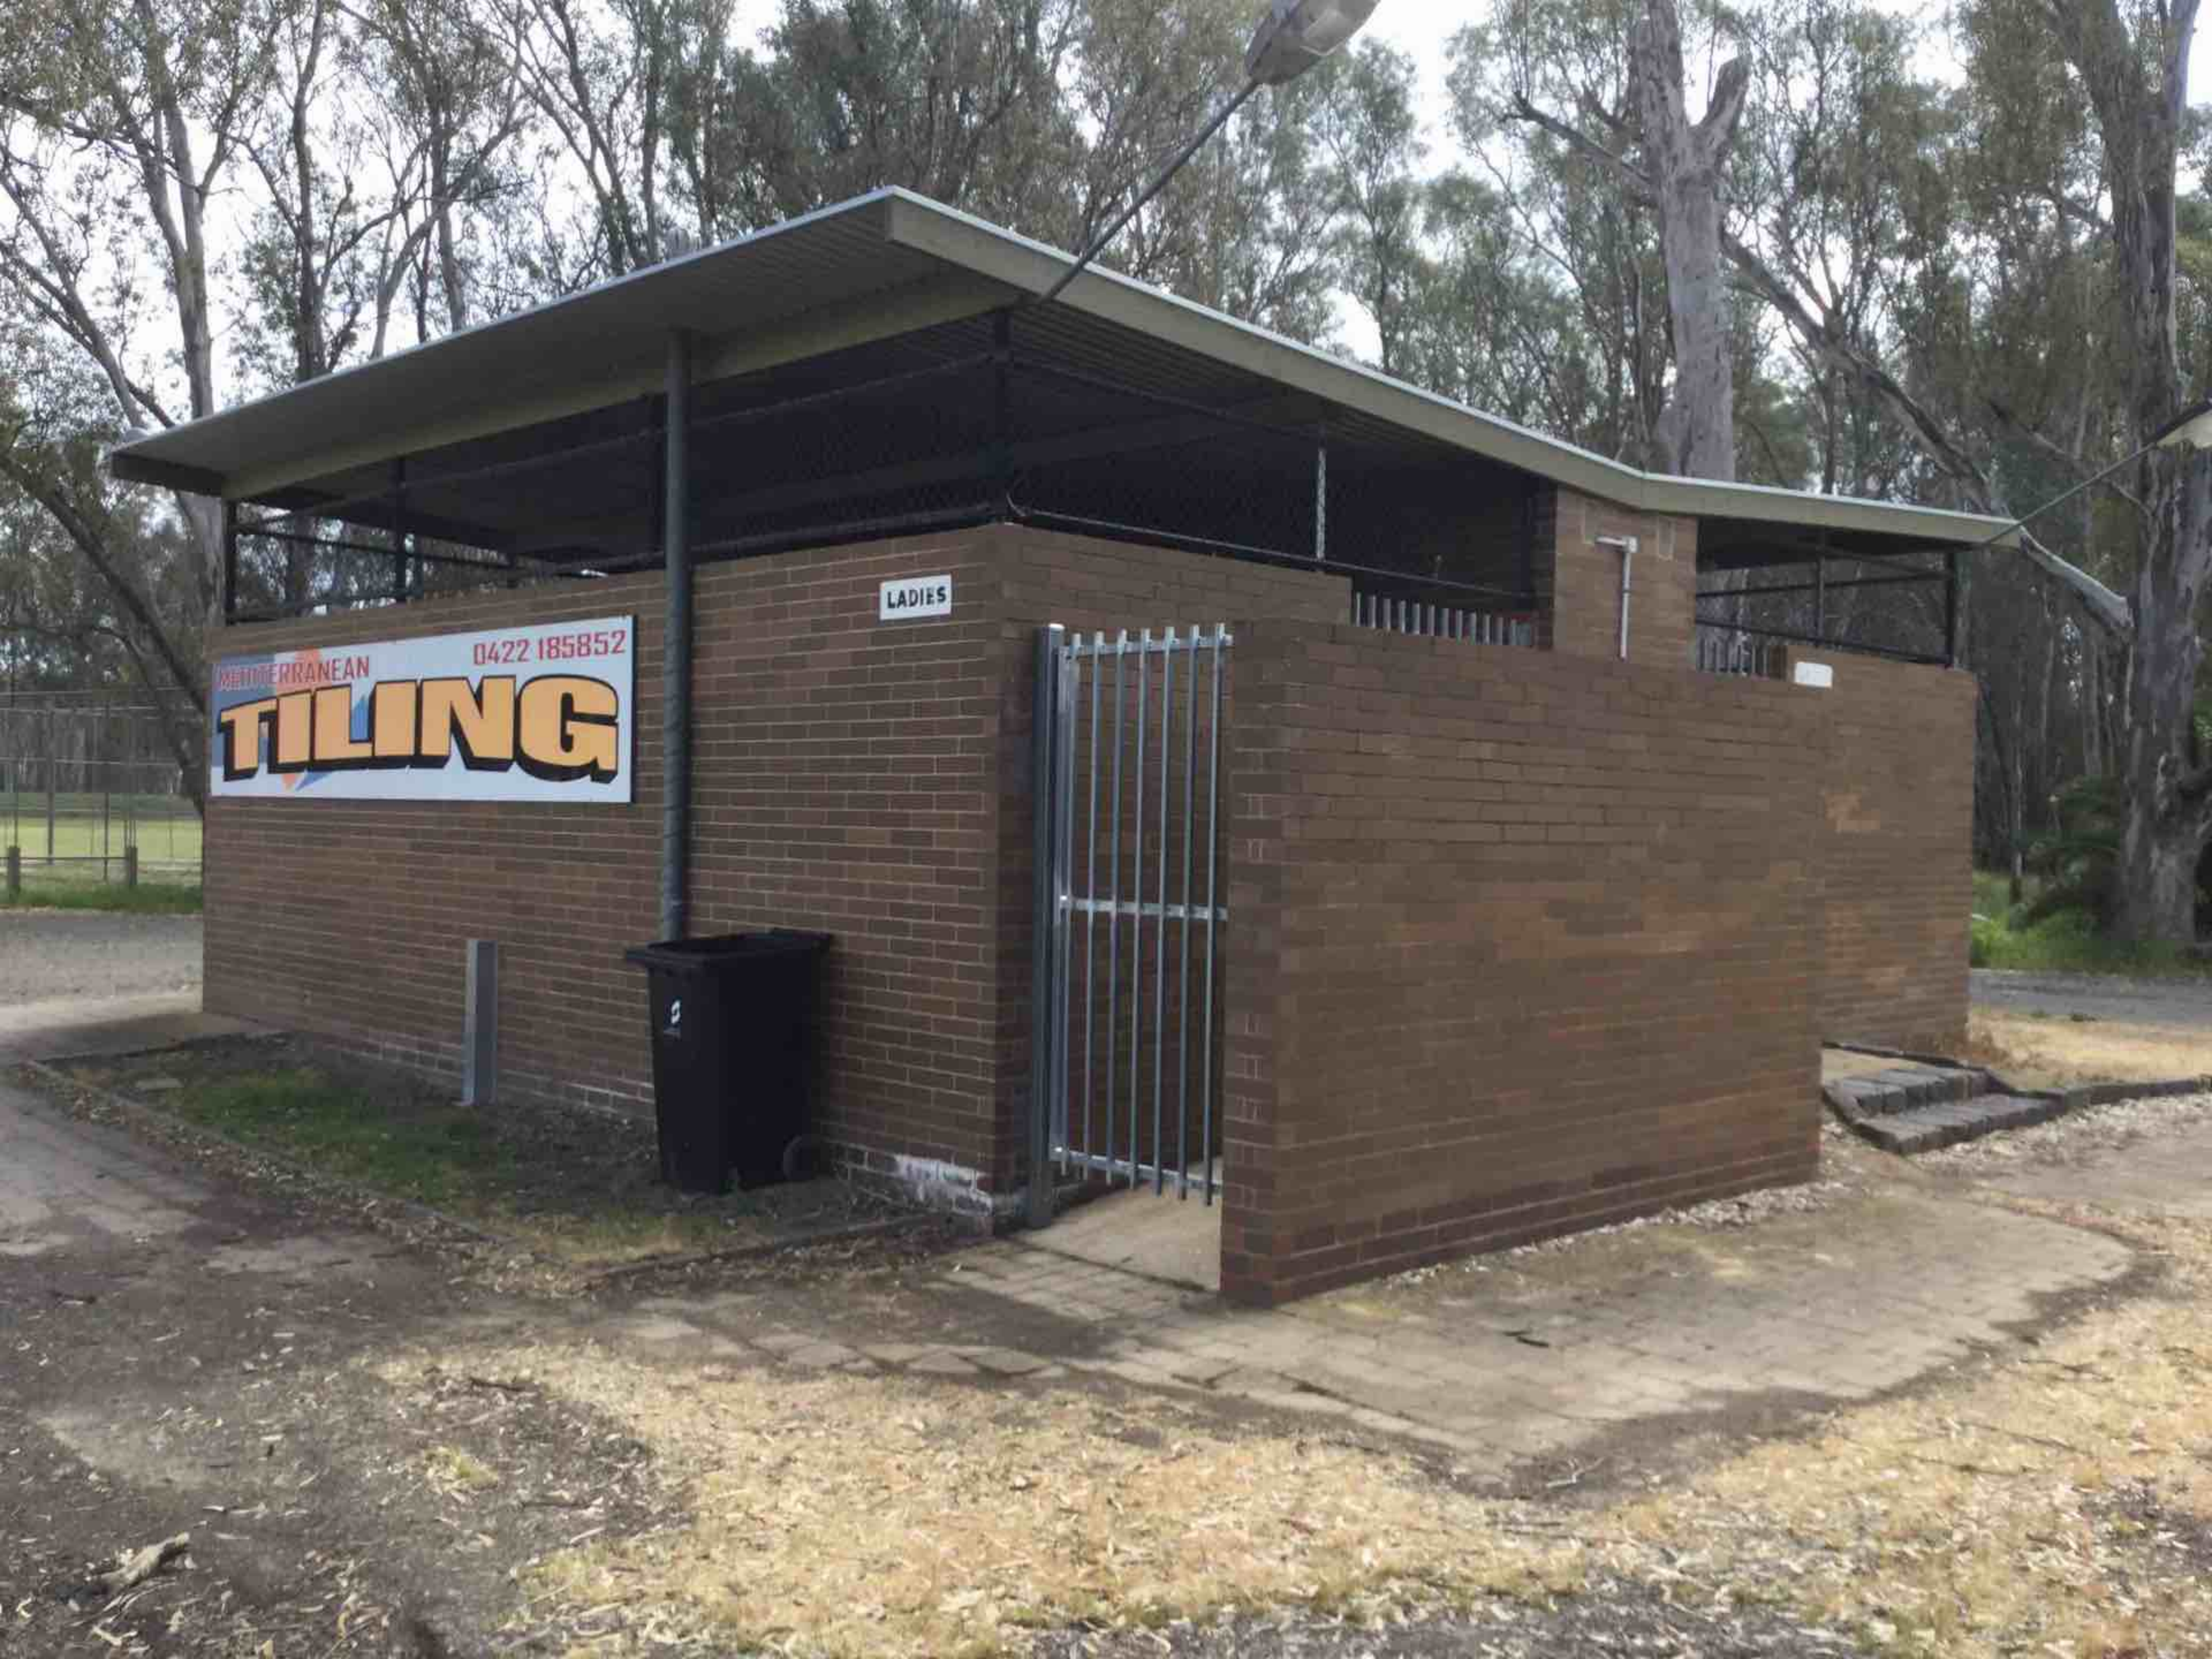
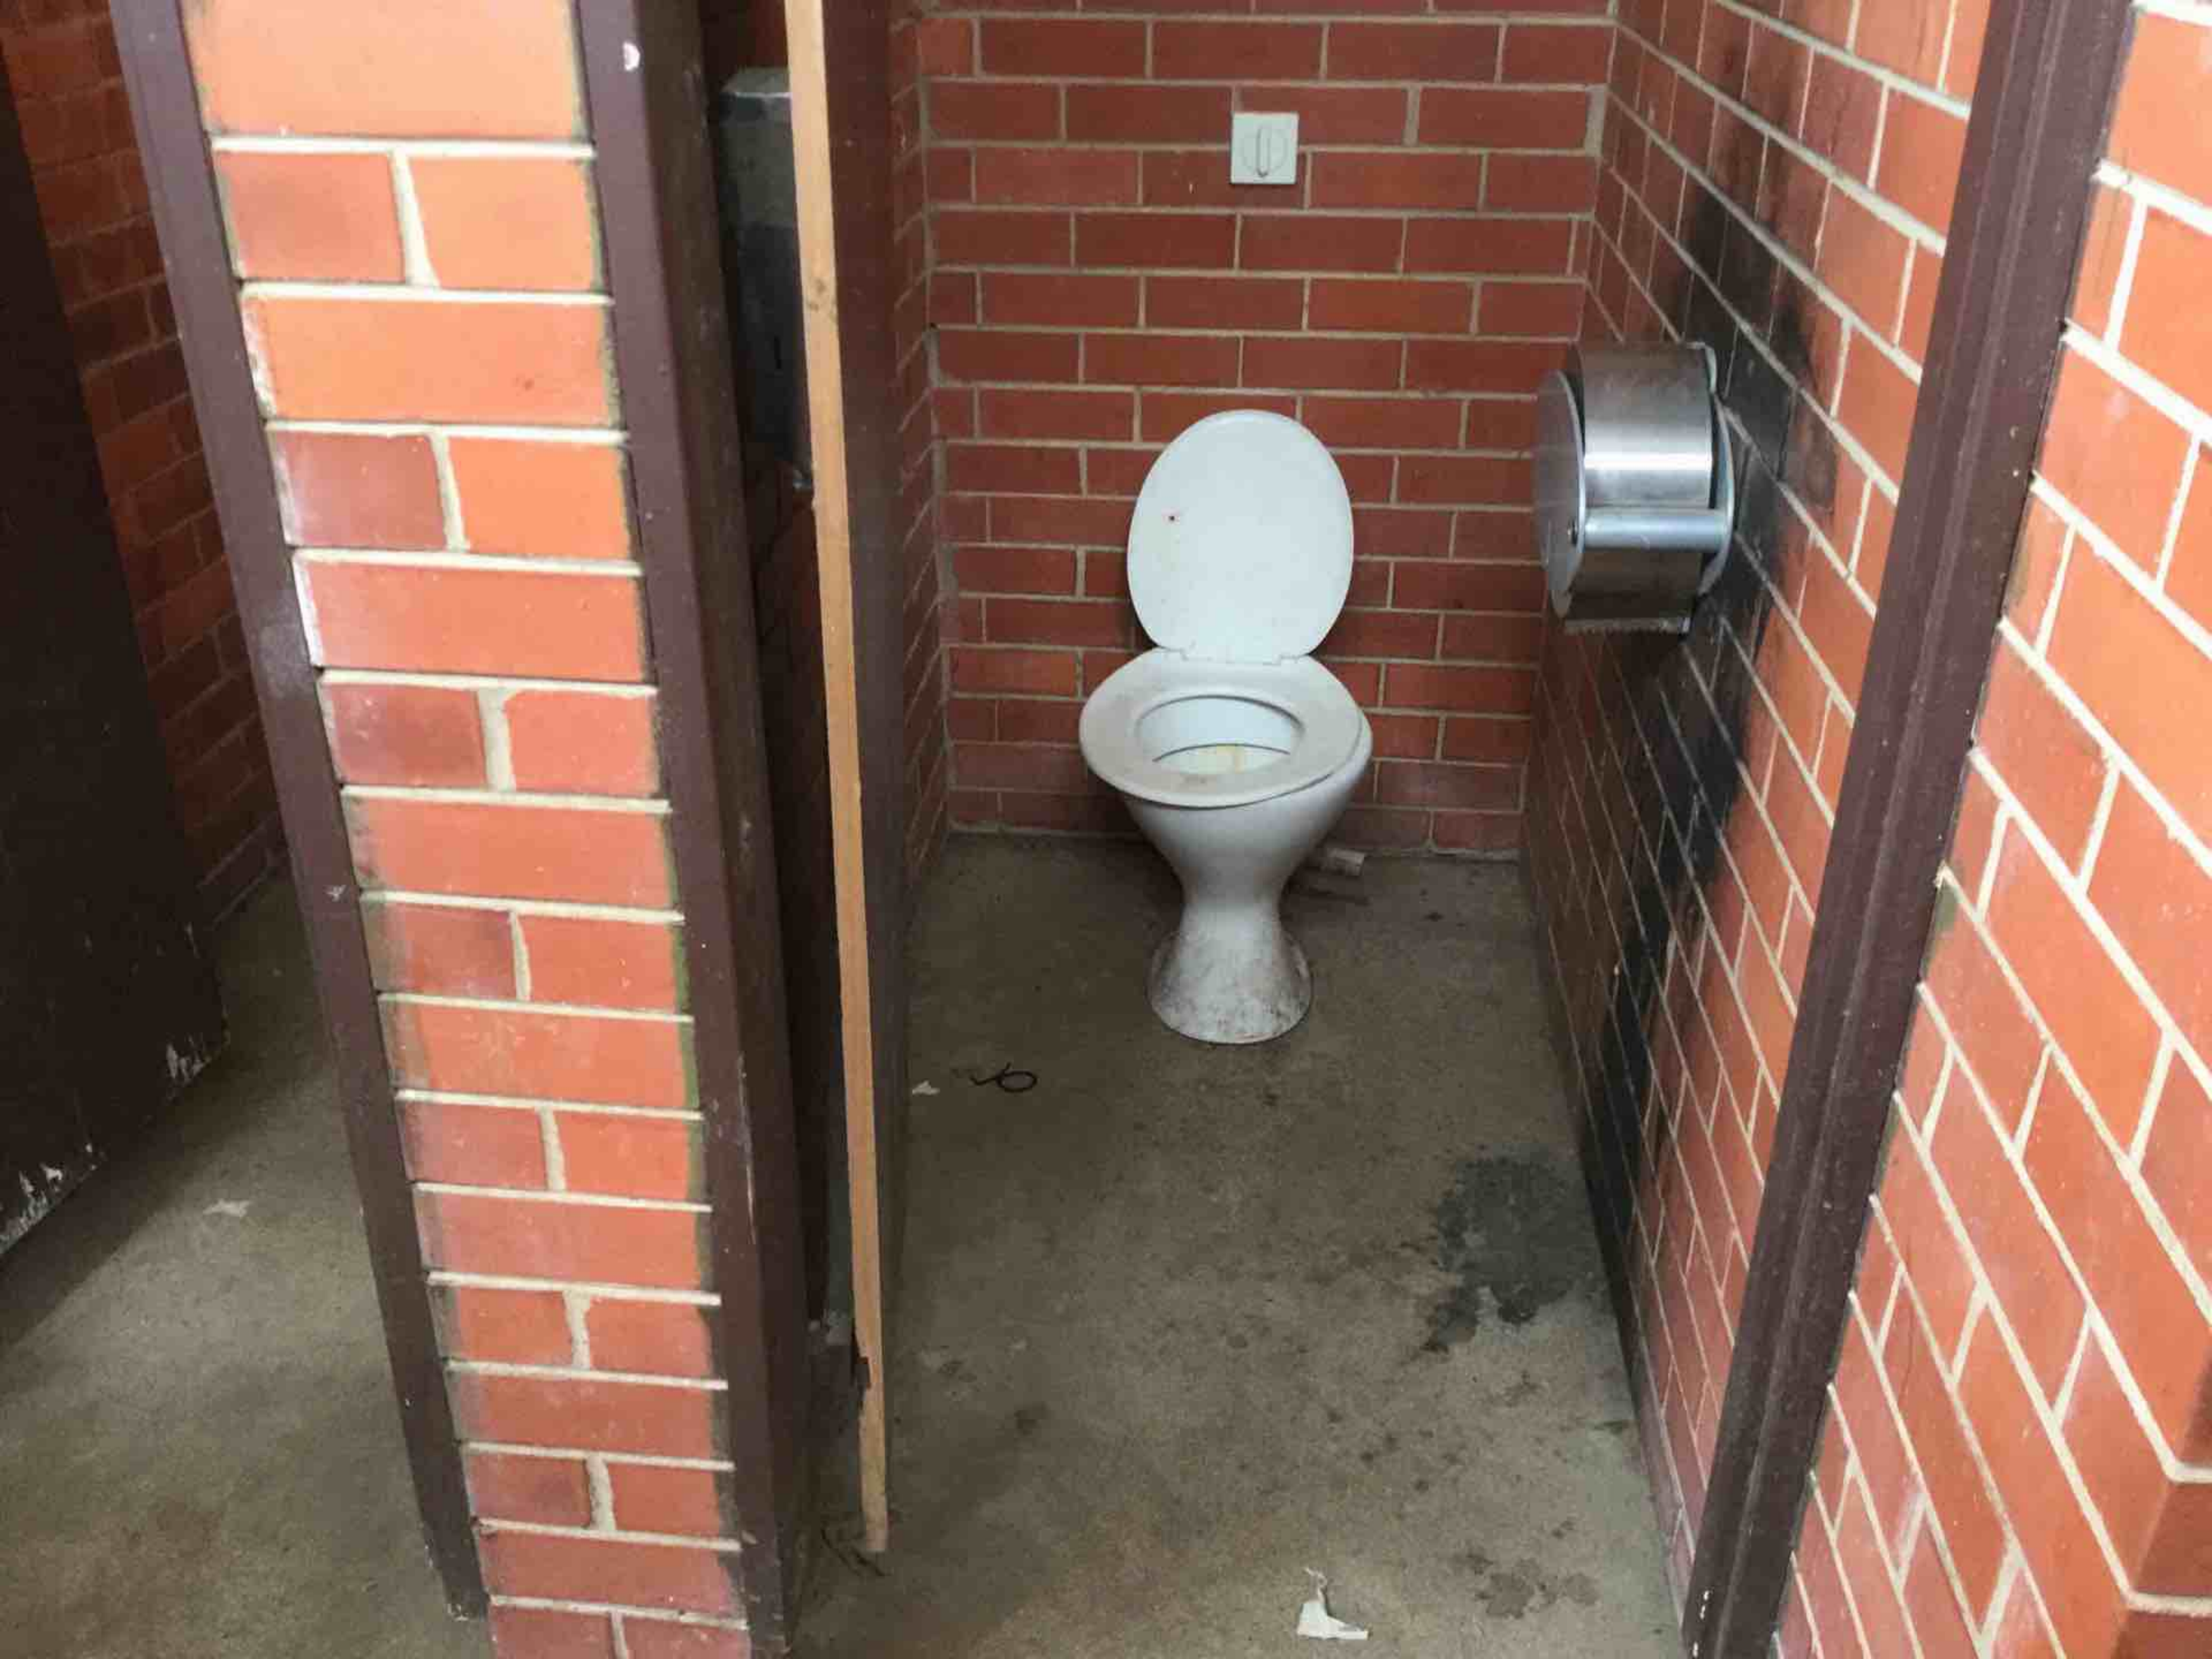
Observation Type	Code	Grade	Score	Notes
BU-Building Overall Condition	BUOC	Good	4.0000	Building is not as well kept as some other places, but it is generally in good condition. Note - The toilet does not provide toilets for the disabled.
BU-Ceiling Condition	BUCE	Good	4.0000	Iron ceiling/roof in good condition.
BU-Fitout Condition	BUFI	Moderate	5.0000	Plumbing fixtures are old, and in need of some maintenance, but generally in good condition.
BU-Floor Condition	BUFC	Good	4.0000	Concrete floor in good condition.
BU-Internal Wall Condition	BUIC	Good	4.0000	Brick walls in good condition.
BU-Mechanical Condition	BUMC	Excellent	.0000	N/A
BU-Roof Cladding Condition	BURC	Good	4.0000	Iron roofing generally in good condition.
BU-Roof Structure Condition	BURT	Good	4.0000	Steel and timber structure, generally in good condition.
BU-Wall Condition	BUWC	Good	4.0000	Brick walls generally in a good condition.
