**Officer:** John Gribben (JEG)  
**Route:** BU-Cond Surv Princess Park (BU29)  
**Report Type:** Assessment

**Site:** Princess Park (Shepparton) (F0062)

**Date:** 13/10/2017

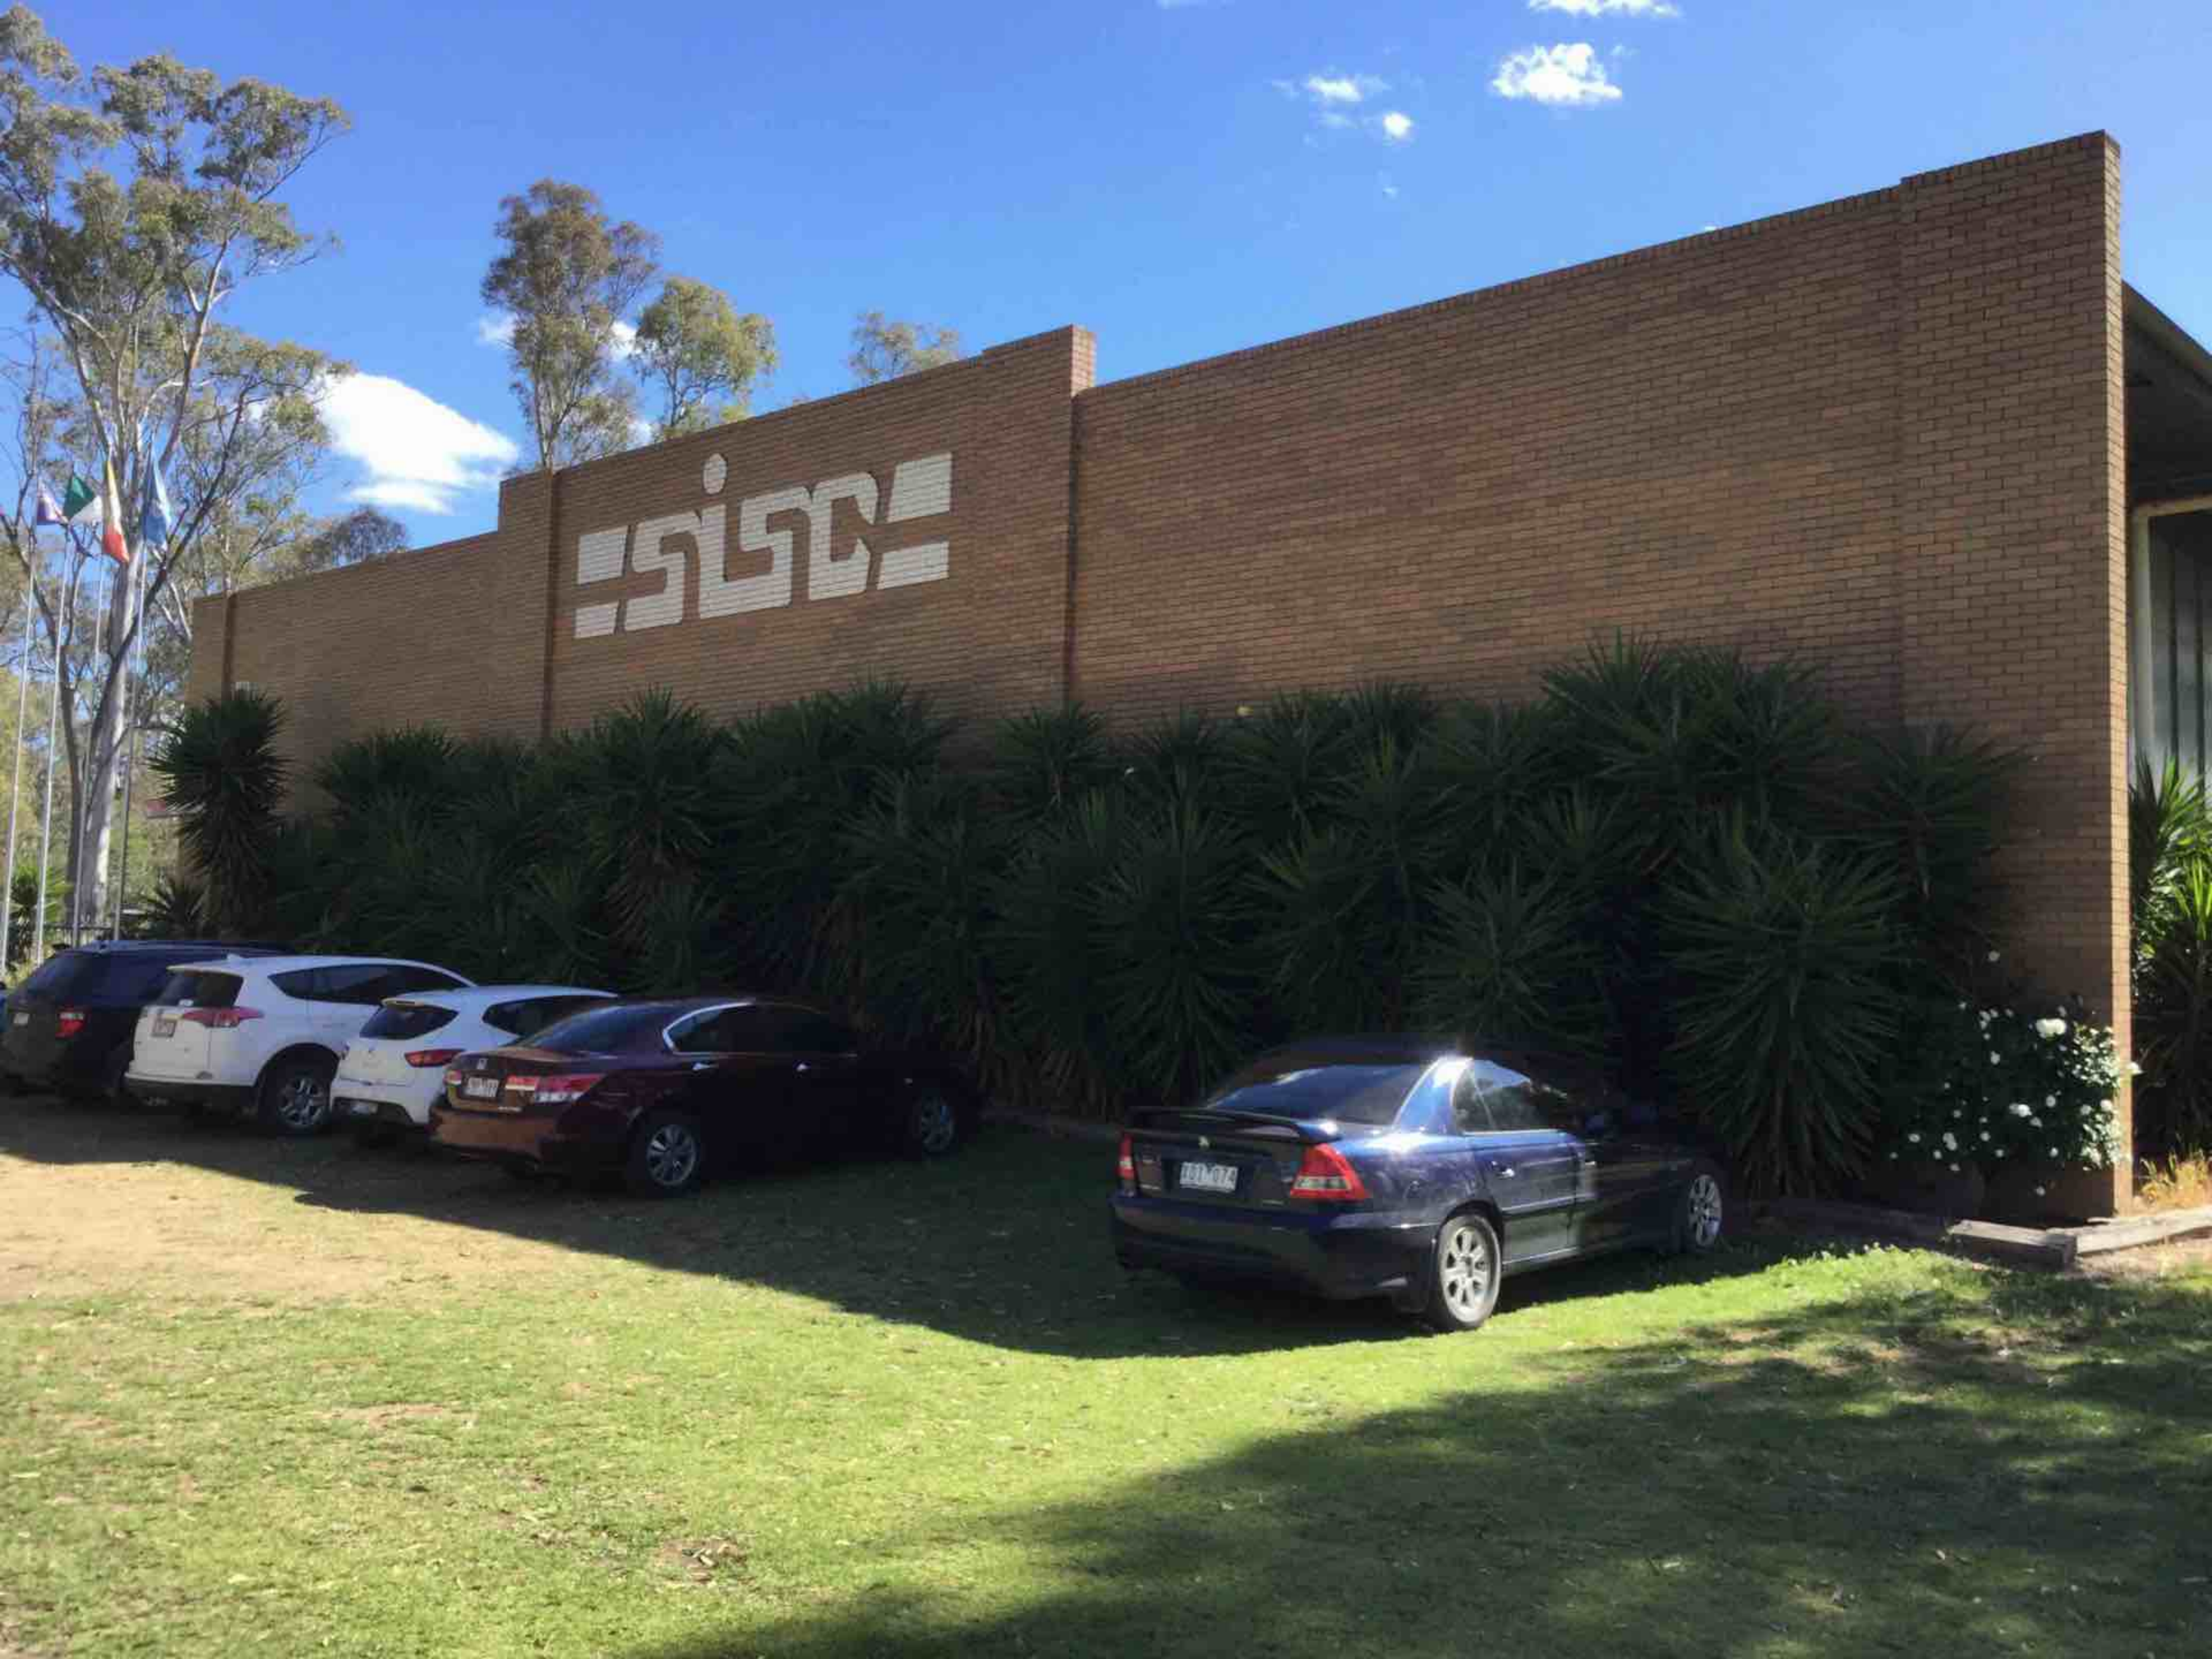
Observation Type	Code	Grade	Score	Notes
BU-Building Overall Condition	BUOC	Moderate	6.0000	Internally the building is in excellent condition, and is well maintained. The exterior of the building appears structurally sound, but because of surface rust on structural steel, and the different brick types that have been used when constructing the building, the aesthetics of the building is poor. Overall the building is a credit to the local Italian Community.
BU-Ceiling Condition	BUCE	Good	4.0000	In the main function room the ceiling appears to be in very good condition.
BU-Fitout Condition	BUFI	Good	4.0000	The kitchen and the bar area are in excellent condition and well maintained. The toilet fittings and fixtures appear well maintained and in good order, but appear to be much older than other fittings throughout.
BU-Floor Condition	BUFC	Good	4.0000	The carpet, parketry, and floor tiles appear to be in very good condition, but some floor tiles are broken in the toilets, but do not appear to be causing a significant problem.

BU-Internal Wall Condition	BUIC	Good	4.0000	Internal walls appear to be well maintained and in very good order.
BU-Mechanical Condition	BUMC	Good	4.0000	Mechanical fixtures appear in good working order and well maintained.
BU-Roof Cladding Condition	BURC	Moderate	5.0000	The roof cladding appears to be in good order and fit for purpose. Having said that, the building appears to have had sections added to it, and some of the materials used do not appear to match. This does not cause a problem for the integrity of the roof in the short term, but may become an issue over the longer term, noting that different profile roof gutters exist etc.
BU-Roof Structure Condition	BURT	Moderate	6.0000	The roof structure appears very good structurally, but surface rust is now showing and starting to detract from the aesthetics of the building.
BU-Wall Condition	BUWC	Poor	7.0000	The building was constructed with different brick types, that were, no doubt, generously donated by the local Italian Community. Structurally the bricks are fine, but the aesthetics of the different brick types does impact on the aesthetics of the building. Plus, some of the upper wall cladding above the bricks is in a poor state of disrepair. This is probably a minor issue for the people using the facility, but it does significantly detract from the aesthetics of the building.
