**Officer:** John Gribben (JEG)  
**Route:** BU-Cond Surv Princess Park (BU29)  
**Report Type:** Assessment

**Site:** Princess Park (Shepparton) (F0062)

**Date:** 13/10/2017

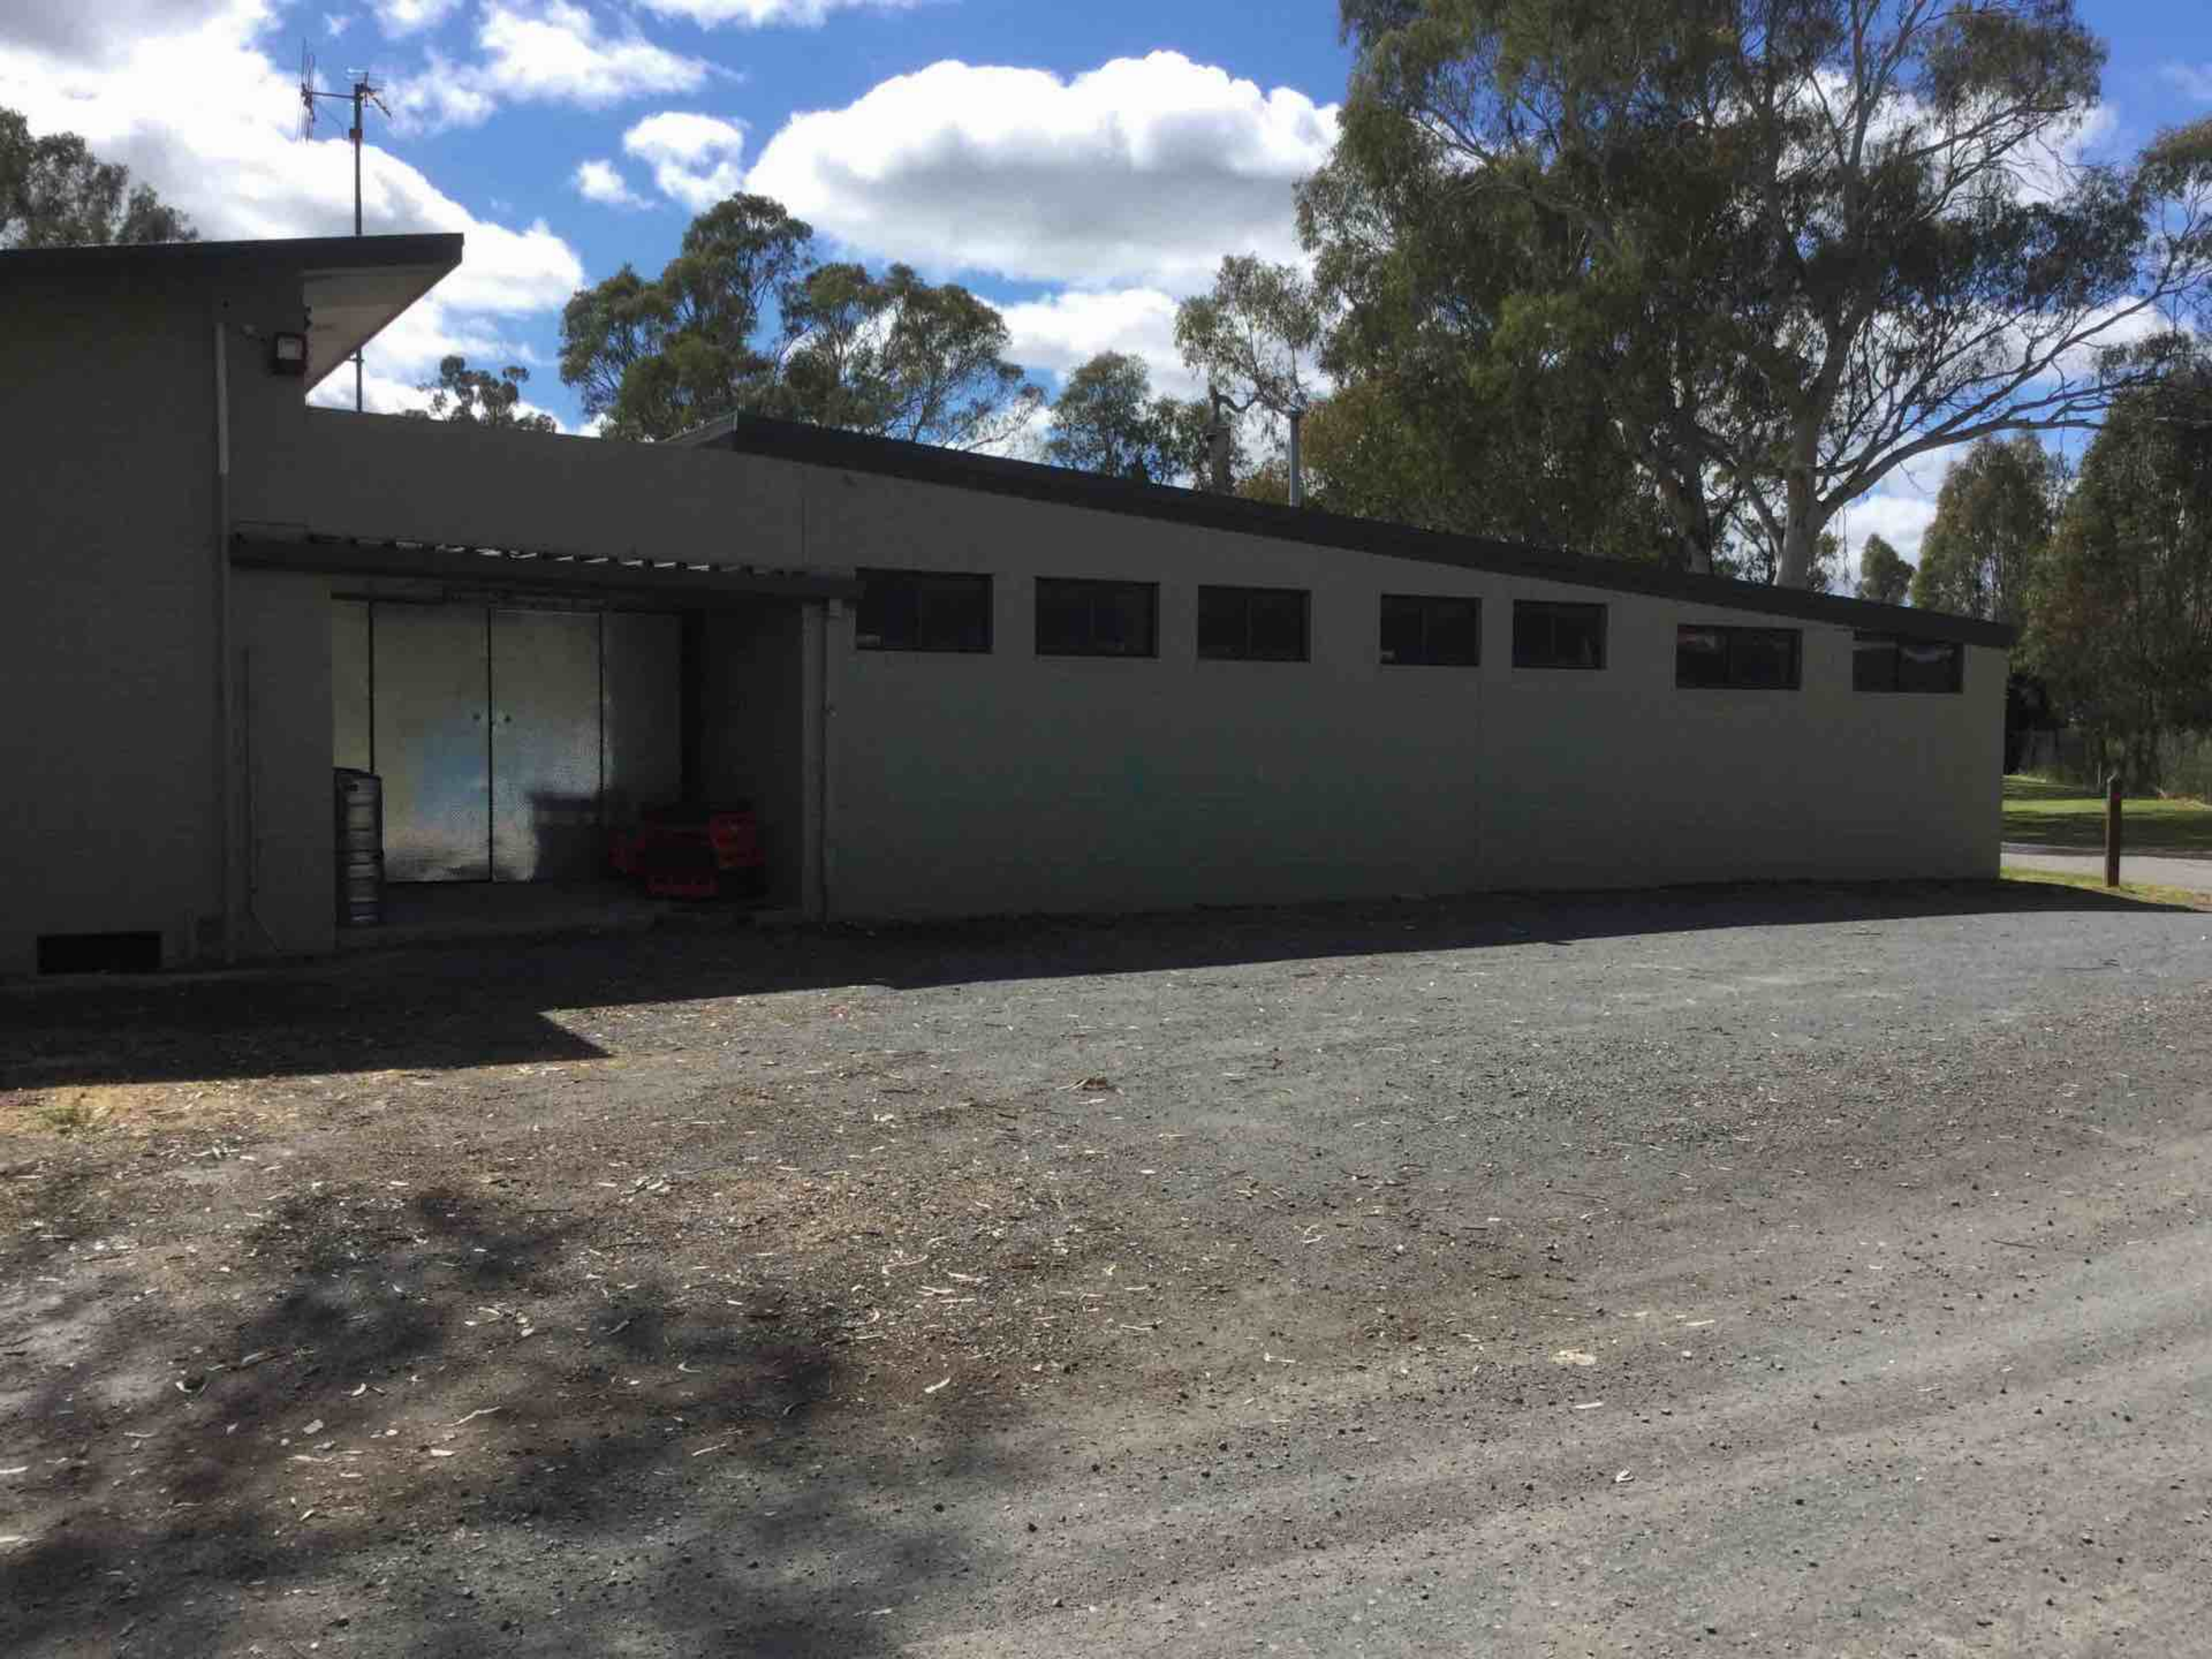
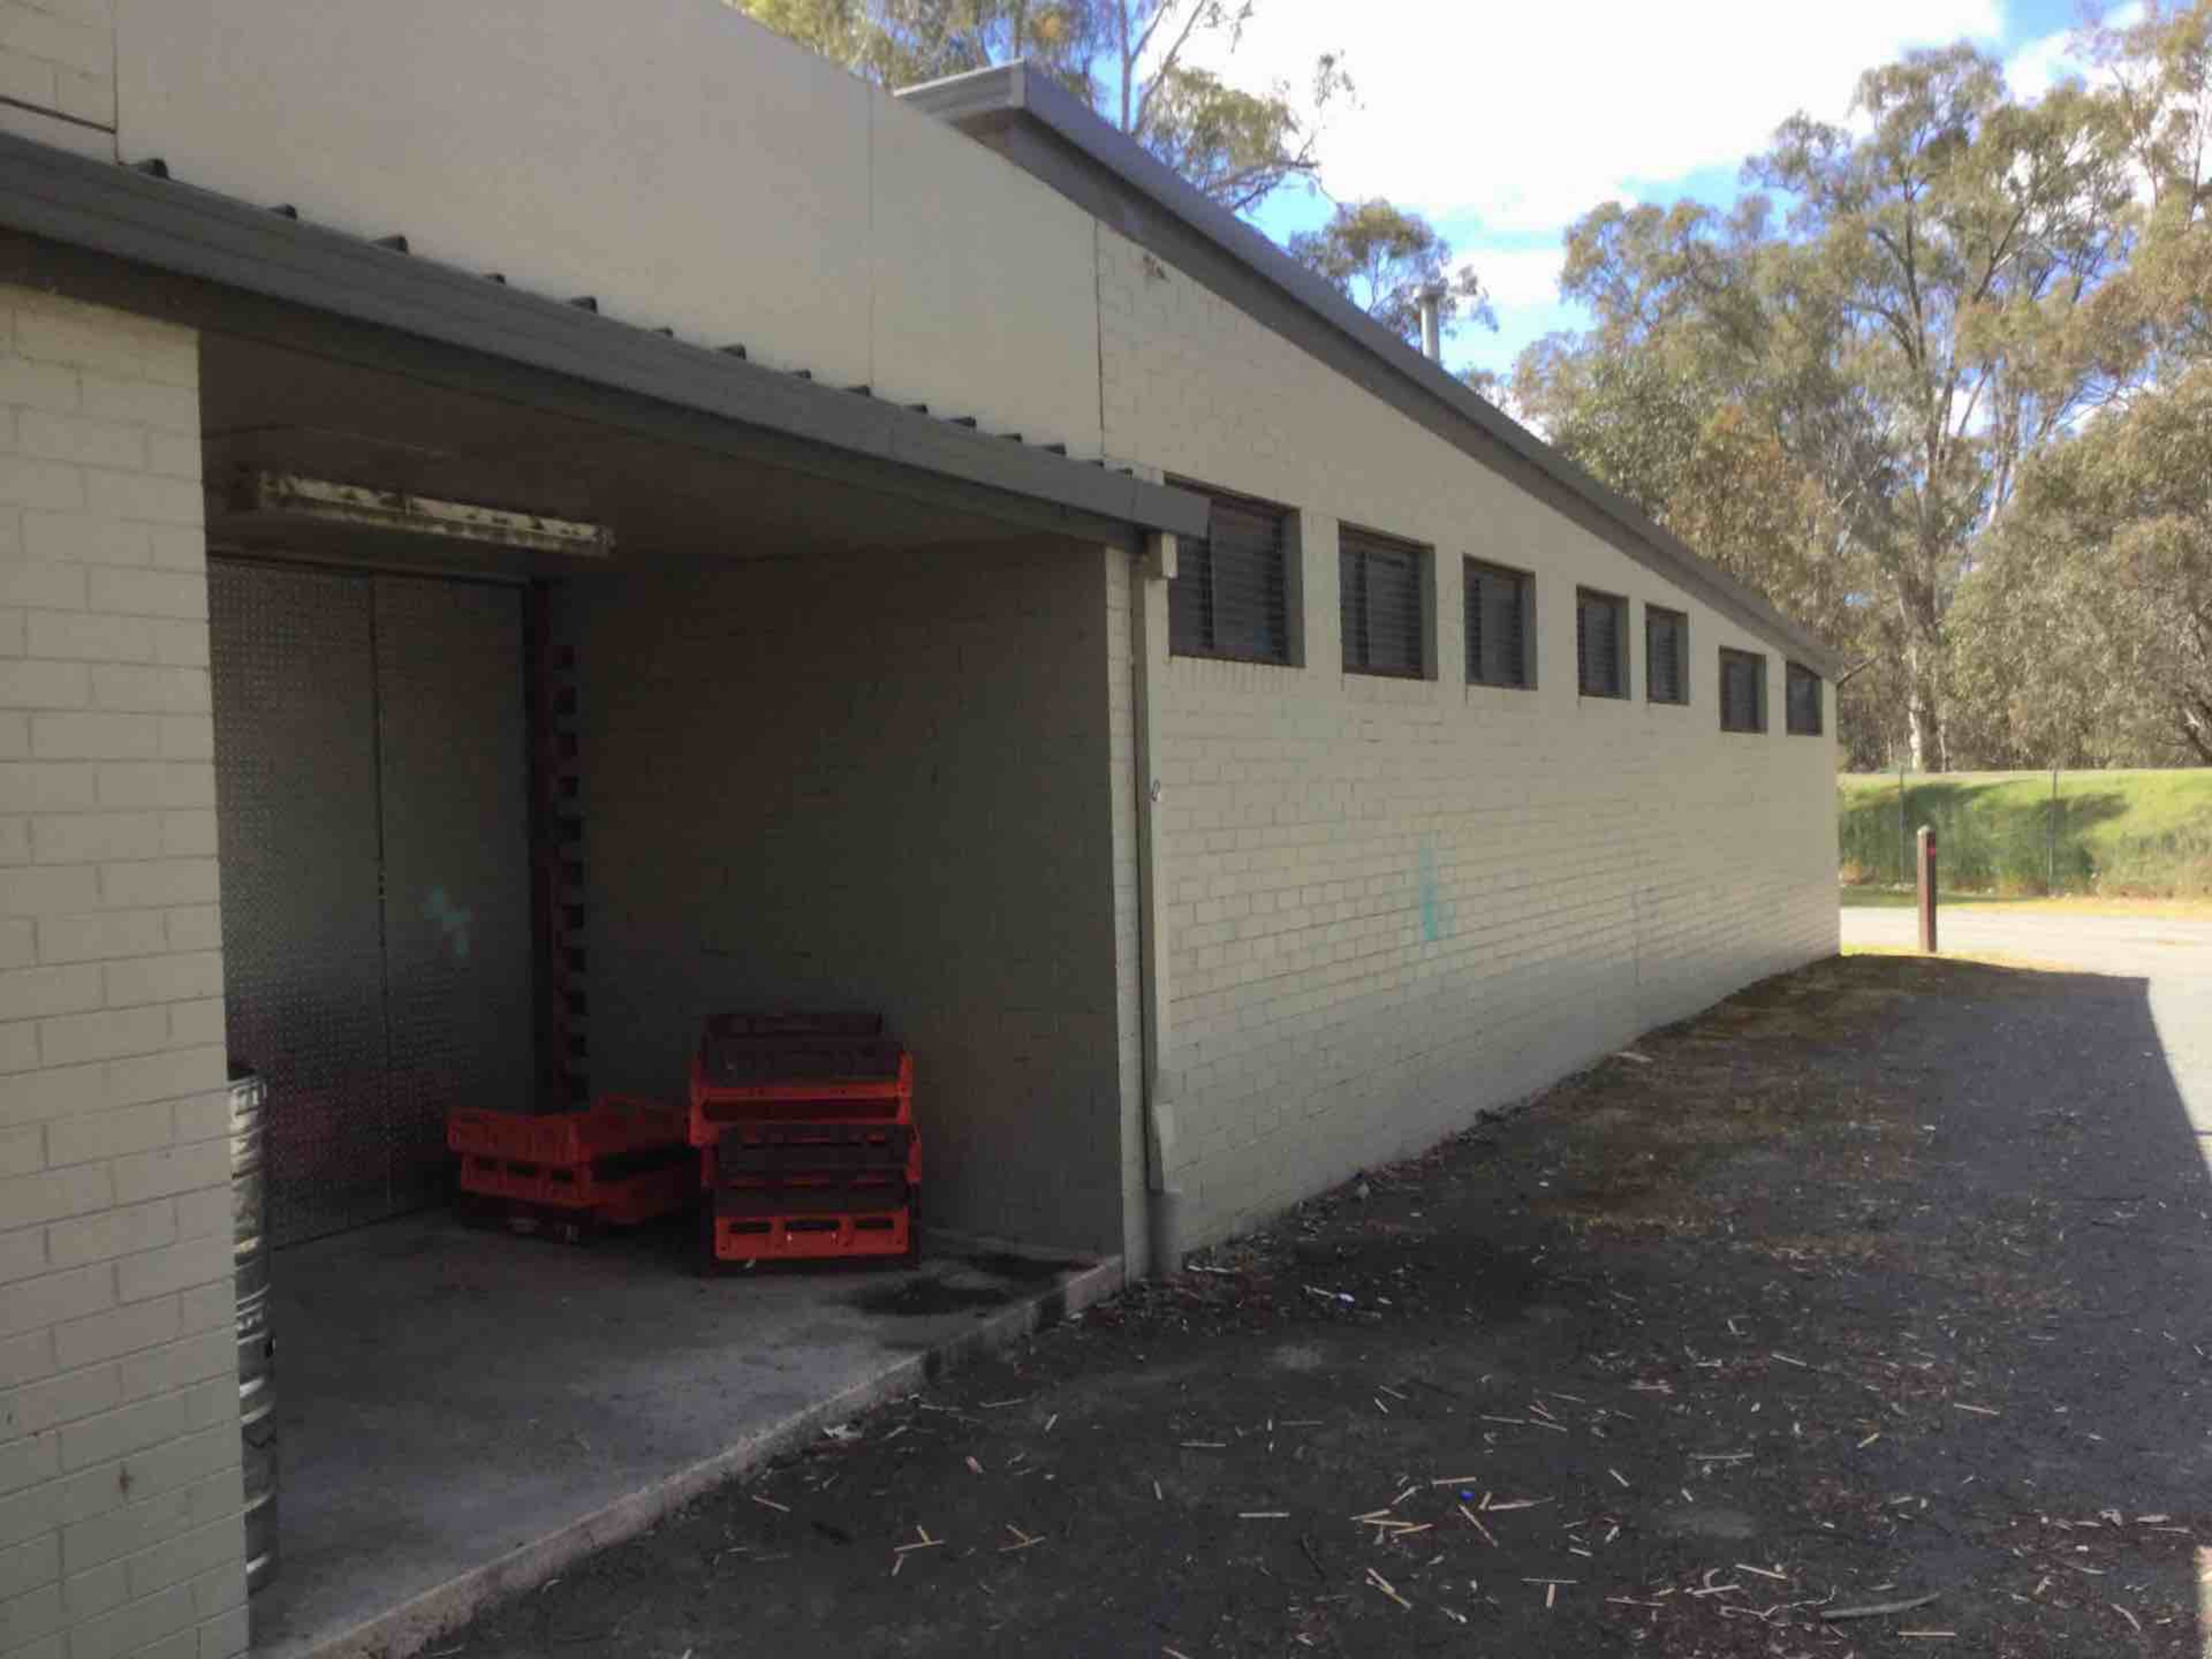
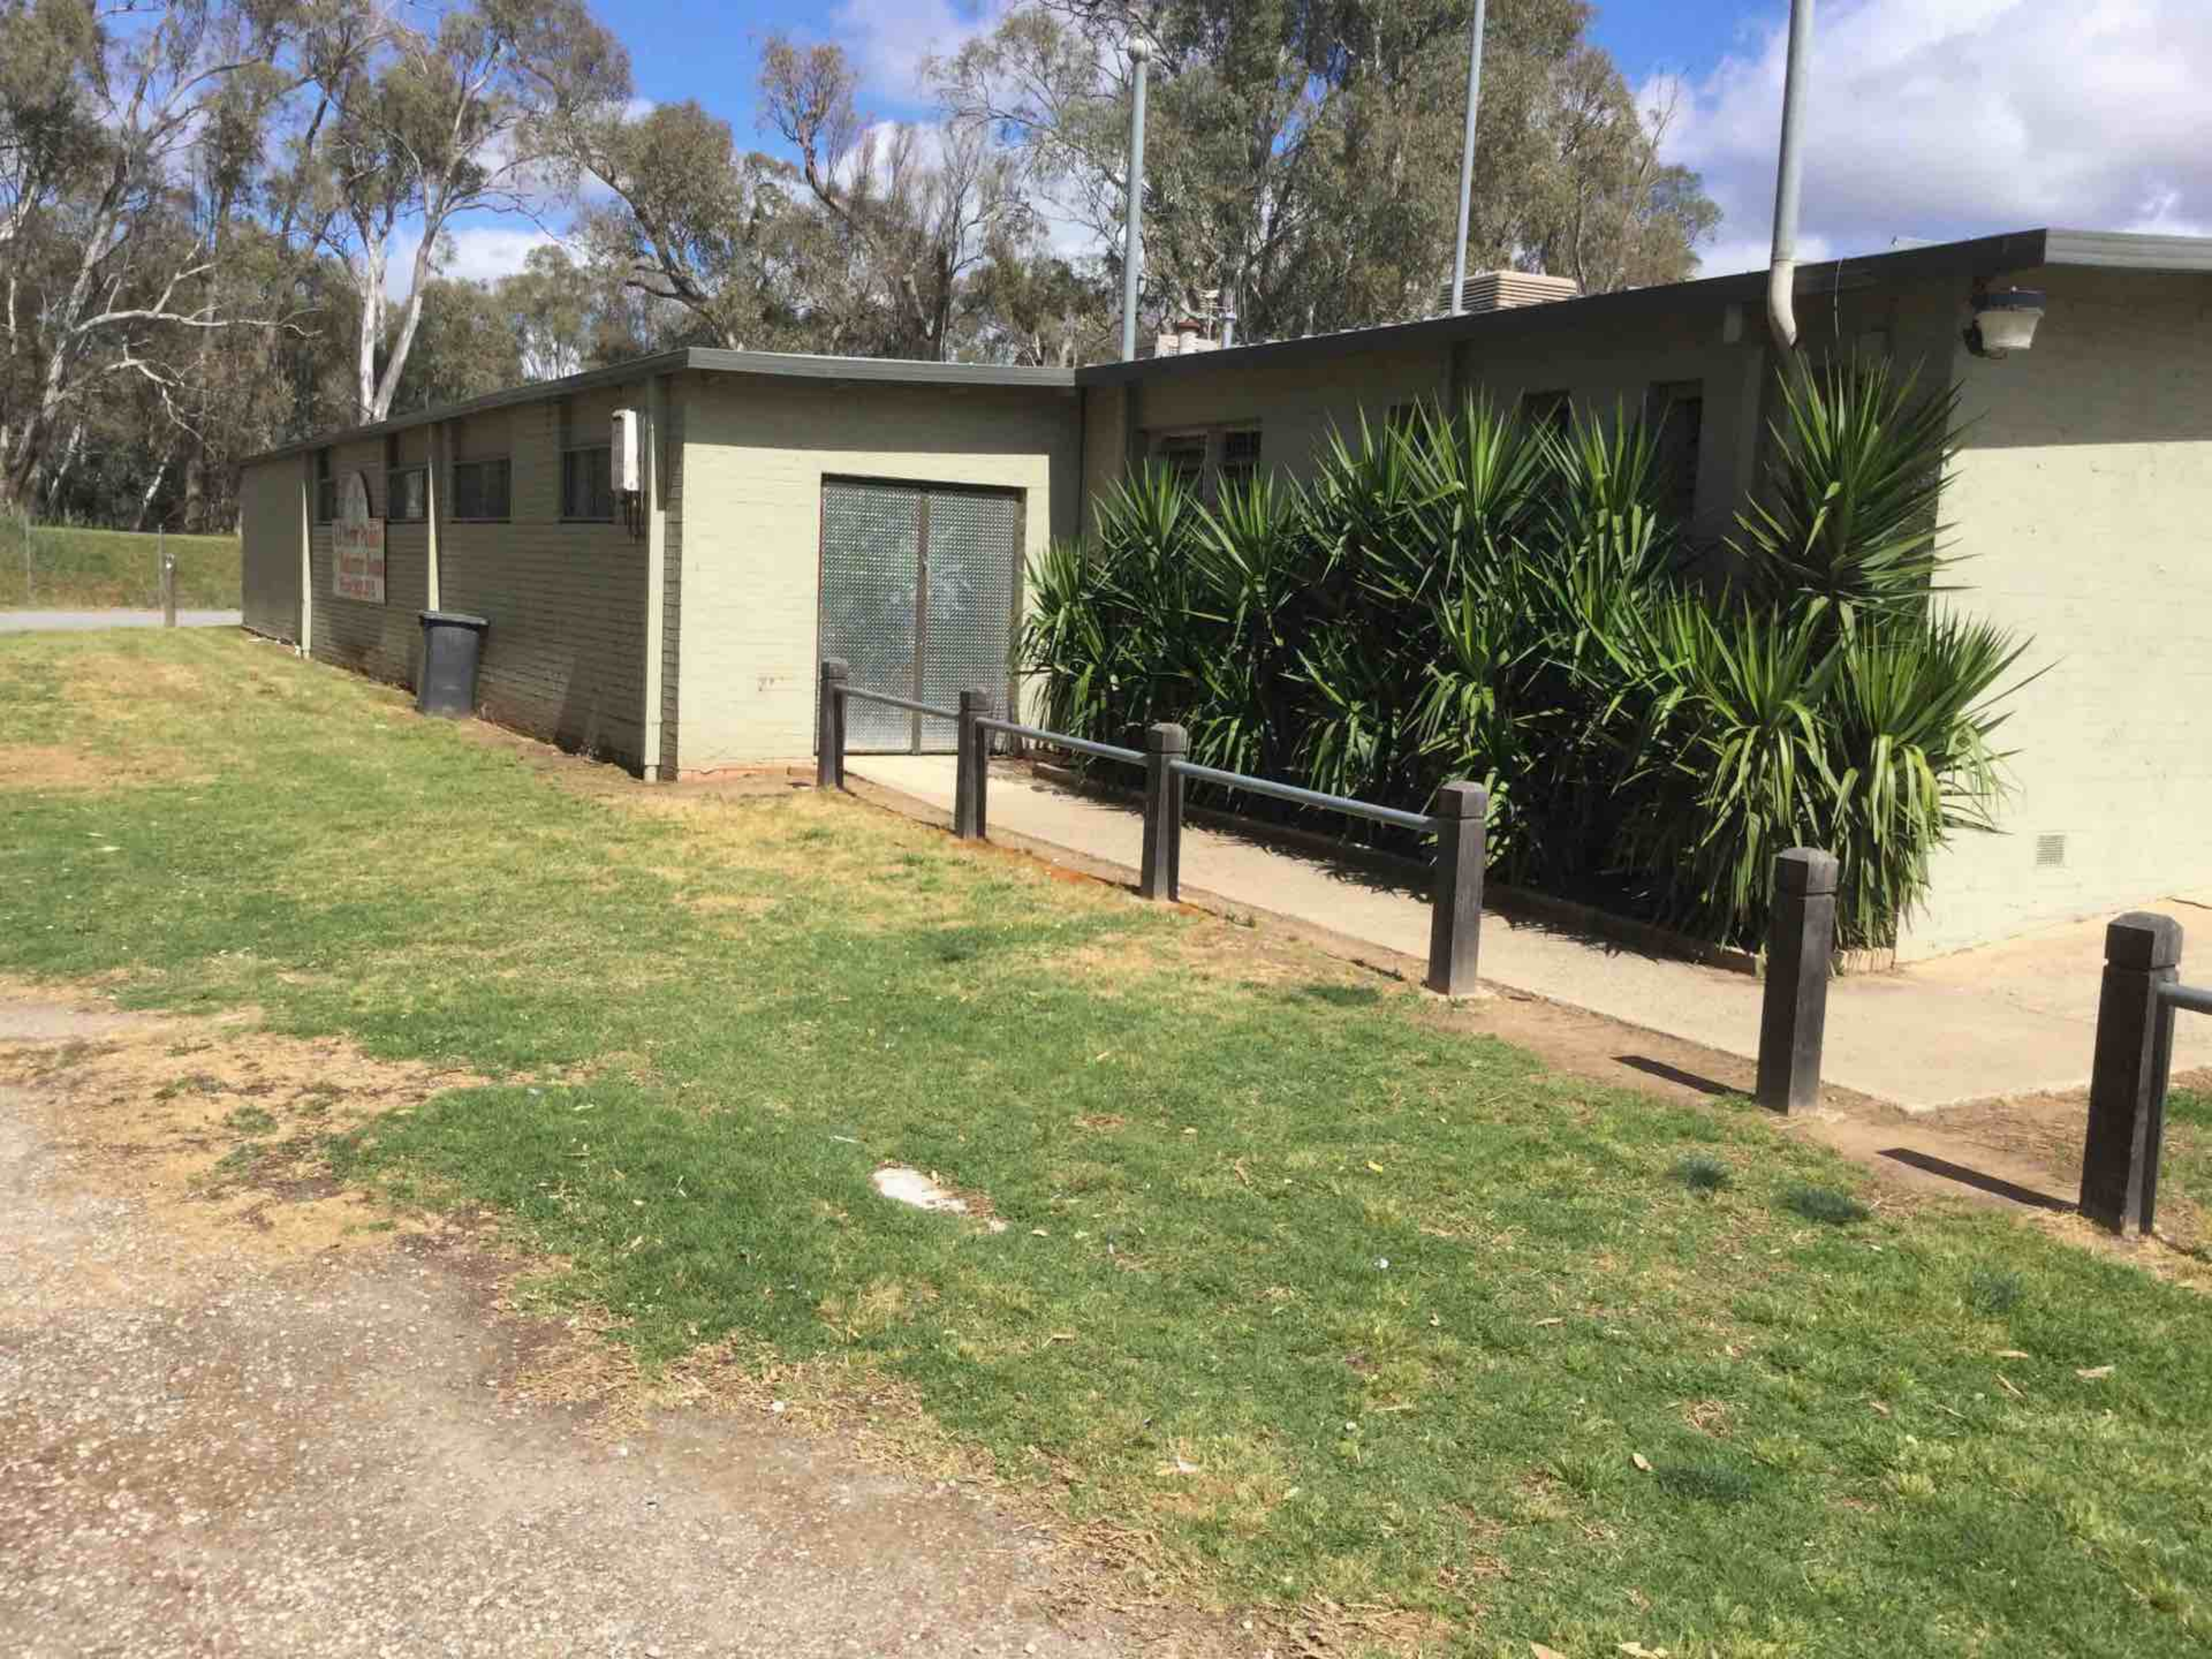
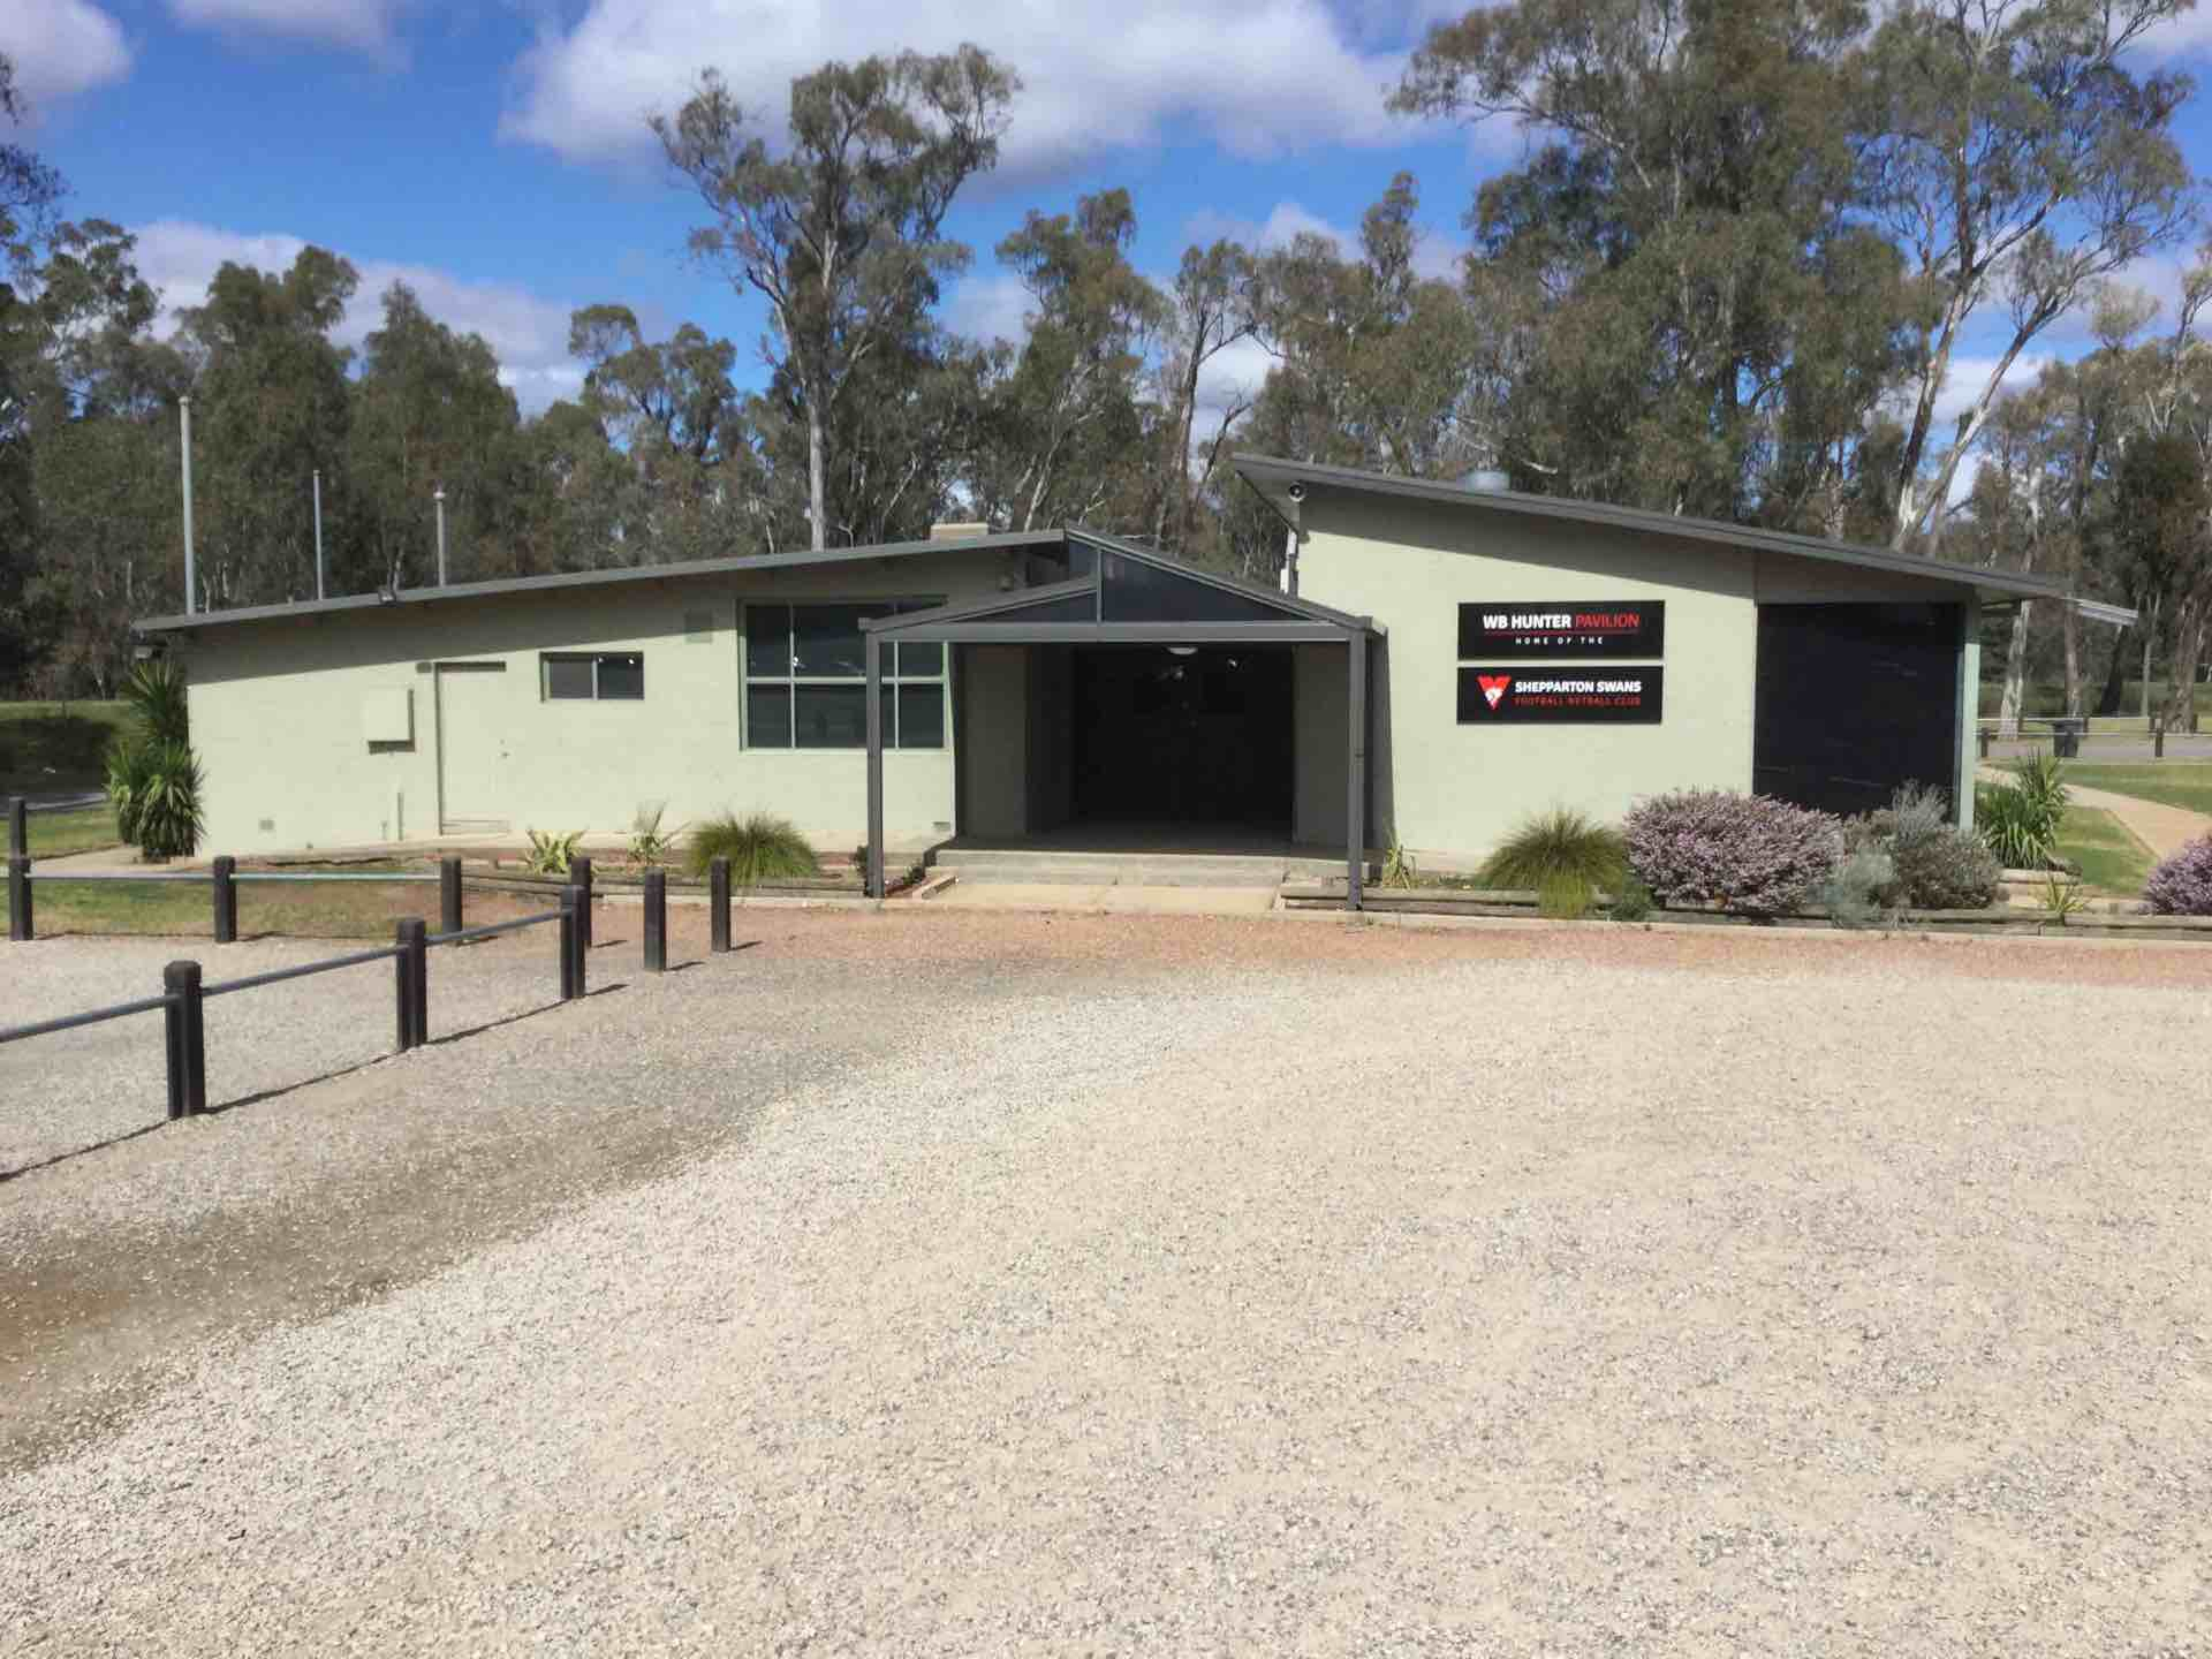
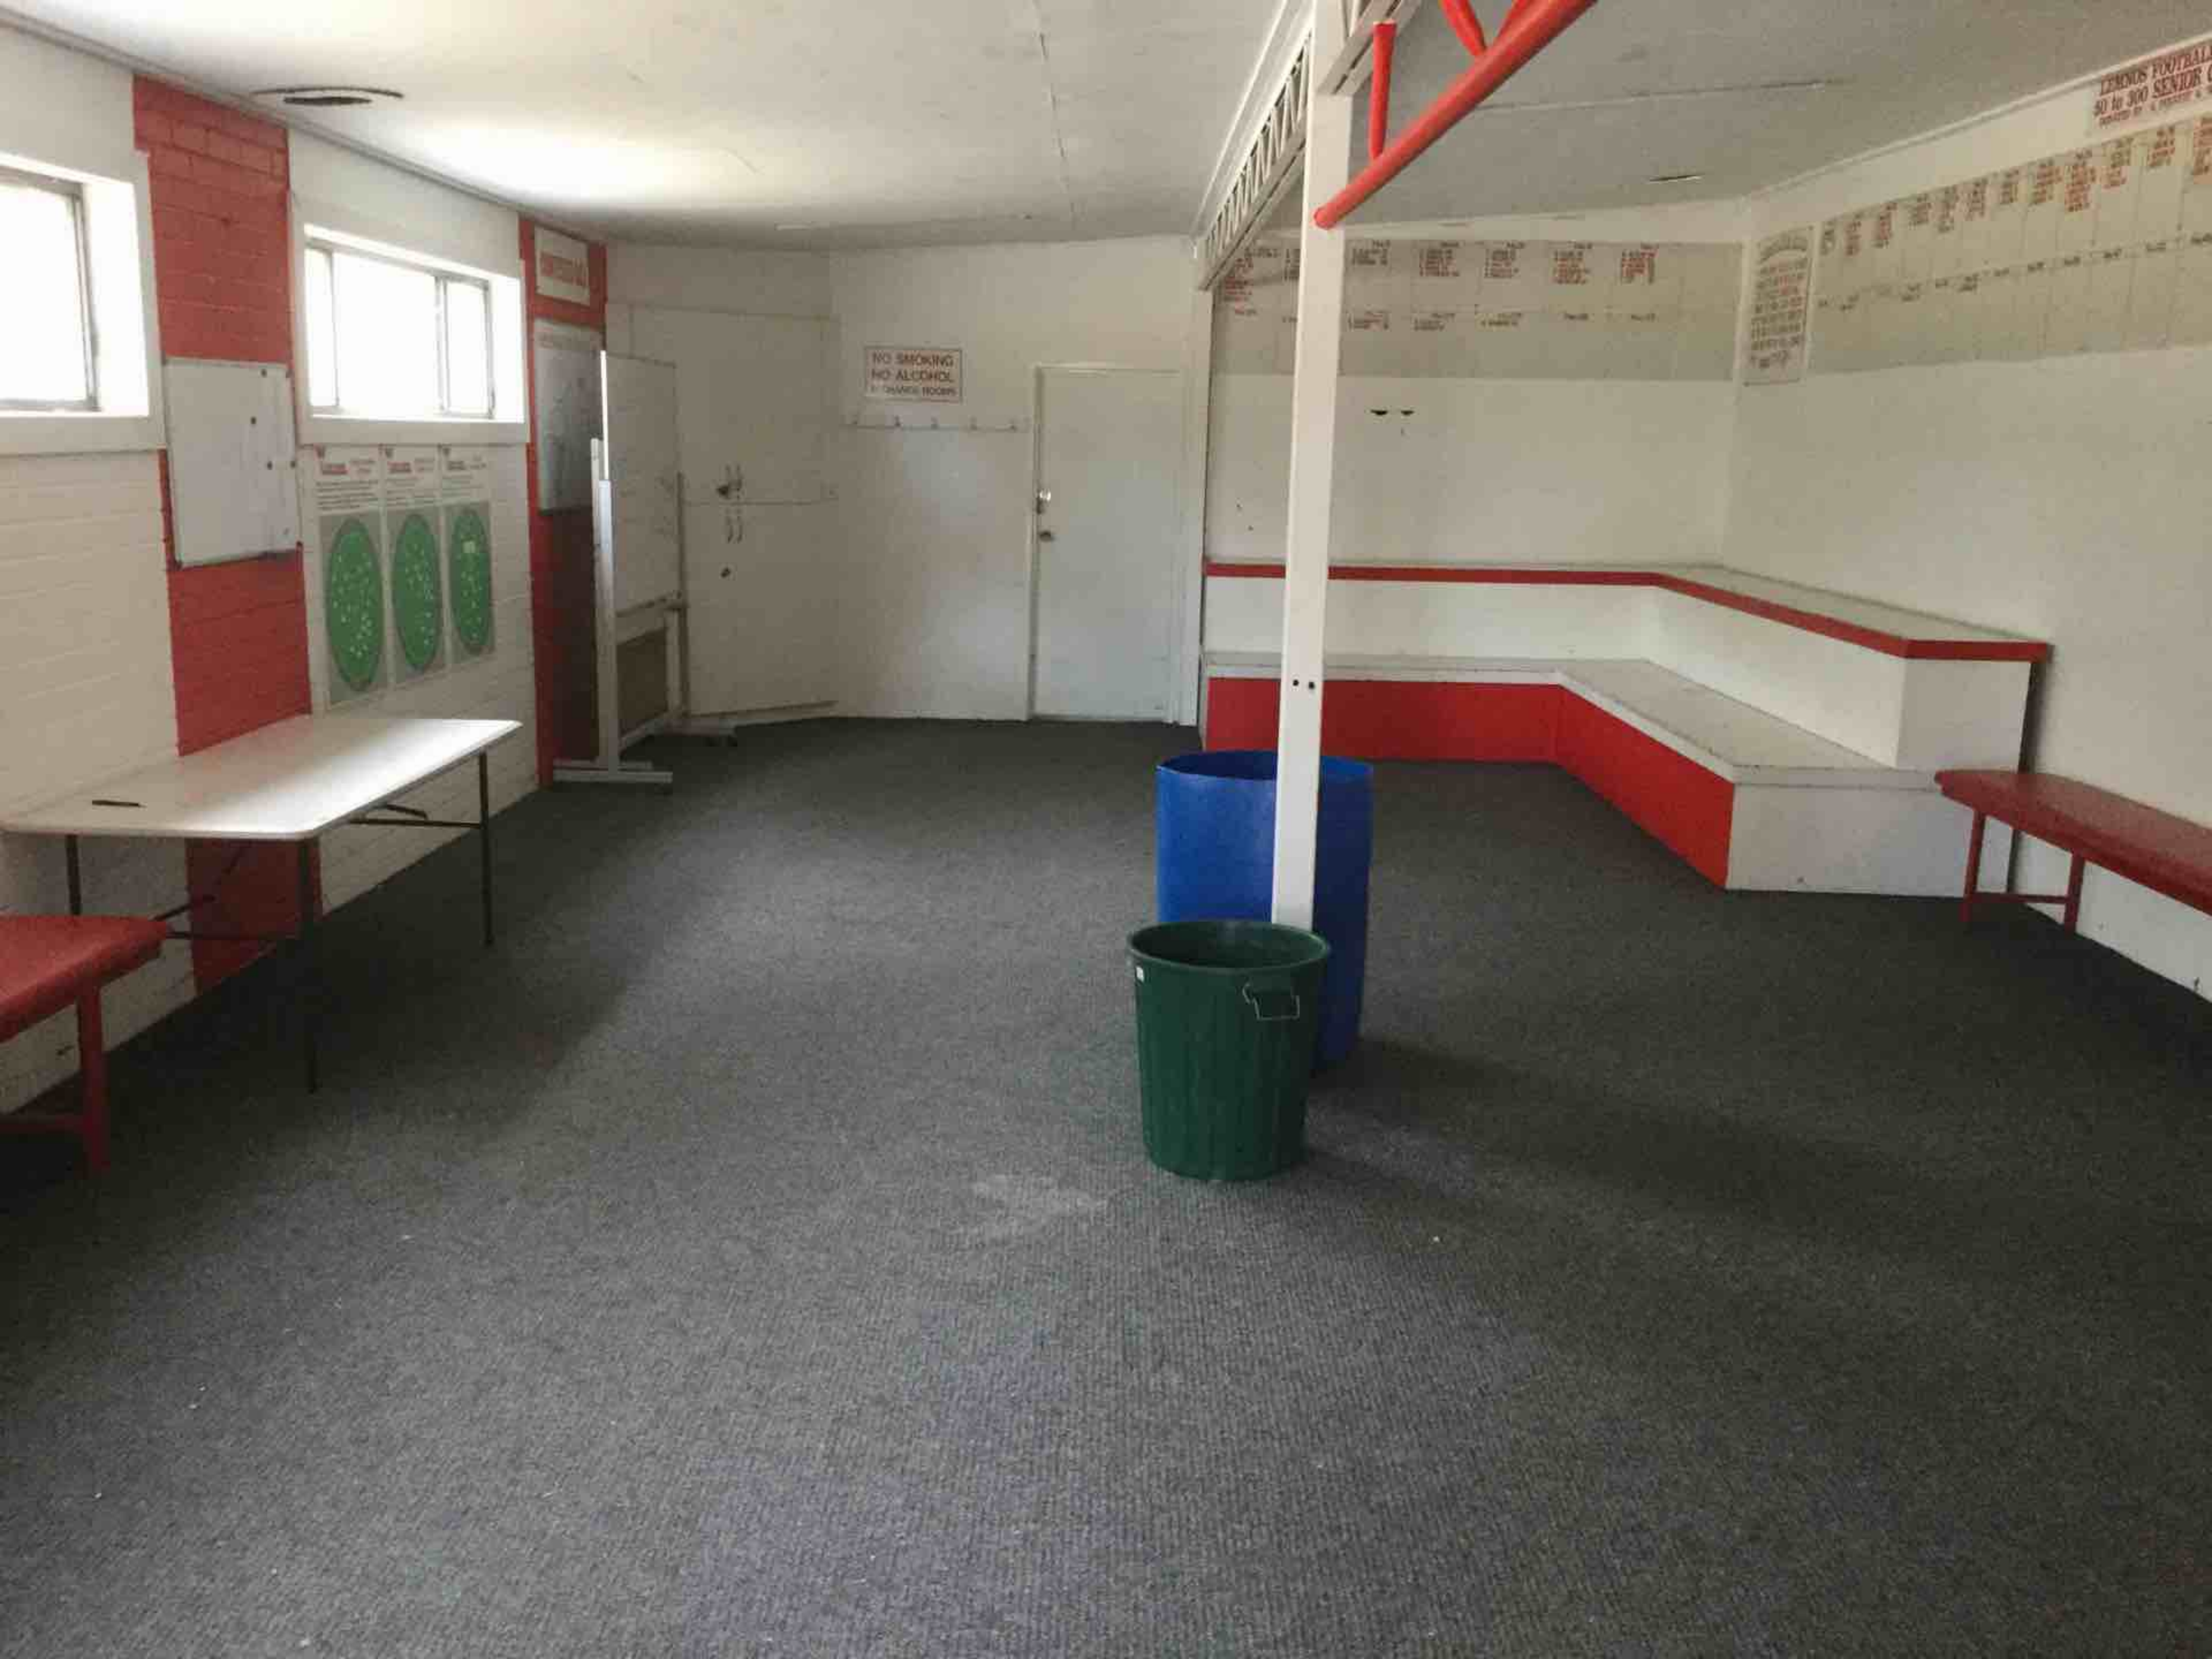
Observation Type	Code	Grade	Score	Notes
BU-Building Overall Condition	BUOC	Good	4.0000	The southern/older part of the Pavillion appears to be in a good condition, and remains functional. Maintenance has been spent on the facility in recent years(carpet and external painting etc), but some internal painting and improvements to the changerooms/showers would improve the aesthetics. Note - The changerooms are not well suited for female use.
BU-Ceiling Condition	BUCE	Good	4.0000	Ceiling in original condition,but still in a very good condition.
BU-Fitout Condition	BUFI	Good	4.0000	Typical of Football Clubrooms of the 1980's. Changerooms are not well suited for use by female that want to access showers etc.
BU-Floor Condition	BUFC	Moderate	5.0000	Original carpet and new carpet in foyer and function room. Timber flooring in function room needs to have nails punched to tighten the floor and remove squeaks.

BU-Internal Wall Condition	BUIC	Good	4.0000	Walls in a very good condition, although some areas require painting to improve aesthetics.
BU-Mechanical Condition	BUMC	Moderate	5.0000	An older Evap cooler through the function room, but appears to be in a good working order.
BU-Roof Cladding Condition	BURC	Good	4.0000	Original iron on roof, but appears to be in a good condition.
BU-Roof Structure Condition	BURT	Good	3.0000	An original steel web truss structure, but appears to be in excellent condition.
BU-Wall Condition	BUWC	Good	4.0000	Externally walls have been painted within the last 5 years. Structurally the walls appear in a very good condition. Some of the internal walls need freshening up, but are generally in a good condition.
