**Officer:** John Gribben (JEG)  
**Route:** BU-Cond Surv Princess Park (BU29)  
**Report Type:** Assessment

**Site:** Princess Park (Shepparton) (F0062)

**Date:** 13/10/2017

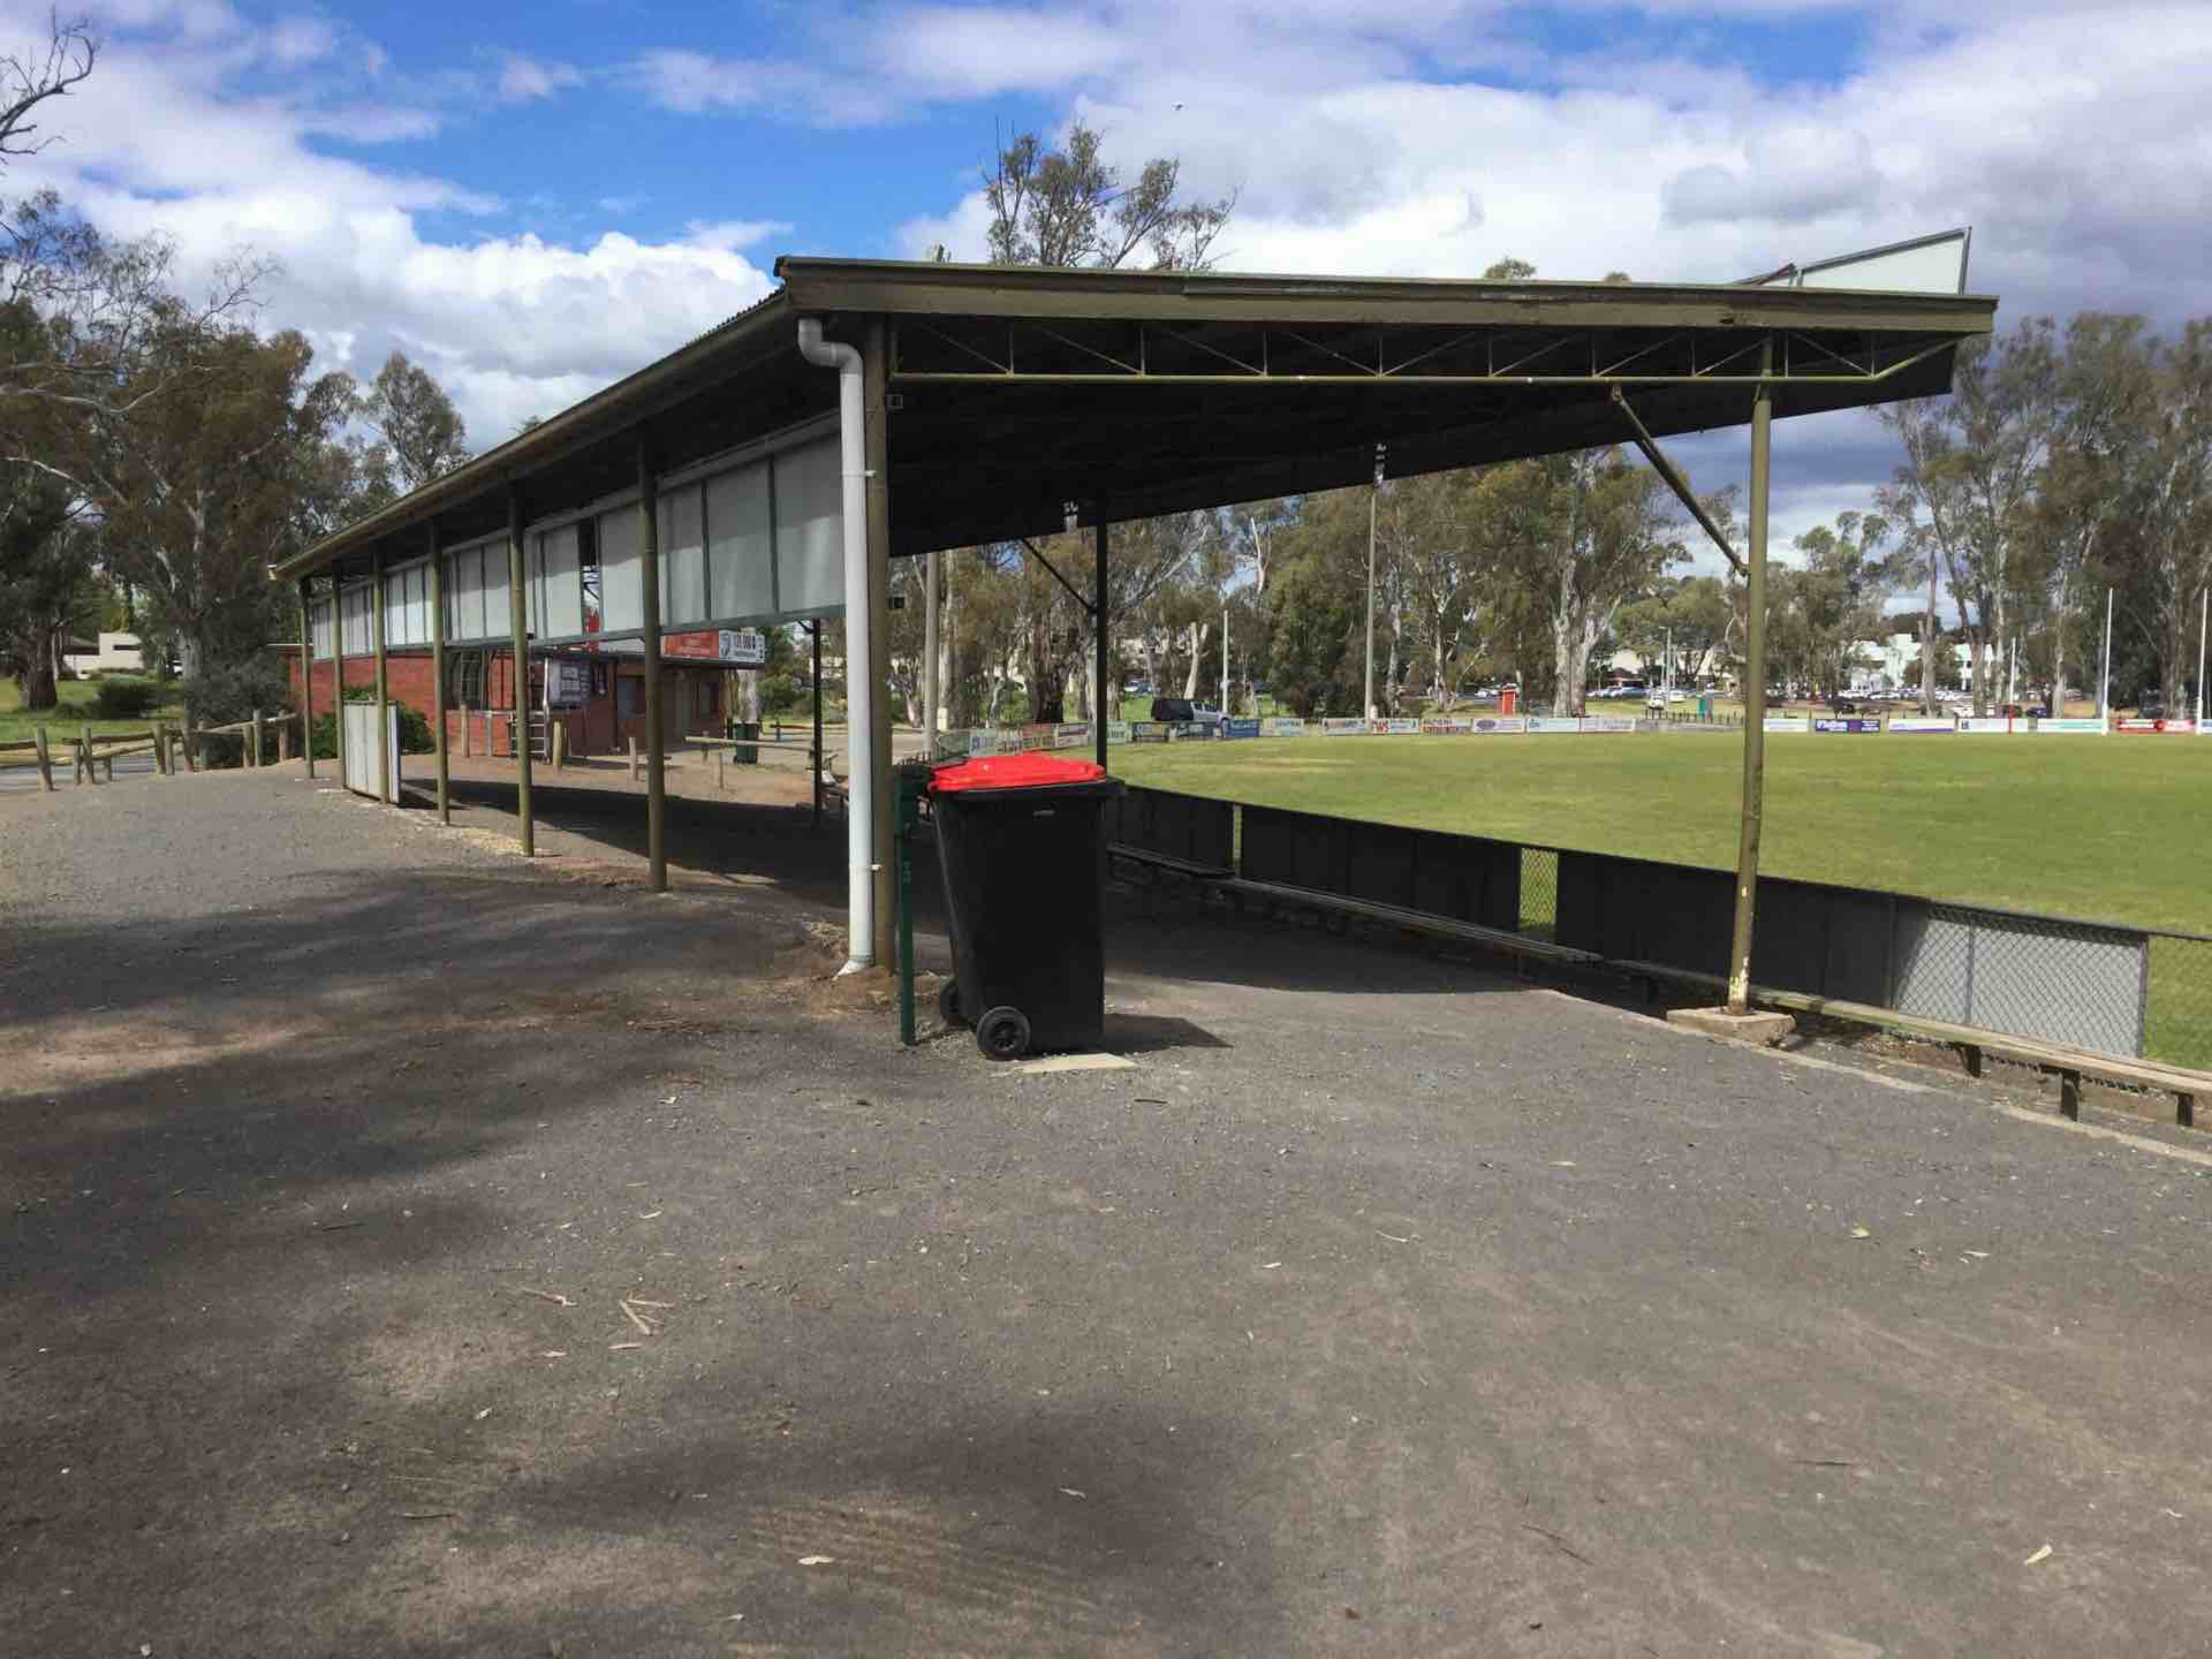
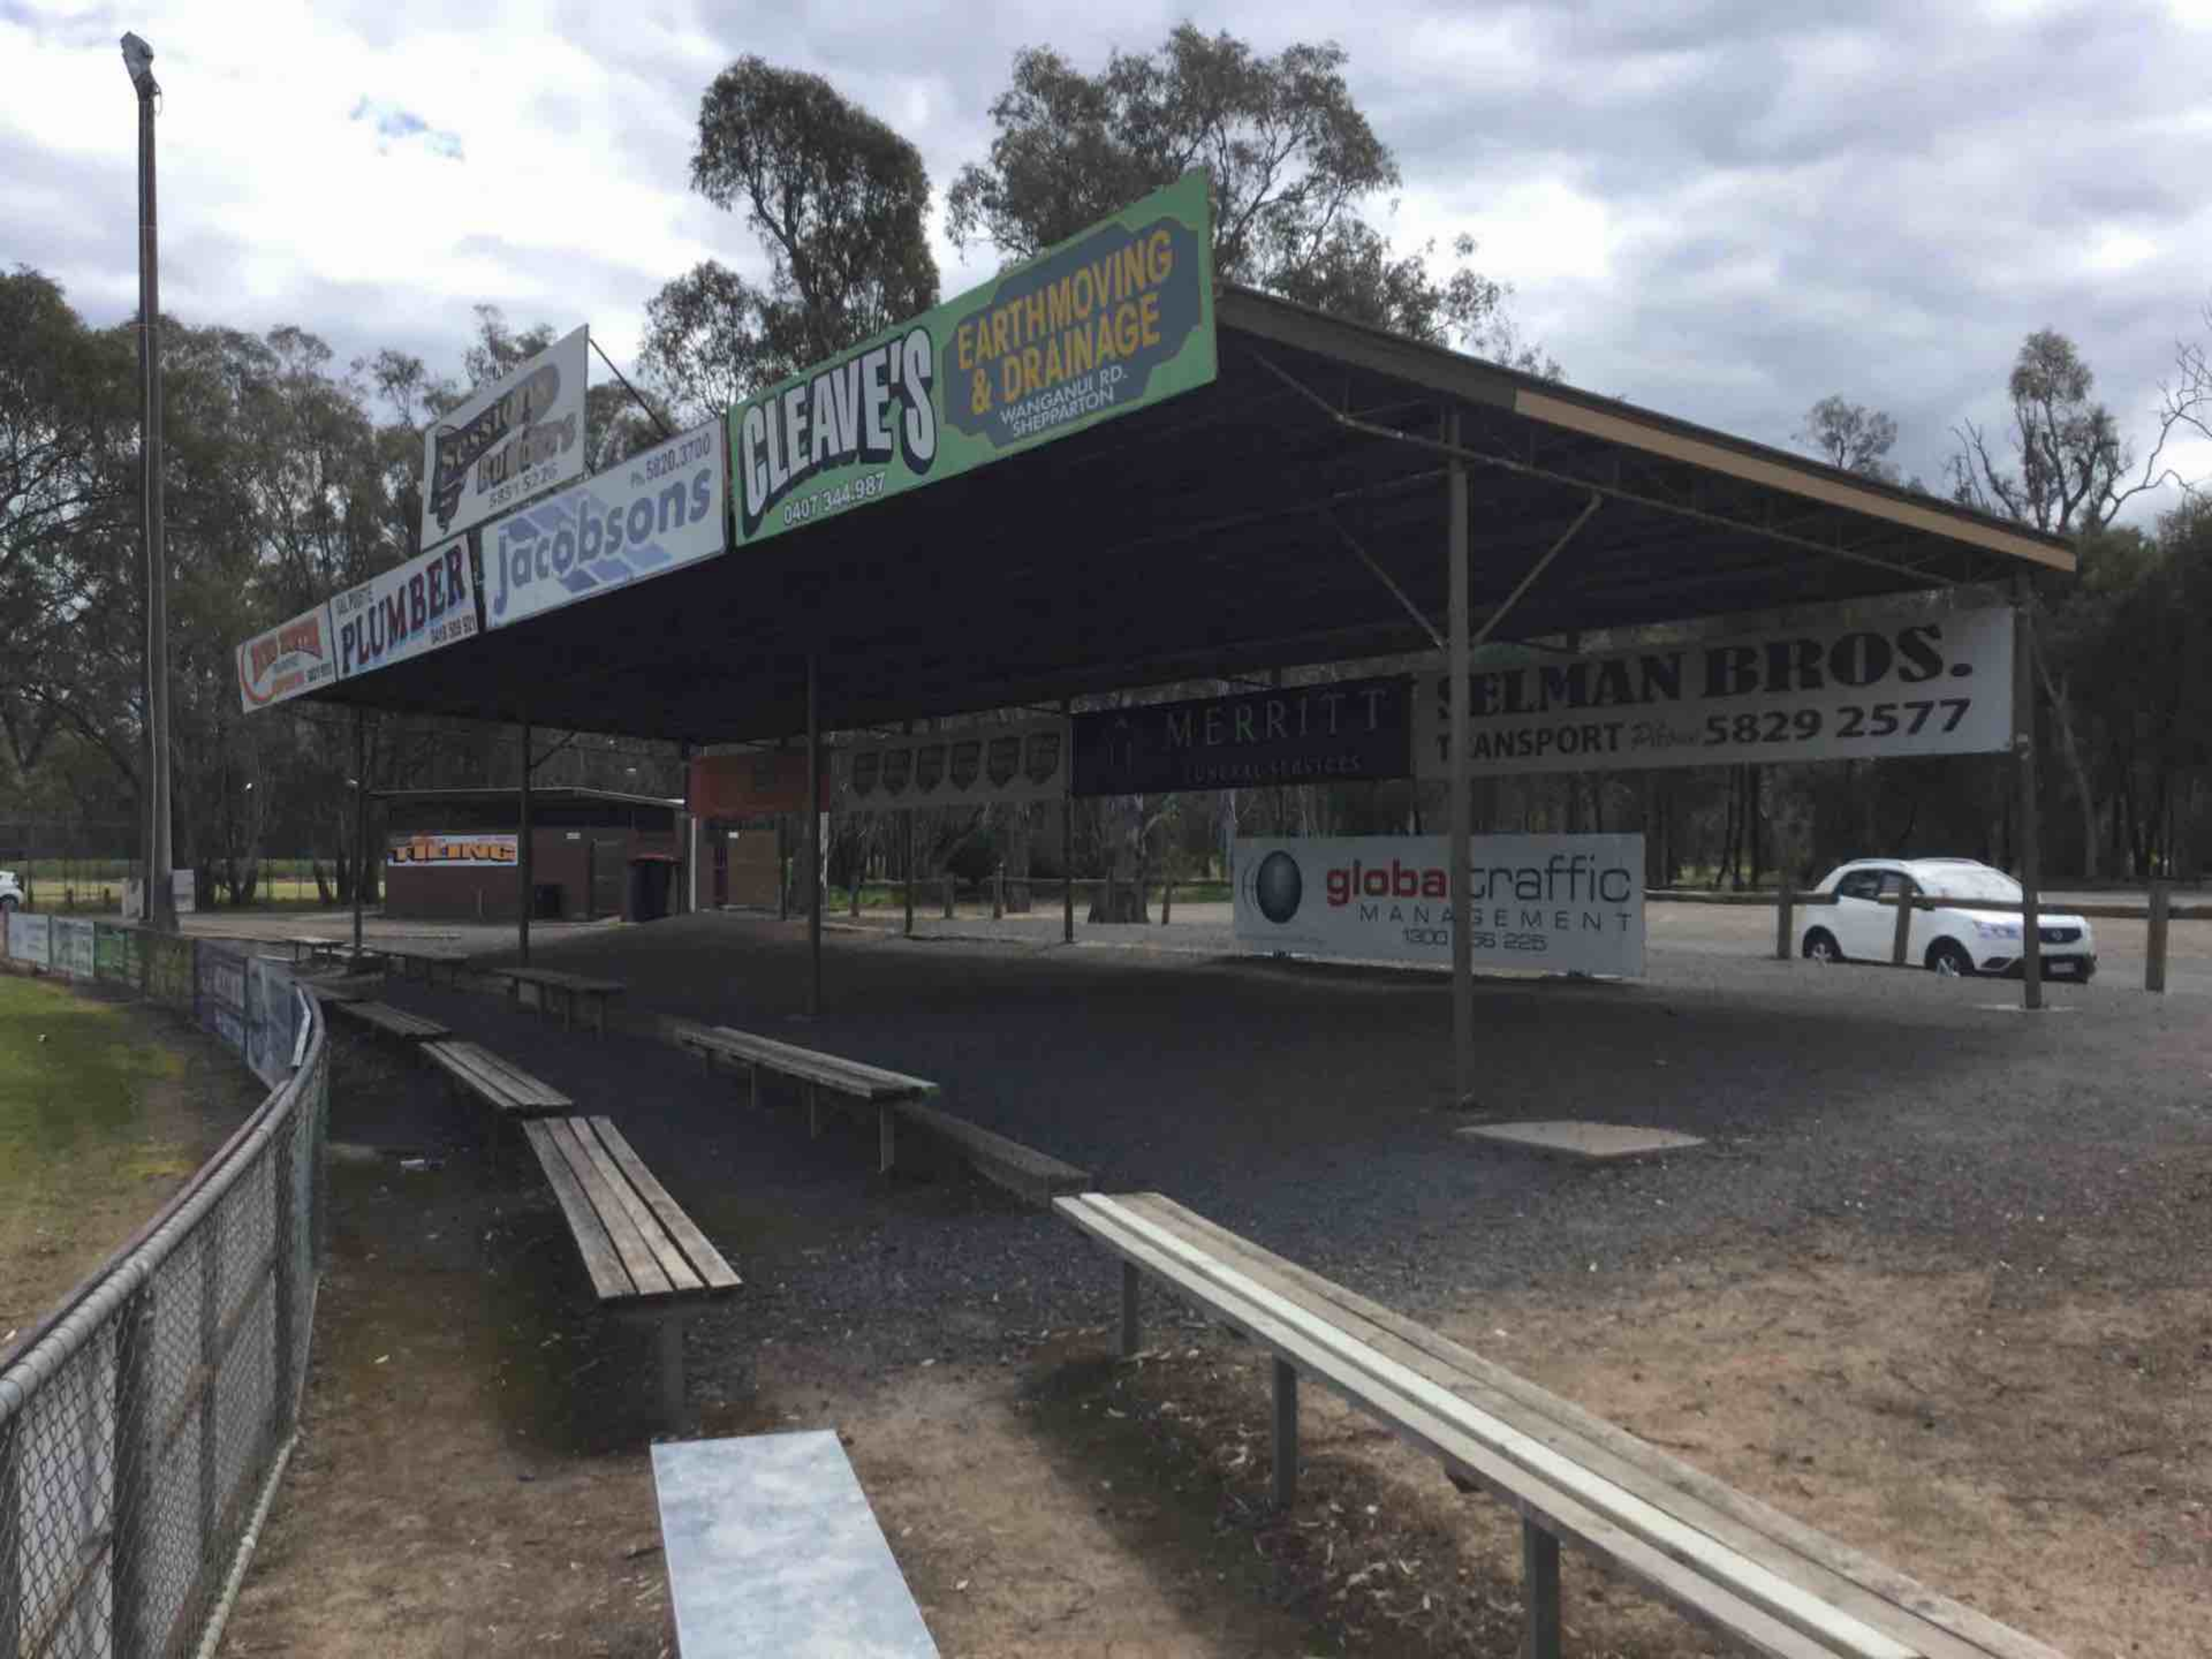
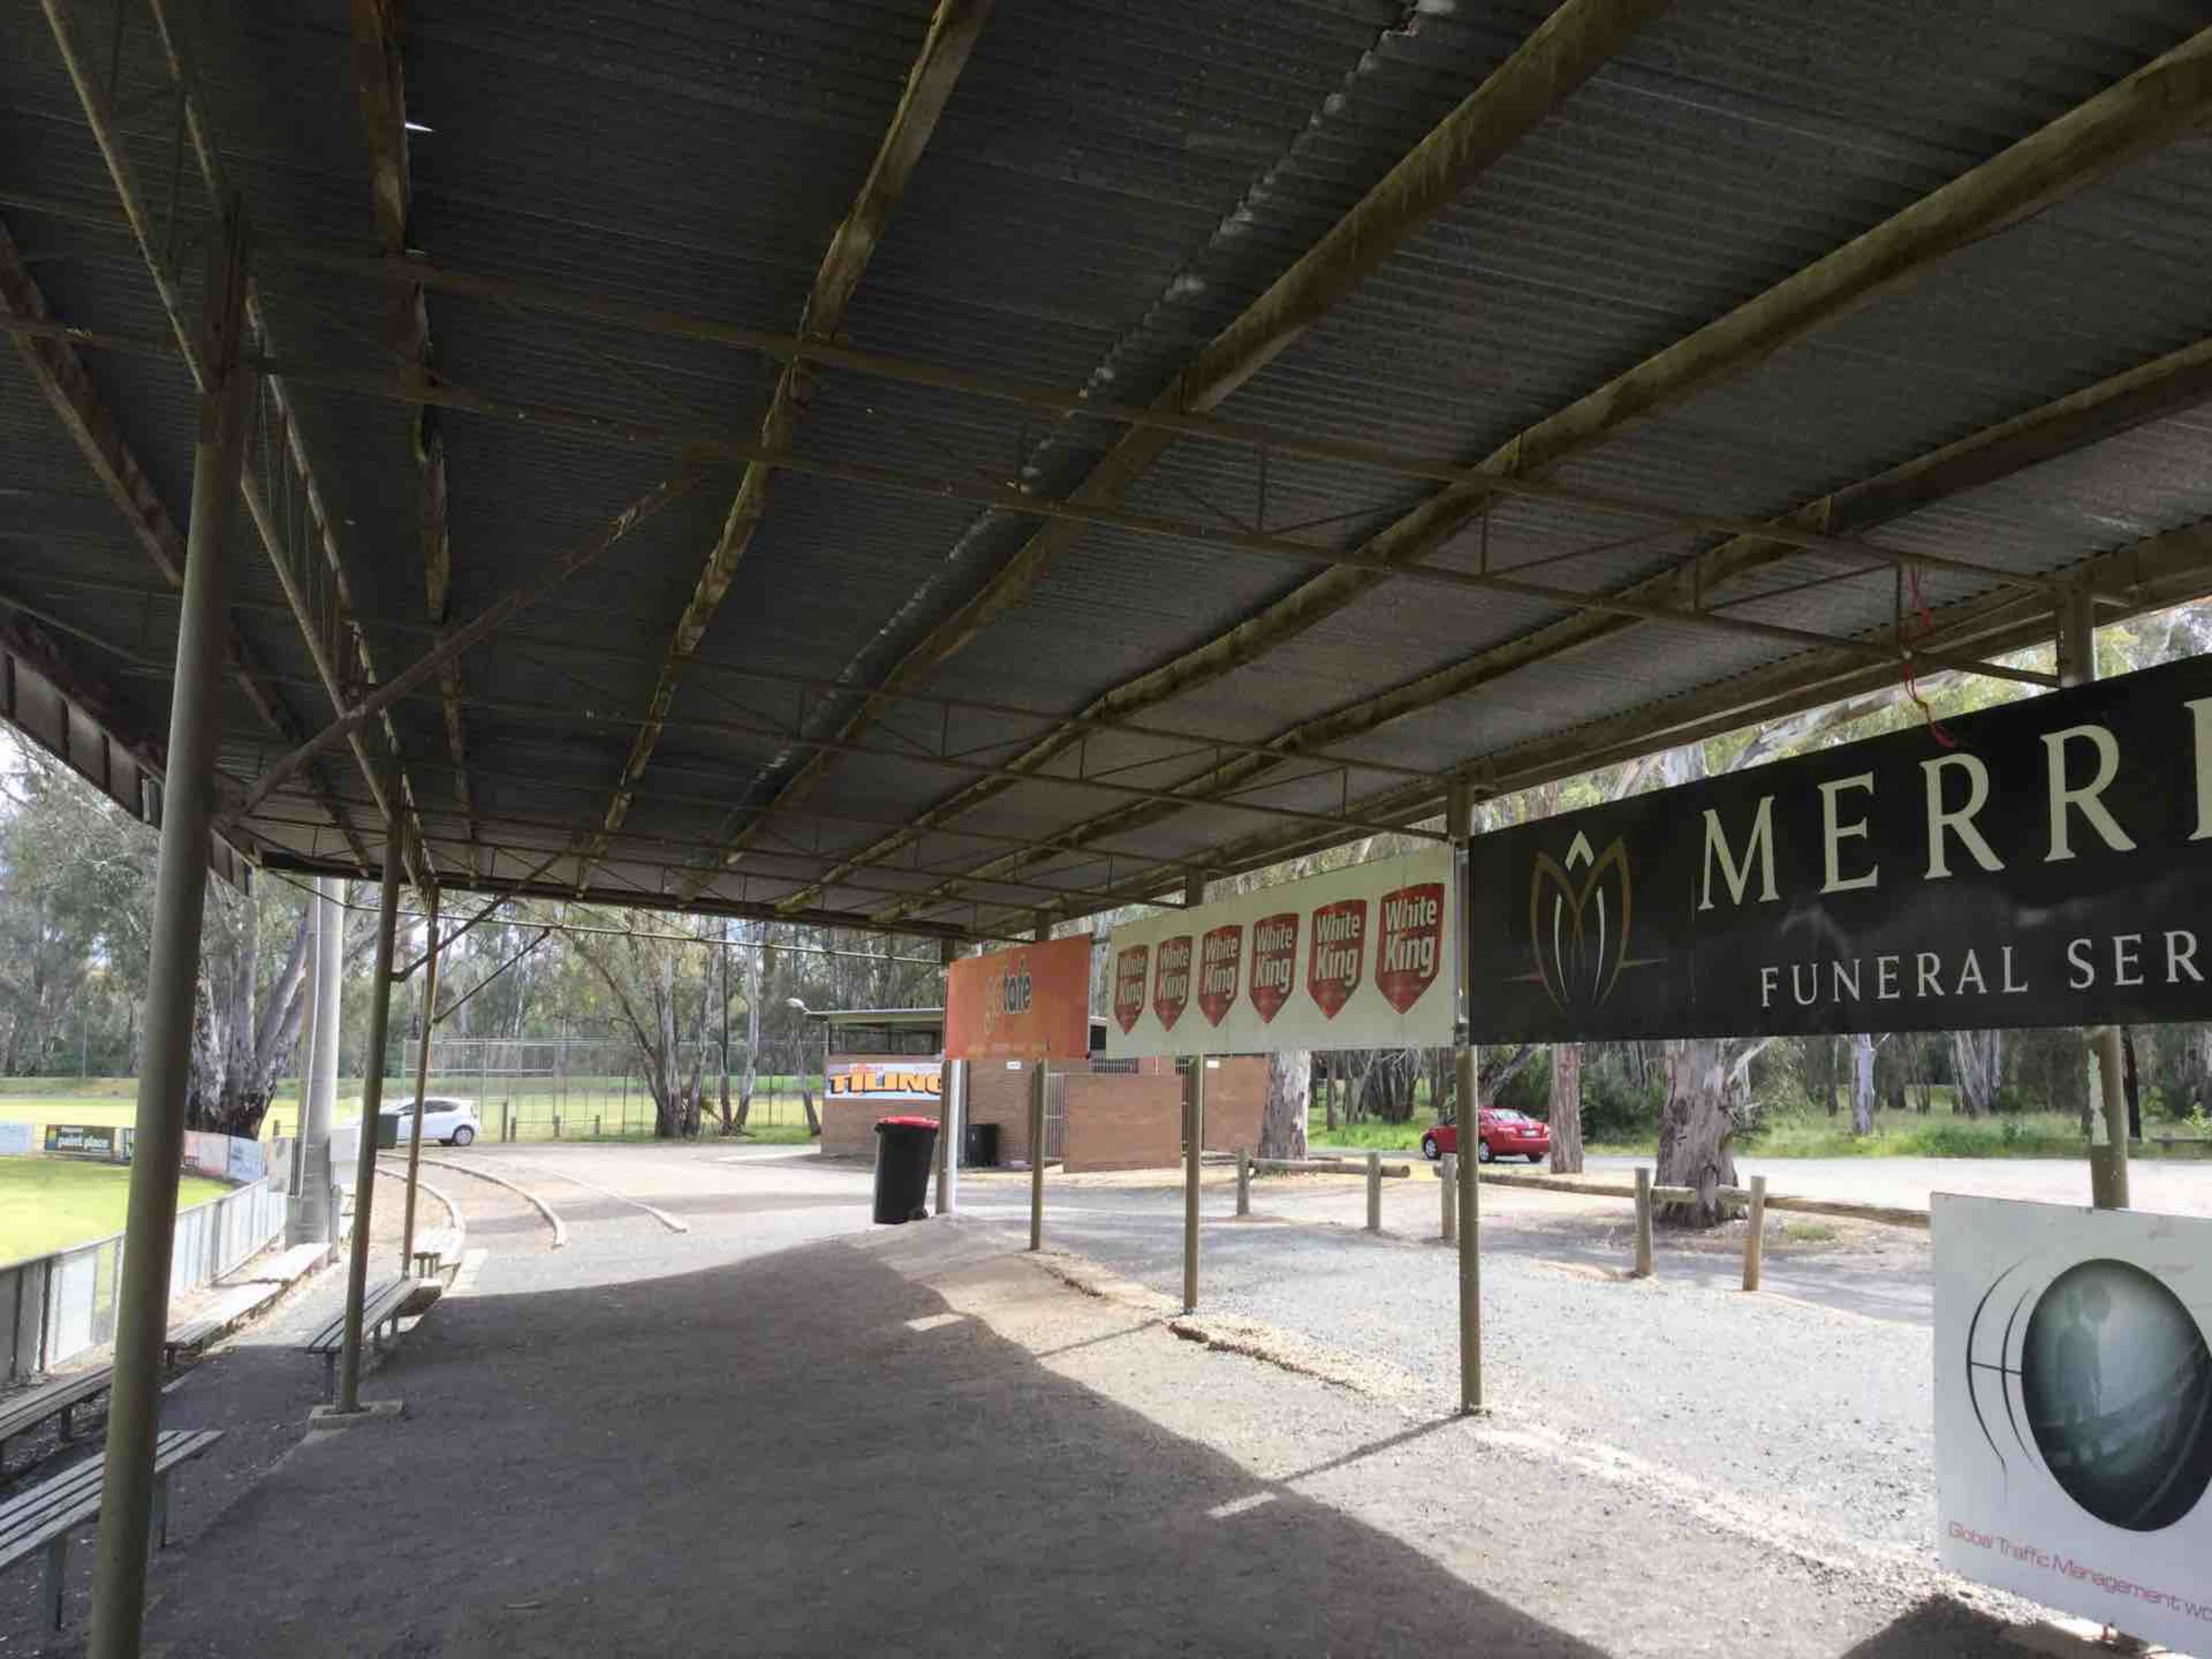
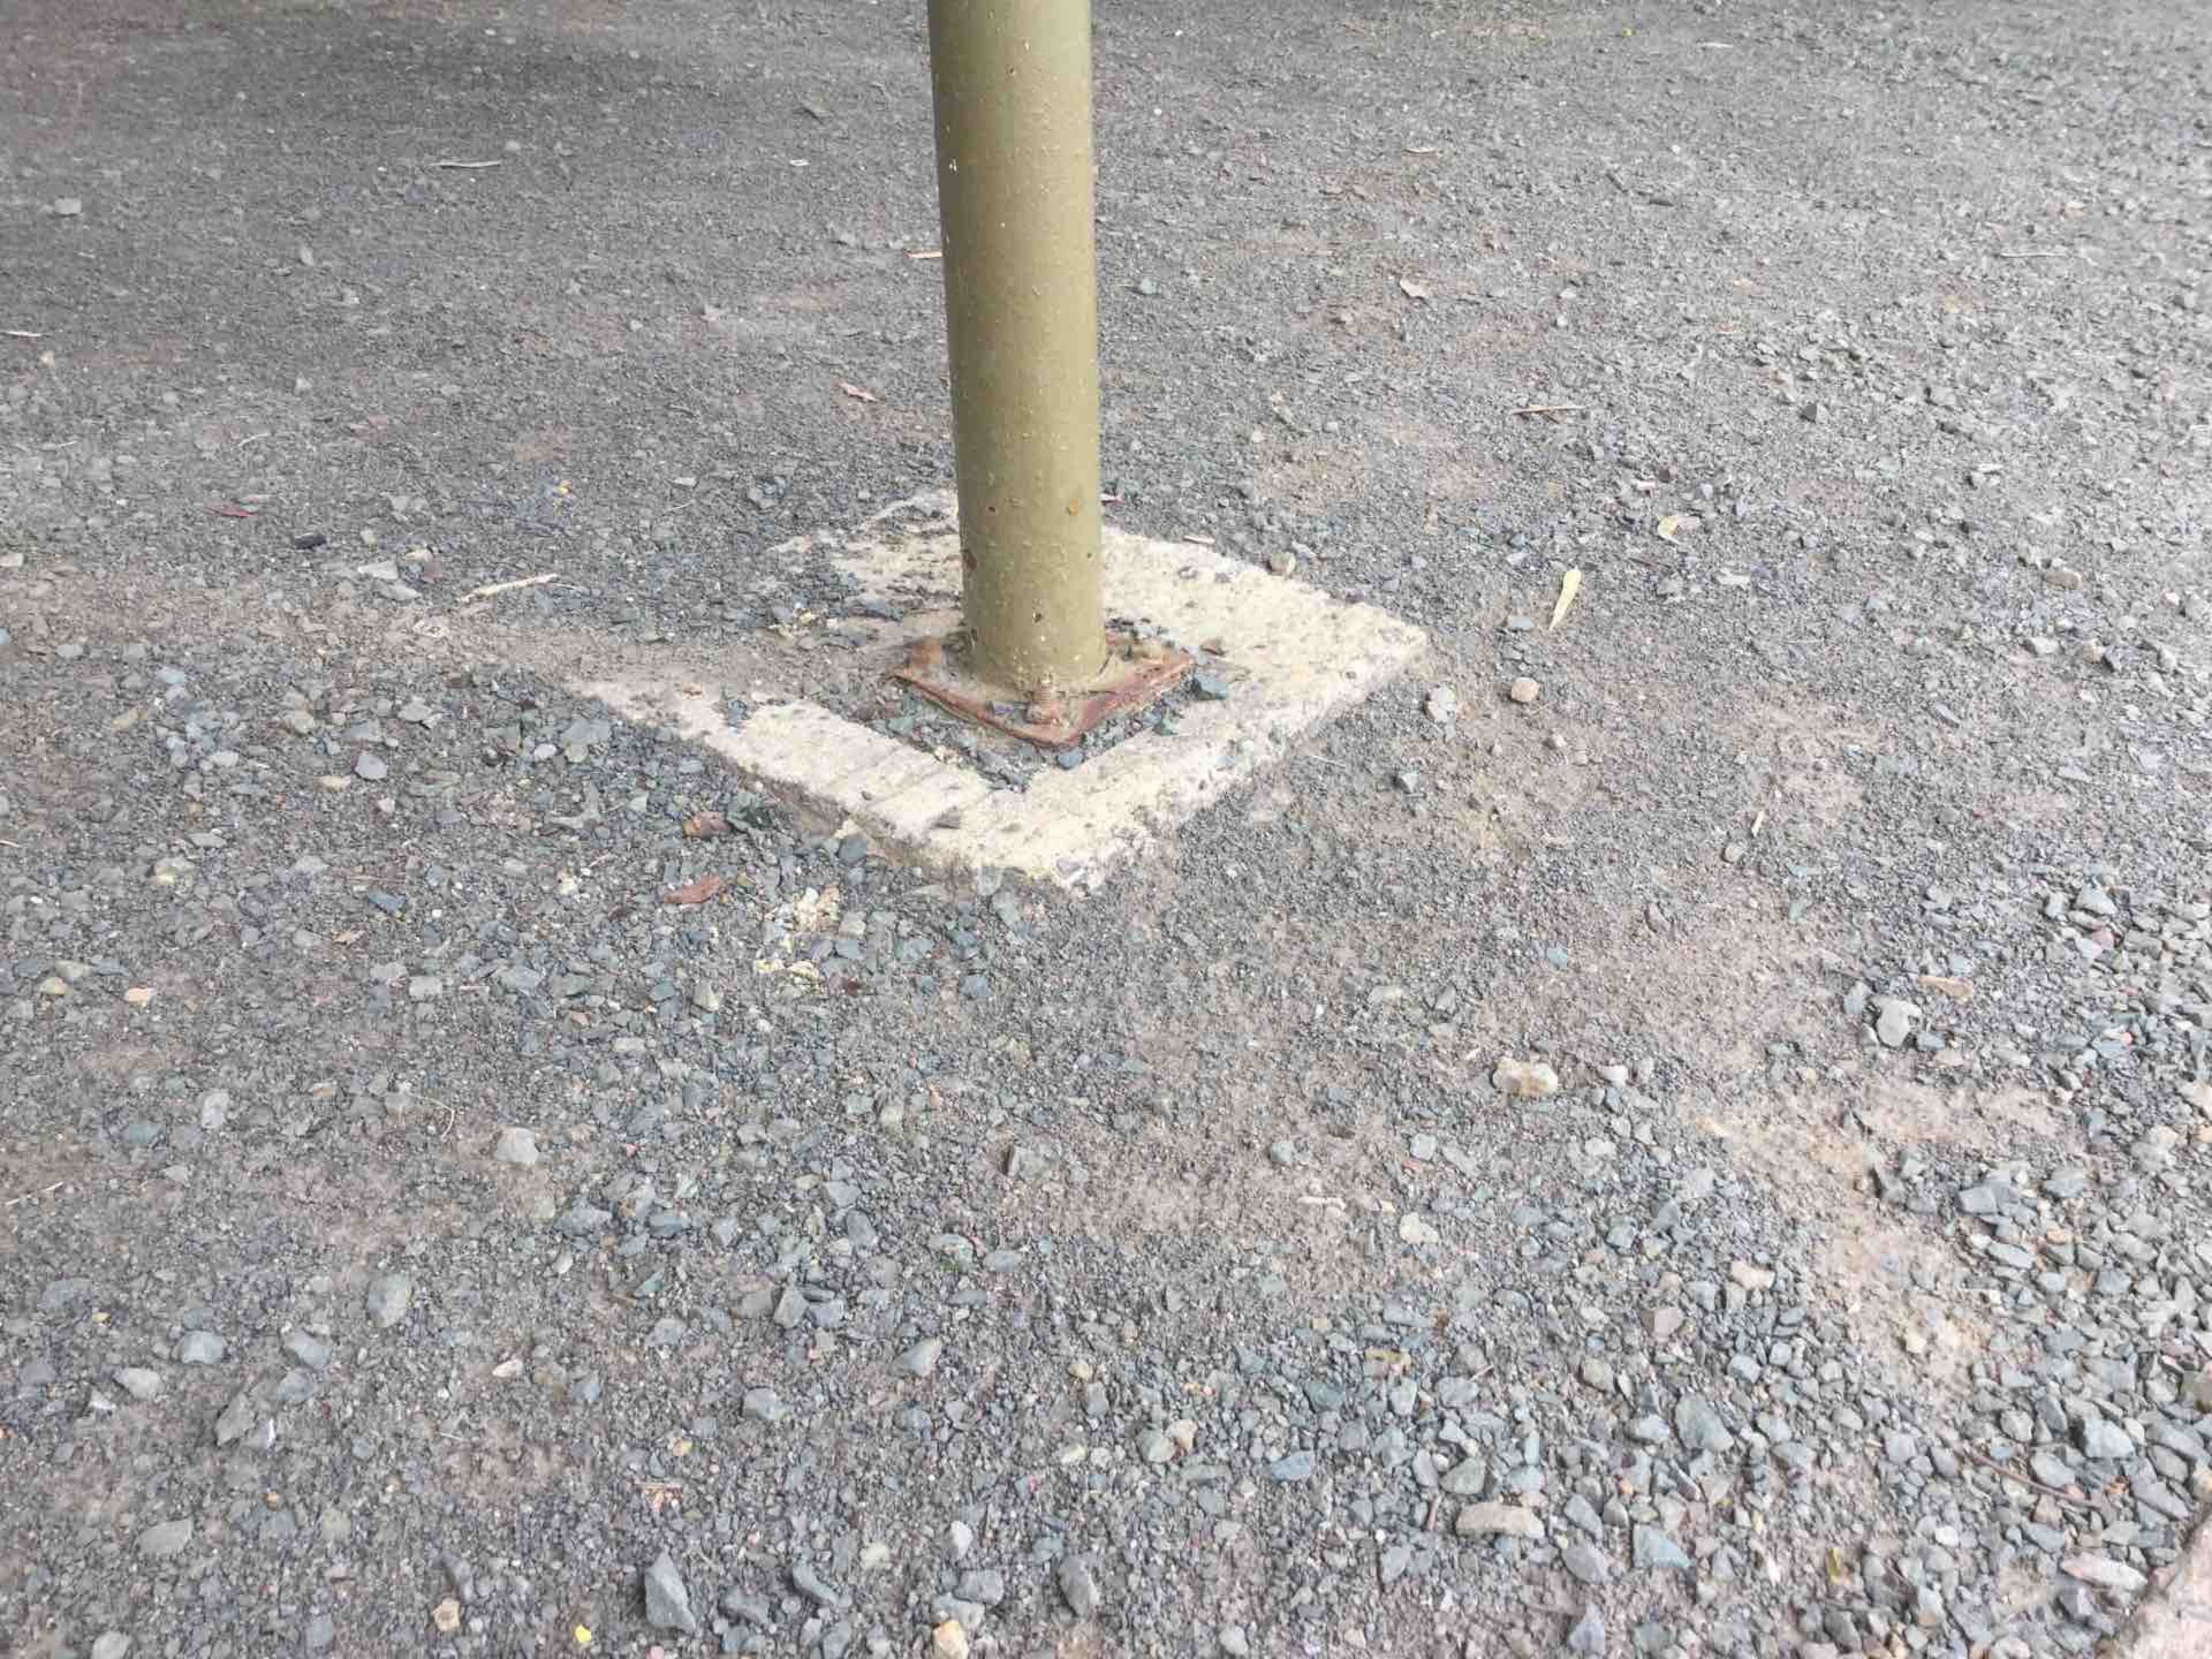
Observation Type	Code	Grade	Score	Notes
BU-Building Overall Condition	BUOC	Moderate	5.0000	Shelter is old, but appears in good condition, with some minor rust marks showing at the base of columns, and some structural timber in the roof deflecting.
BU-Ceiling Condition	BUCE	Excellent	.0000	N/A corrugated iron.
BU-Fitout Condition	BUFI	Excellent	.0000	N//A
BU-Floor Condition	BUFC	Excellent	.0000	N/A (Dirt/gravel)
BU-Internal Wall Condition	BUIC	Excellent	.0000	N/A
BU-Mechanical Condition	BUMC	Excellent	.0000	N/A
BU-Roof Cladding Condition	BURC	Good	4.0000	Old corrugated iron, but serviceable.
BU-Roof Structure Condition	BURT	Moderate	6.0000	Steel structure in good condition, with small amount of rust at base of columns. Timer purlins have deflected over time, but appear still sound.
BU-Wall Condition	BUWC	Excellent	.0000	N/A
