# Community Update

## Toolamba Bridge | 30 January 2017

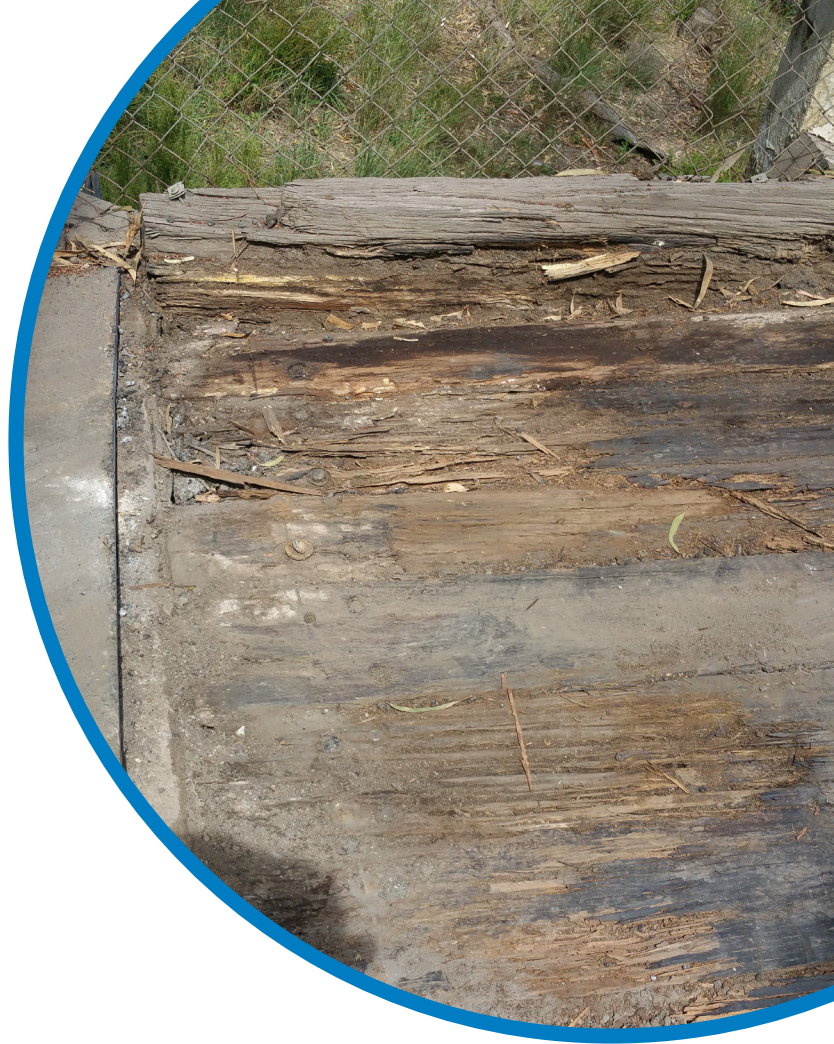
The bridge was closed late December 2016 due to the failure of a number of decking planks from termite damage.

Council has commenced to remove the asphalt seal that was placed over the timber deck in 2006 to reveal the full extent of termite damage to decking timbers. It is estimated that this task, and the replacement of up to 90 metres of decking timber, will cost in the order of \$30,000 to \$50,000 and will see the bridge opened in the short term while a tender process is undertaken to repair the bridge later in 2017.

Supply of iron bark or other suitable hardwood decking planks is proving difficult and it could be 2 months before we have the materials available to complete the short term works.
