Report

Shepparton Mooroopna 1% AEP Flood Mapping Project

Greater Shepparton City Council

24 August 2021

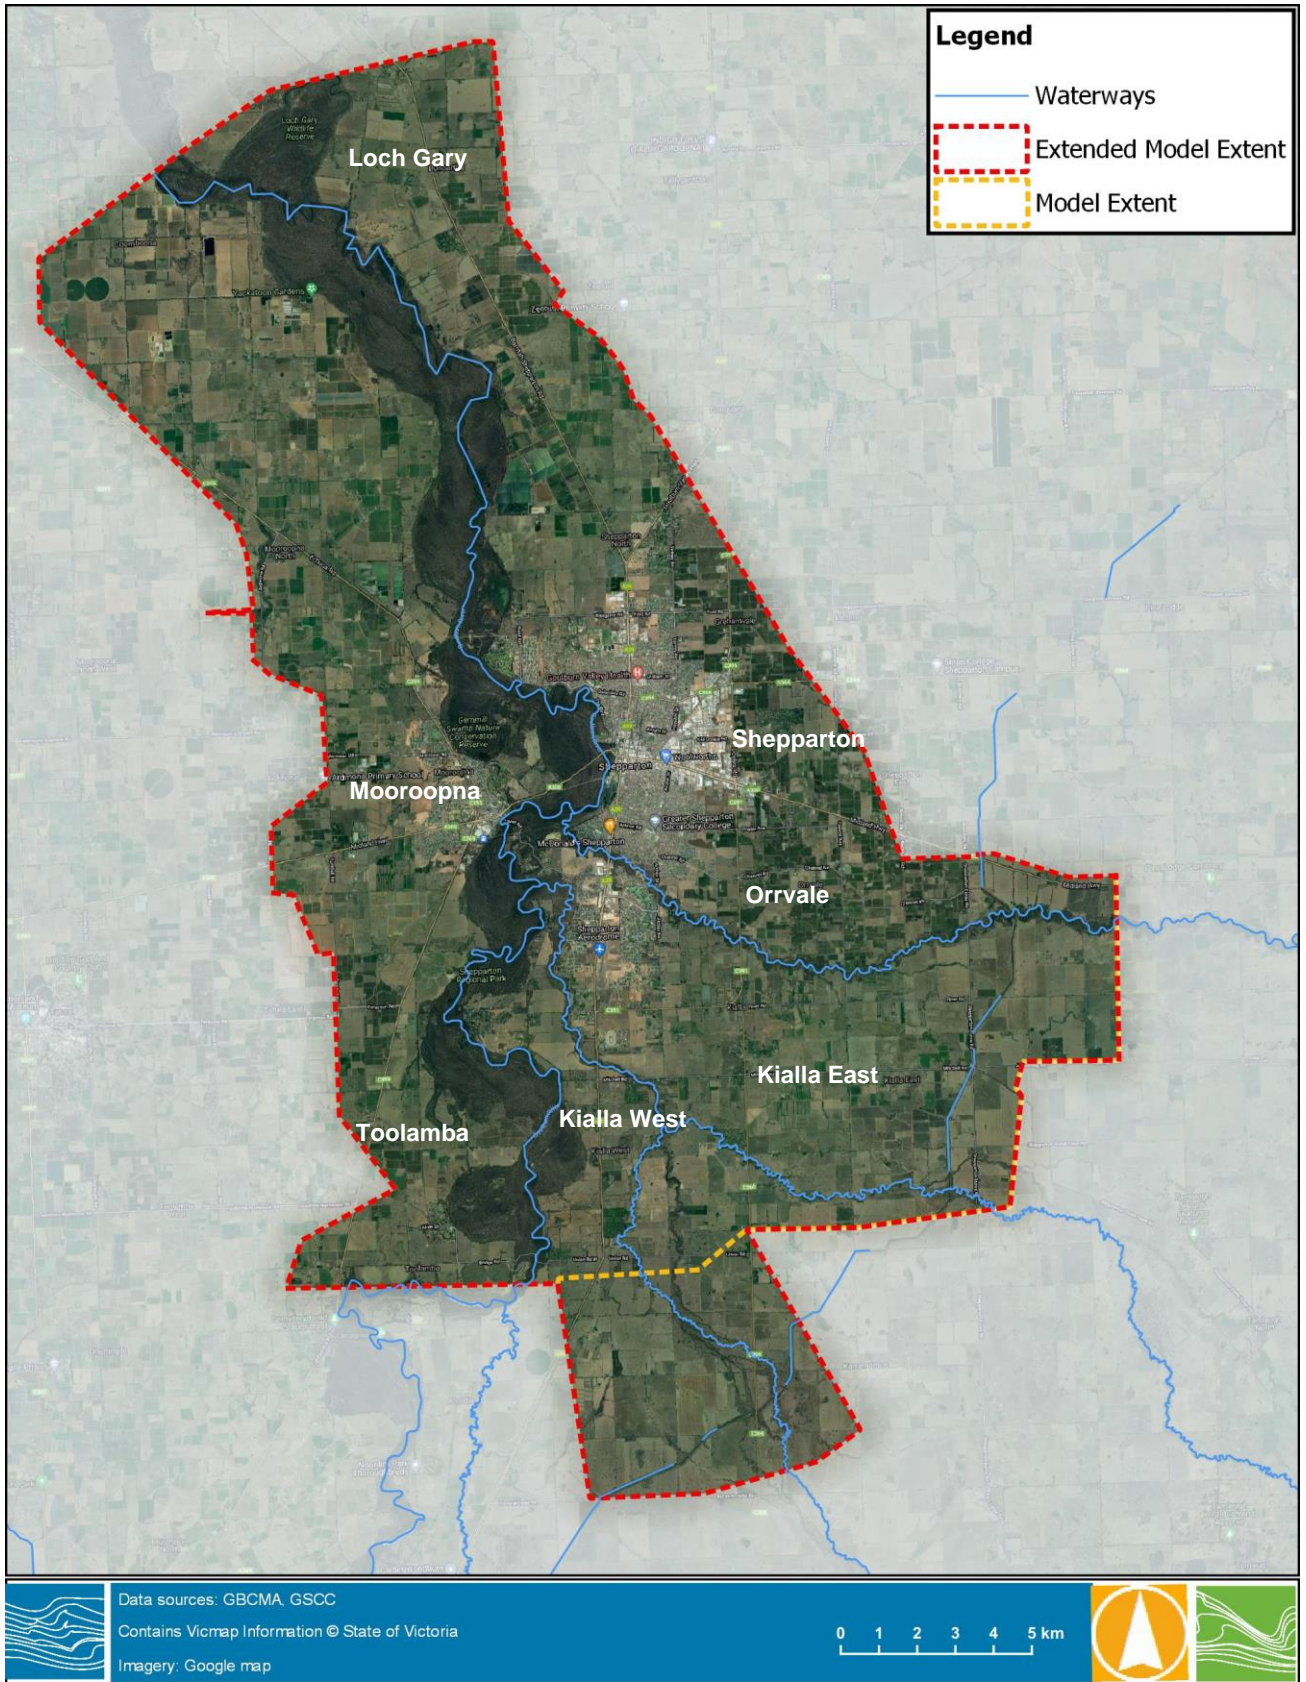
FIGURE 2-1 HYDRAULIC MODEL EXTENT

Shepparton and Mooroopna are situated on the Goulburn River at the confluence with the Broken River and Seven Creeks. The study area extended upstream of Shepparton to Toolamba and downstream of Shepparton to Loch Garry on the Goulburn River, upstream of Shepparton to Kialla East on the Broken River and upstream of Shepparton to Kialla West on Seven Creeks. Figure 2-1 shows the hydraulic model and flood mapping extent used for the 1% AEP mapping. The Seven Creeks inflow boundary was placed upstream of the East Goulburn Main Channel for the Climate Change analysis (Section 6).

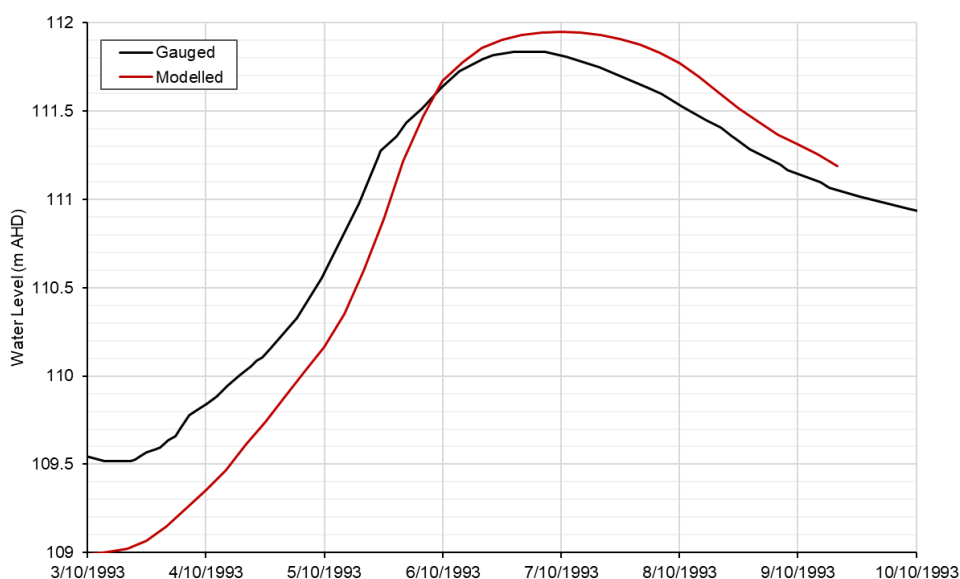
FIGURE 4-1 MODELLED AND GAUGED WATER LEVELS FOR THE GOULBURN RIVER AT SHEPPARTON (1993)

The overall trend showed the modelled flood levels had no bias higher or lower than the surveyed flood levels and were predominately well within the satisfactory error interval expected for model calibration. Comparison with the previous calibration suggests there are several calibration points along the Broken River floodplain which are now lower than the previous calibration. This is due to the fact that the previous calibration utilised a LiDAR data set that was lowered by 100mm. The updated LiDAR used for the current study matches feature survey much closer in this area. Figure 4-1 below shows a plot of the water level at the Goulburn River at Shepparton gauge, comparing the model results to gauged data. The graph shows the rising and falling limbs of the modelled hydrograph are well represented within the model, and the peak elevation is approximately 110 mm higher than the gauged data.

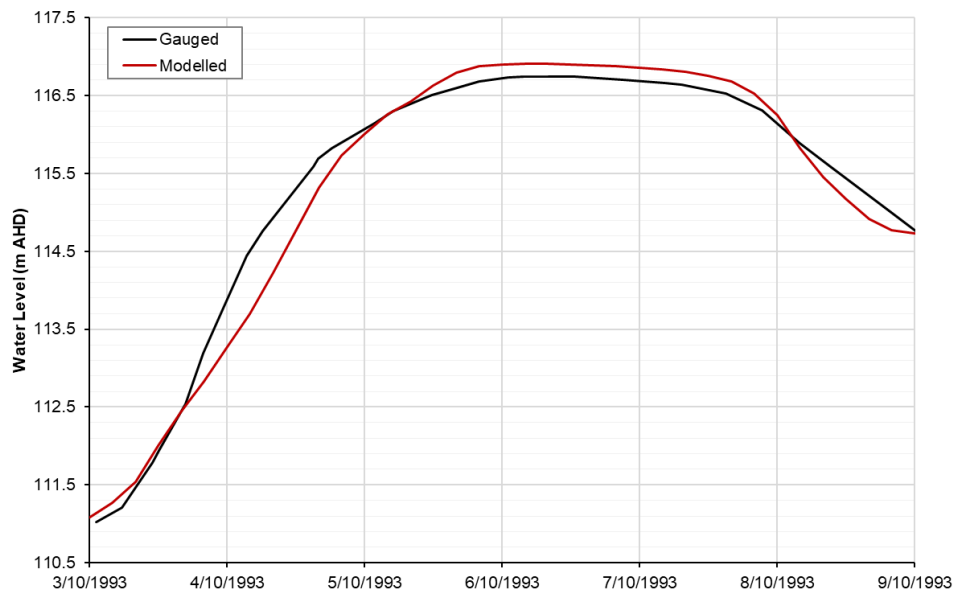
FIGURE 4-2 MODELLED AND GAUGED WATER LEVELS FOR THE BROKEN RIVER AT ORRVALE (1993)

Figure 4-2 shows the modelled and observed water levels at the Broken River at Orrvale gauge, the graph shows the rising limb of the modelled hydrograph arrives slightly later than the gauged data, the peak elevation is well represented in the model, despite overestimating the peak by 157 mm. There is limited streamflow data for Seven Creeks at Kialla West for the 1993 flood event. A 36-hour period which shows the peak passing the gauge was captured, and is shown against the modelled flood levels in Figure 4-3. The model has the peak slightly delayed, however appears to represent the gauged hydrograph shape well.

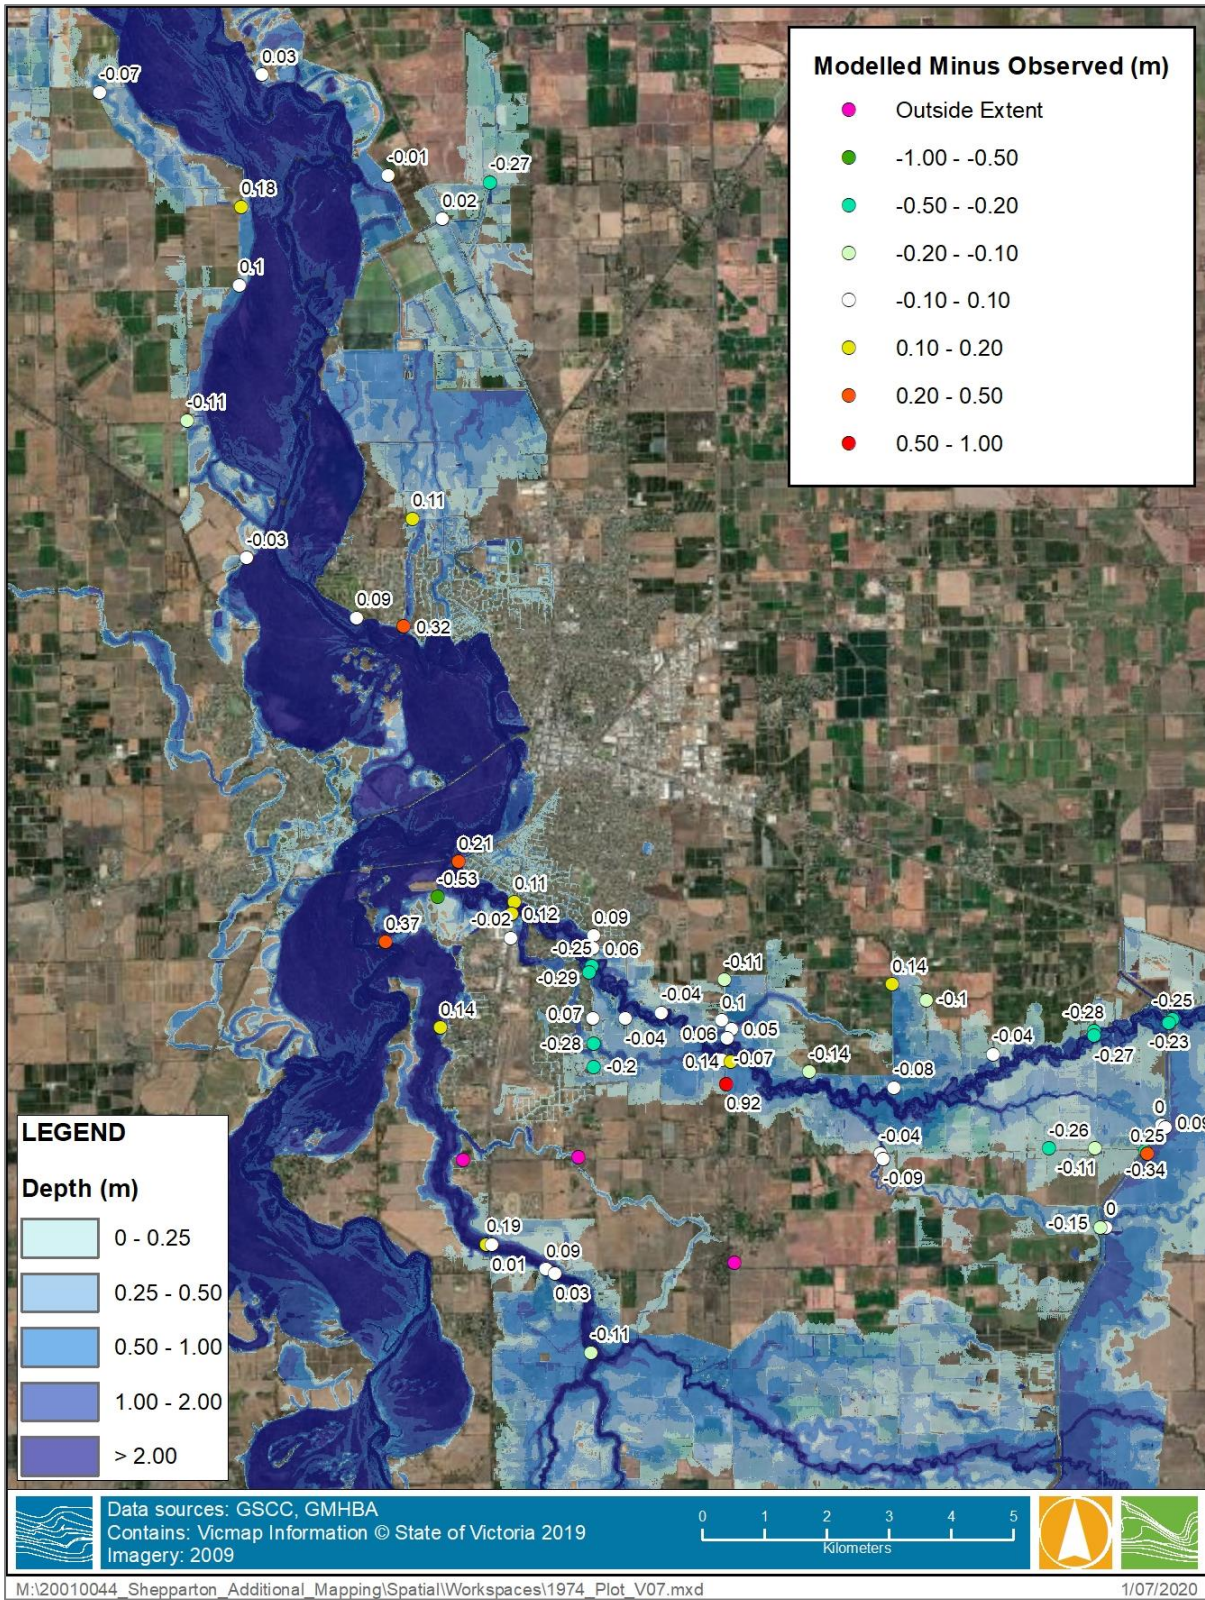
FIGURE 4-4 HYDRAULIC MODEL CALIBRATION PLOT – OCTOBER 1993 EVENT

The modelled flood extent matched observations, gauged river heights and aerial photographs very well, and was deemed an acceptable calibration result. Figure 4-6 shows the water surface profiles along the three main waterways for the 1993 flood event. These are plotted with the chainage distance of the waterway along the x – axis and the running distances (provided by the GBCMA) have also been included at key features along the waterways.

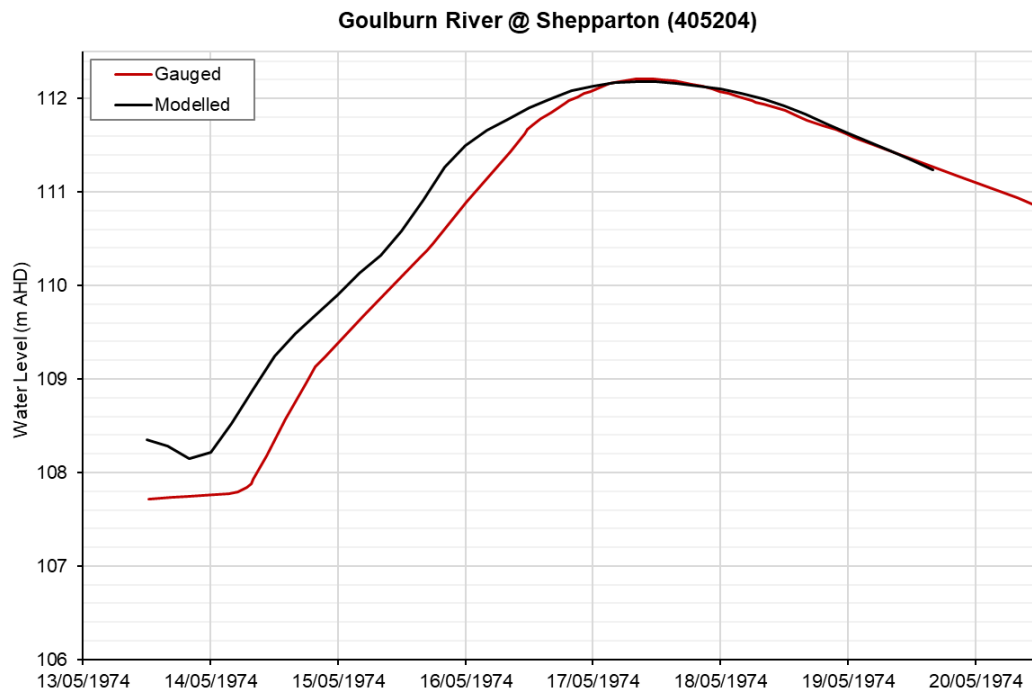
FIGURE 4-7 MODELLED AND GAUGED WATER LEVELS (GOULBURN RIVER AT SHEPPARTON) 1974

Figure 4-7 shows a comparison of modelled and observed water levels at the Goulburn River at the Shepparton gauge. The graph show the rising limb of the modelled hydrograph arrives slightly earlier than the gauged data, but matches the rate of rise extremely well. The peak elevation is approximately 28 mm lower than the gauged data, and the falling limb recedes at a very similar rate to that gauged.

Due to the distance between upstream gauge locations and the upstream extent of the model, the timing of inflow hydrographs involved estimated timing for the three river systems. A much closer match between the modelled and observed 1974 data has been achieved by making the following changes to the inflow hydrograph timings from the Shepparton-Mooroopna Flood Mapping and Flood Intelligence Study:

- Moving the Goulburn River inflows back 6-hours.
- Moving the Broken River inflows forwards 7-Hours.

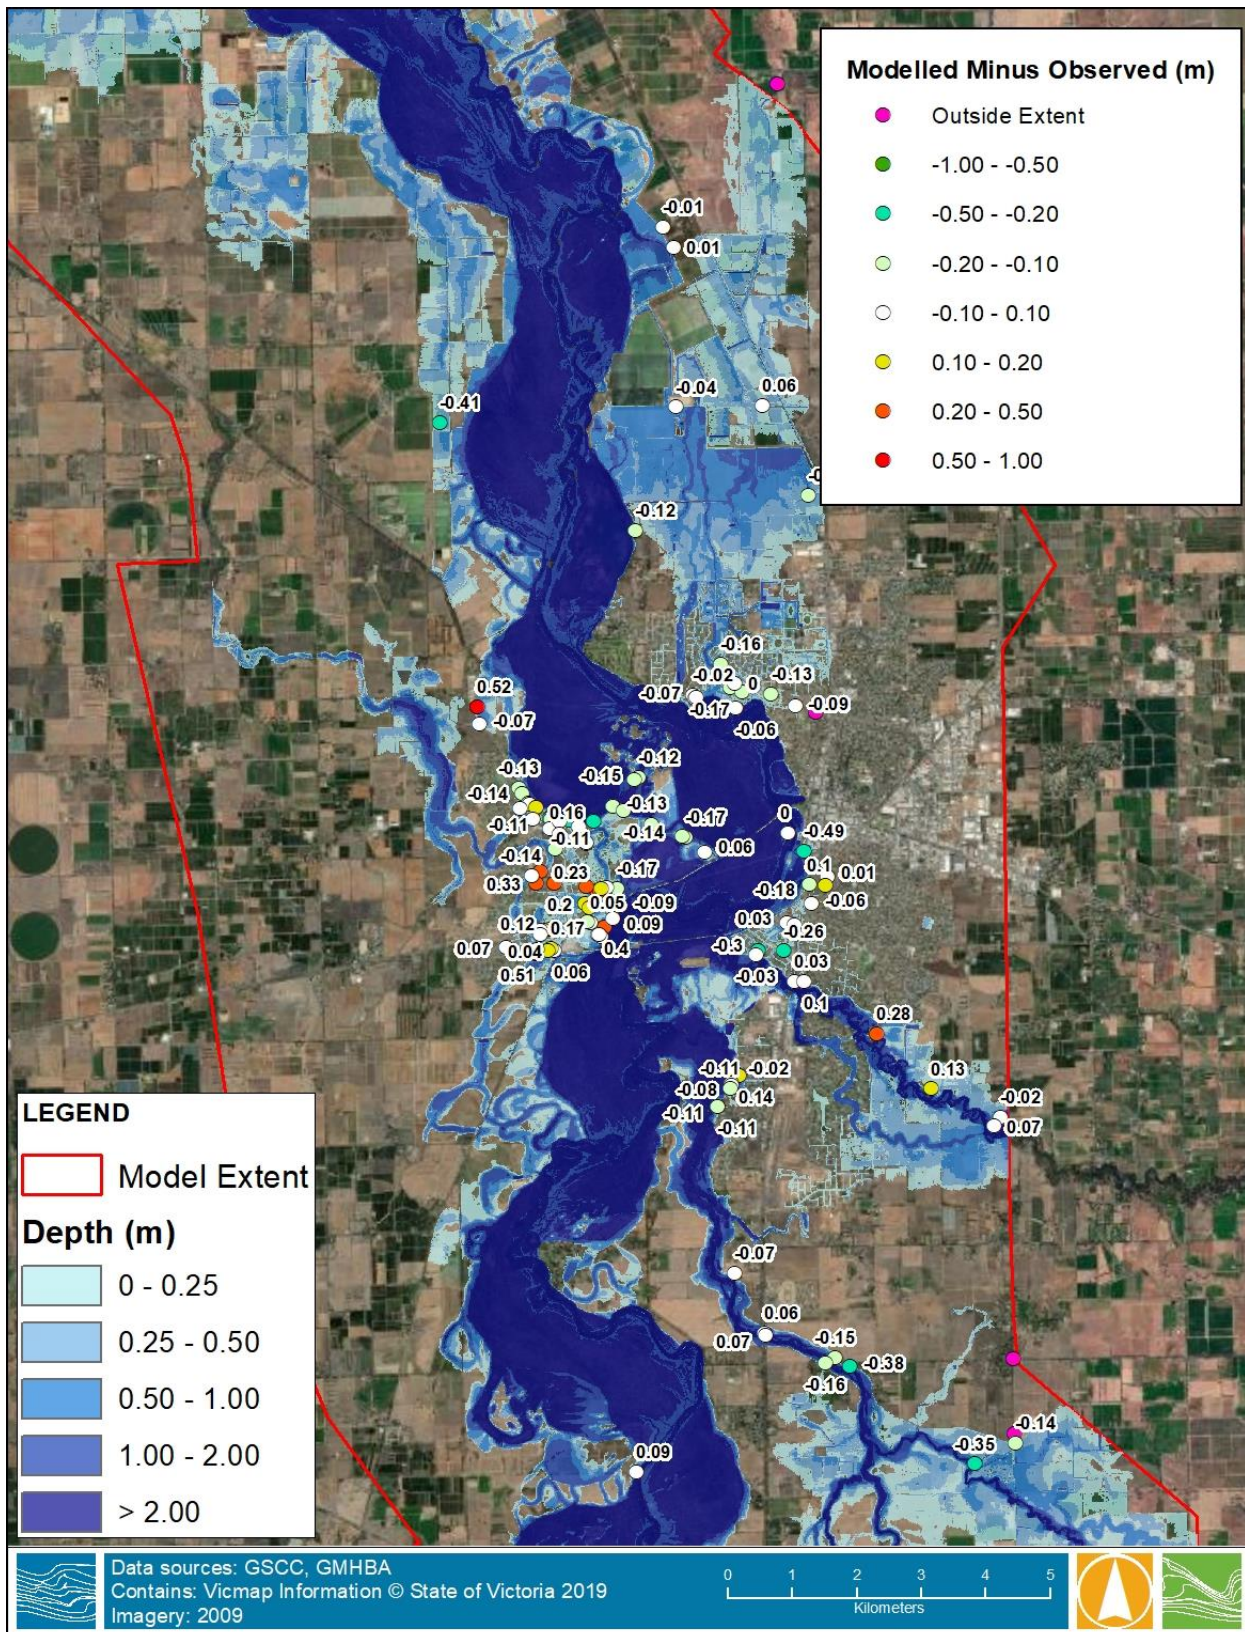
FIGURE 4-8 HYDRAULIC MODEL VALIDATION PLOT – MAY 1974 EVENT

There were 377 flood marks available in the VFD for the May 1974 flood event. A number of these appear to be duplicates and 114 of these points were classified with a reliability of 'Good' or 'High'. Only the surveyed points with this level of reliability were used to validate the hydraulic model, giving confidence to the reliability of the reproduced flood behaviour. Validation plots of the May 1974 flood event are shown in Figure 4-8 and Figure 4-9. Of the 115 survey flood marks used the following comparisons between modelled and observed levels were made:

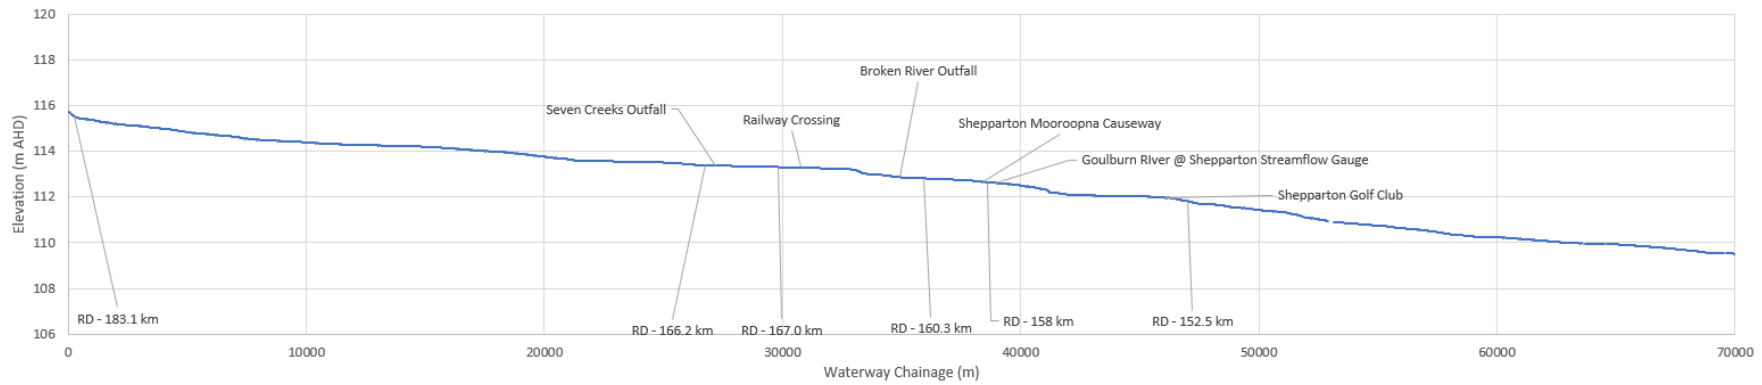
FIGURE 4-10 WATER SURFACE PROFILE – 1974 MODELLED FLOOD EVENT (FROM TOP: BROKEN RIVER, GOULBURN RIVER, SEVEN CREEKS)

Figure 4-10 shows the water surface profiles along the three main waterways for the 1974 flood event. These are plotted with the chainage distance of the waterway along the x – axis and the running distances (provided by the GBCMA) have also been included at key features along the waterways.

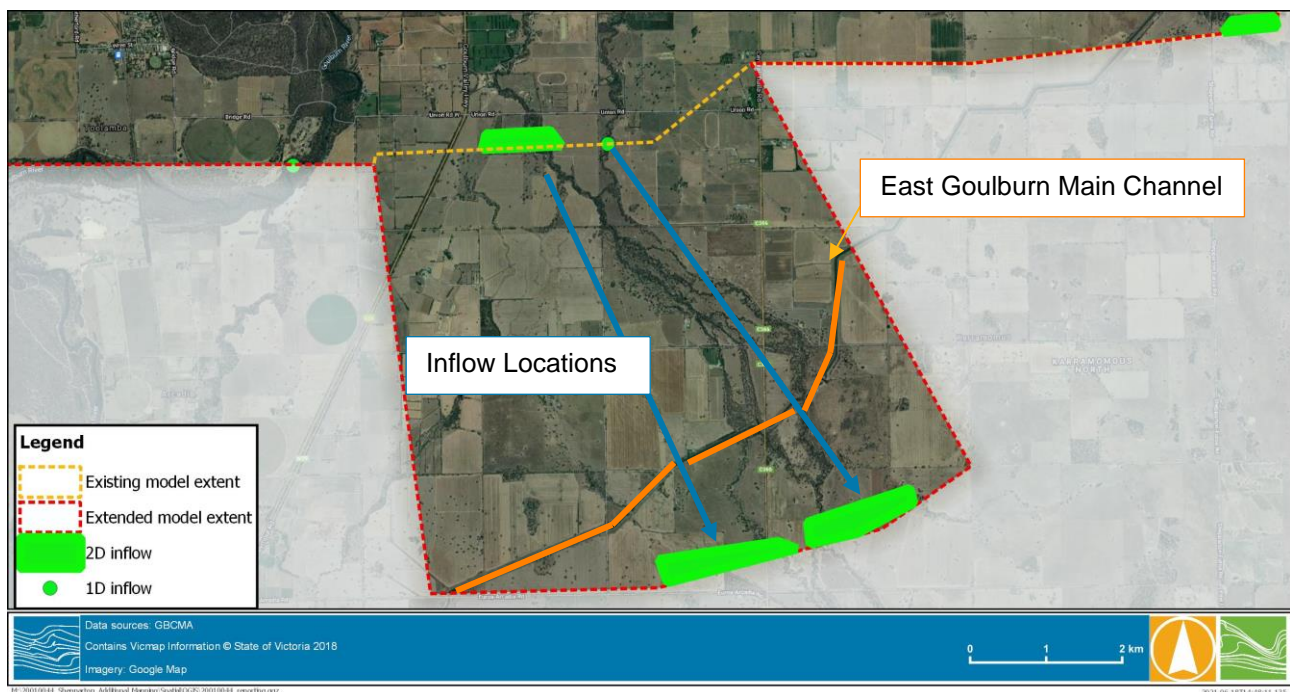
FIGURE 6-1 EXTENDED MODEL BOUNDARY AND INFLOW LOCATIONS AT SEVEN CREEKS

The Flood Frequency Analysis (FFA) undertaken to determine design flow rates at the key gauge locations (Broken River at Orrvale and Seven Creeks at Kialla West) do not take into account the impact of such a hydraulic control, nor does the hydrology modelled as part of the HARC investigation. The FFA undertaken as part of the Shepparton-Mooroopna Flood Mapping and Intelligence Study (2019) showed the 1993 flood event was close to a 1% AEP event on the Broken River and Seven Creeks system which provides a high degree of certainty for flows up to that magnitude. The identification of the impact of the hydraulic control on higher flows suggests that the 0.5% AEP should be placed upstream of the EGMC.

Given the Broken River and Honeysuckle Creek inflow locations are located upstream of the EGMC, the Seven Creeks inflows were also placed upstream for the Climate Change modelling.

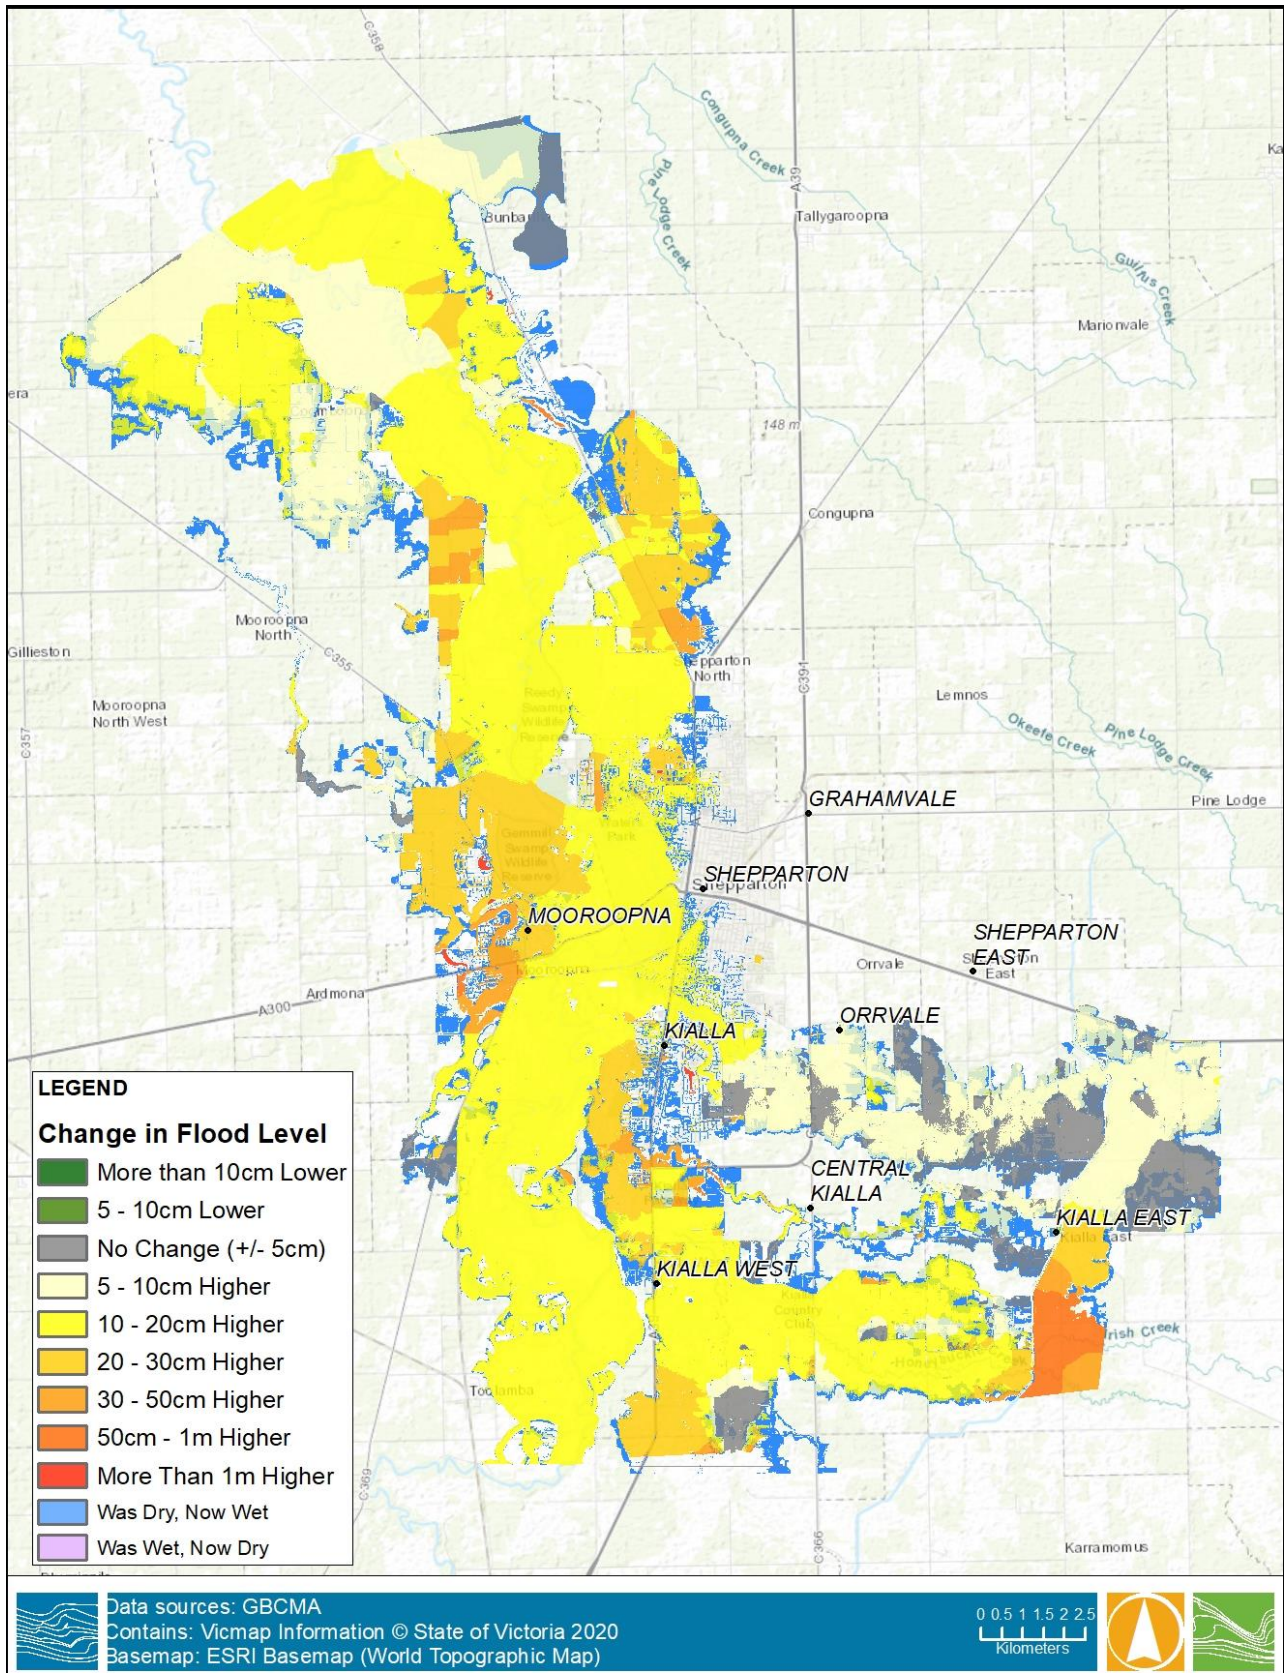
FIGURE 6-2 CLIMATE CHANGE FLOOD LEVELS MINUS 1% AEP FLOOD LEVELS

Changes to the peak flood levels at the three key gauge locations under climate change conditions are summarised in Table 6-3 and Table 6-4. Hydraulic modelling results show a broad increase in peak flood levels across the study area of around 100-150 mm (Figure 6-2) for the combined results (i.e. maximum of Goulburn dominant and Broken/Seven dominant). Higher increases are shown along the Seven Creeks system between the Goulburn River and Goulburn Valley Highway where the floodplain is confined due to irrigation and drainage infrastructure, these areas also have a slight increase in flood extent. Peak flood depths and water surface elevations are shown in Figure 6-3 and Figure 6-4.

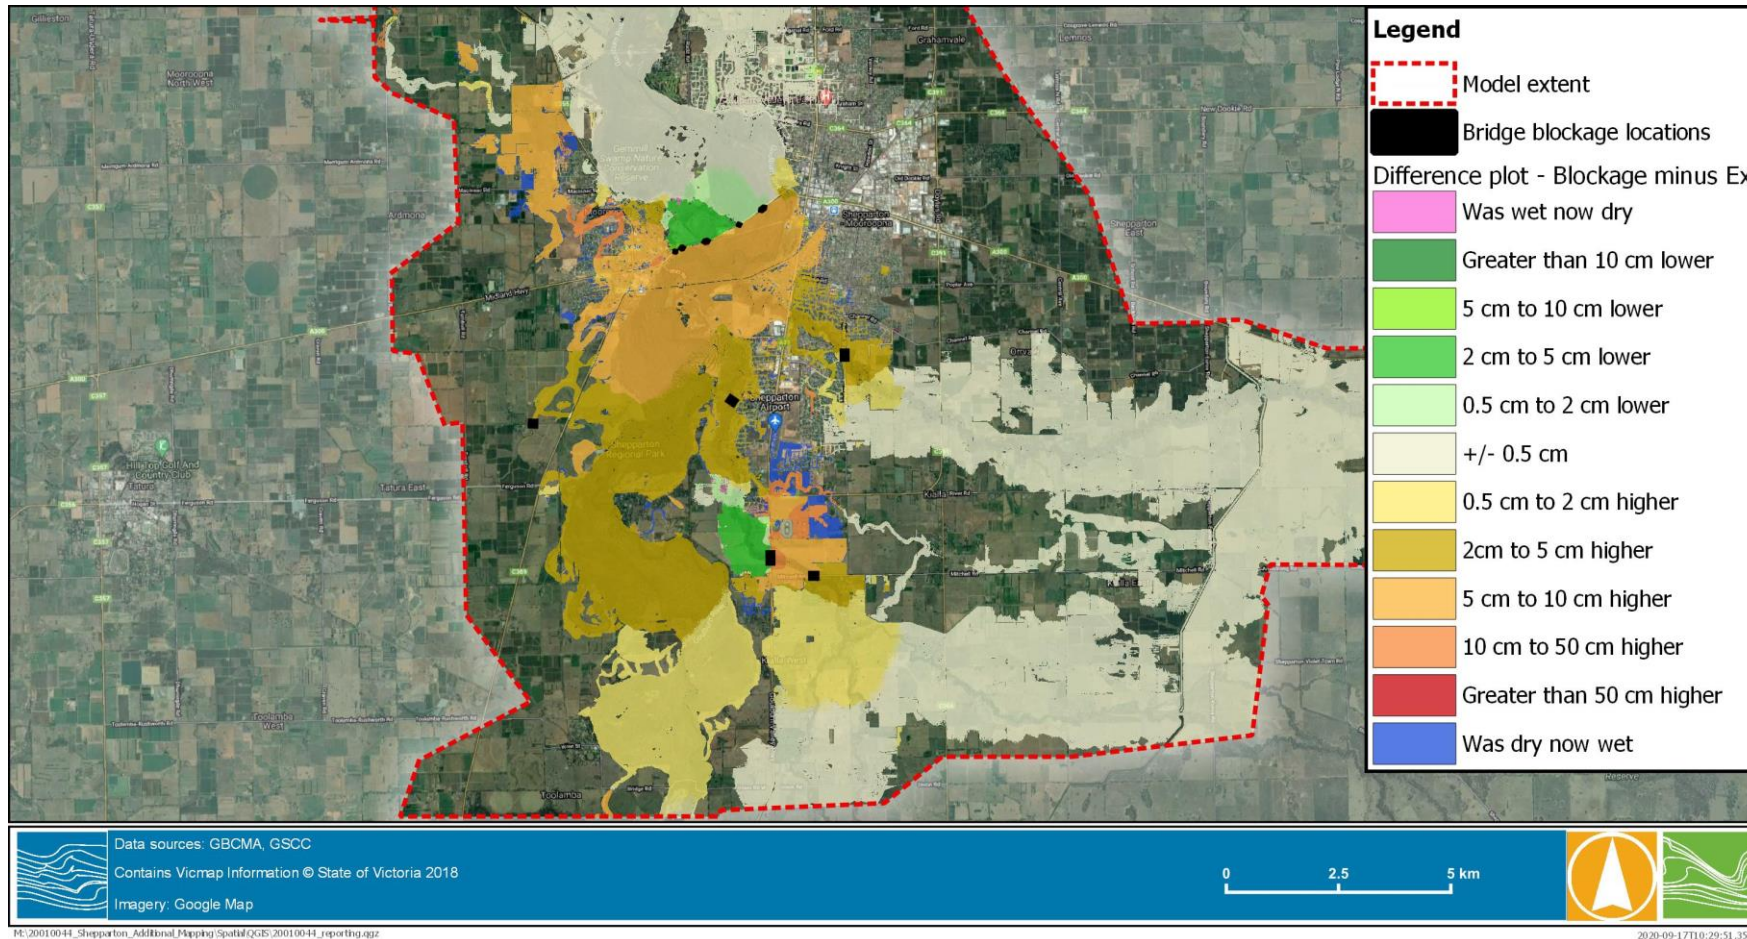
FIGURE 7-1 DIFFERENCE PLOT BRIDGE BLOCKAGE ASSESSMENT 1% AEP BROKEN RIVER

The assessment found several bridges had zero likelihood of blockage due to the factors outlined above. As a conservative approach, bridges openings across the Midland Highway Causeway were tested with 50% blockage to assess the potential flood impact. As a further conservative approach, all bridges listed below were blocked at the same time. To identify the impact of bridge blockages on flood risk, both the 1% AEP Goulburn dominant and 1% AEP Broken River dominant events were simulated with the proposed blockage levels. The maximum flood levels were then compared with existing conditions (0% blockage).

Modelling results found the greatest impact of the blockage in the floodplain was immediately upstream of the structures (as expected). Generally the increase was between 2-5cm with some increases of around 100mm immediately upstream of The Causeway and through parts of the Mooroopna Township. The blockages resulted in two new areas of flood extent (north-west of Mooroopna and South of Kialla Lakes). As mentioned above, this is a relatively conservative assumption based on the cumulative impacts of the ten structures identified being blocked at the same time.

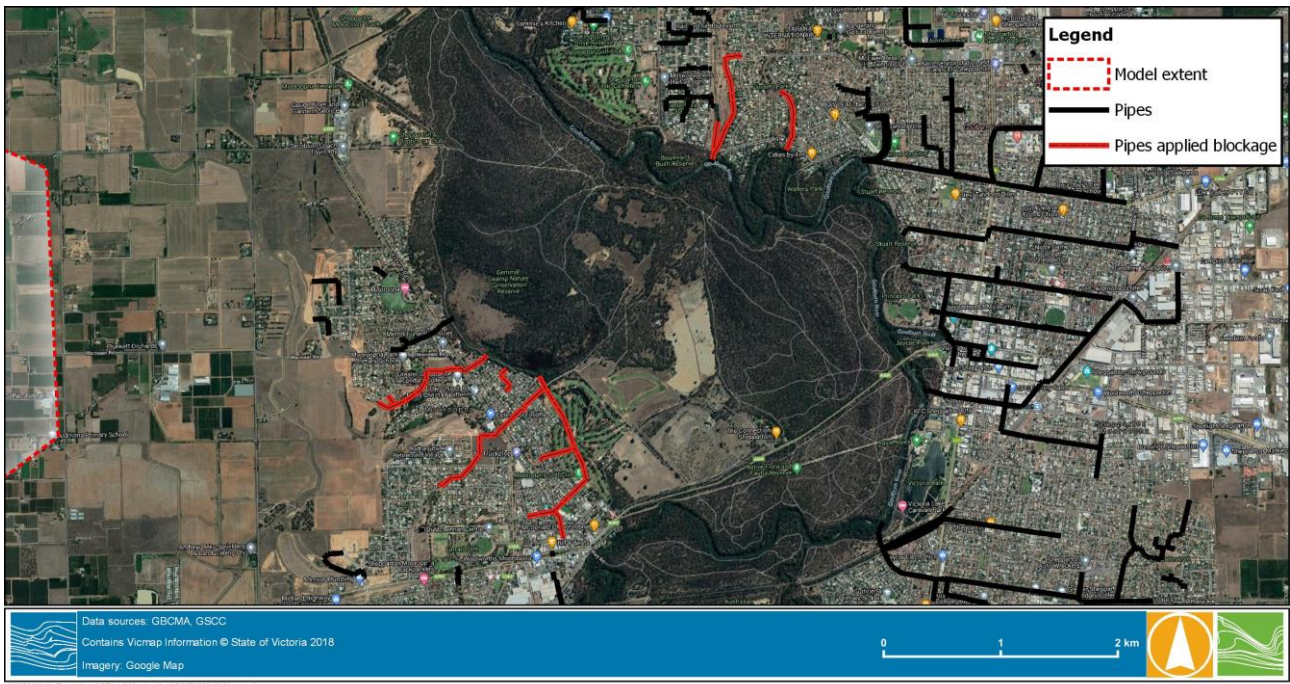
FIGURE 7-3 LOCATIONS OF PIPE BLOCKAGE

A pipe blockage assessment was conducted for several major pipe alignments within the urban areas as shown in Figure 7-3. These pipes were assigned a 100% blockage factor and modelled for a 1% AEP Goulburn River dominant flow. The pipe alignments identified were selected as they provide a connection back to the floodplain from urban areas.

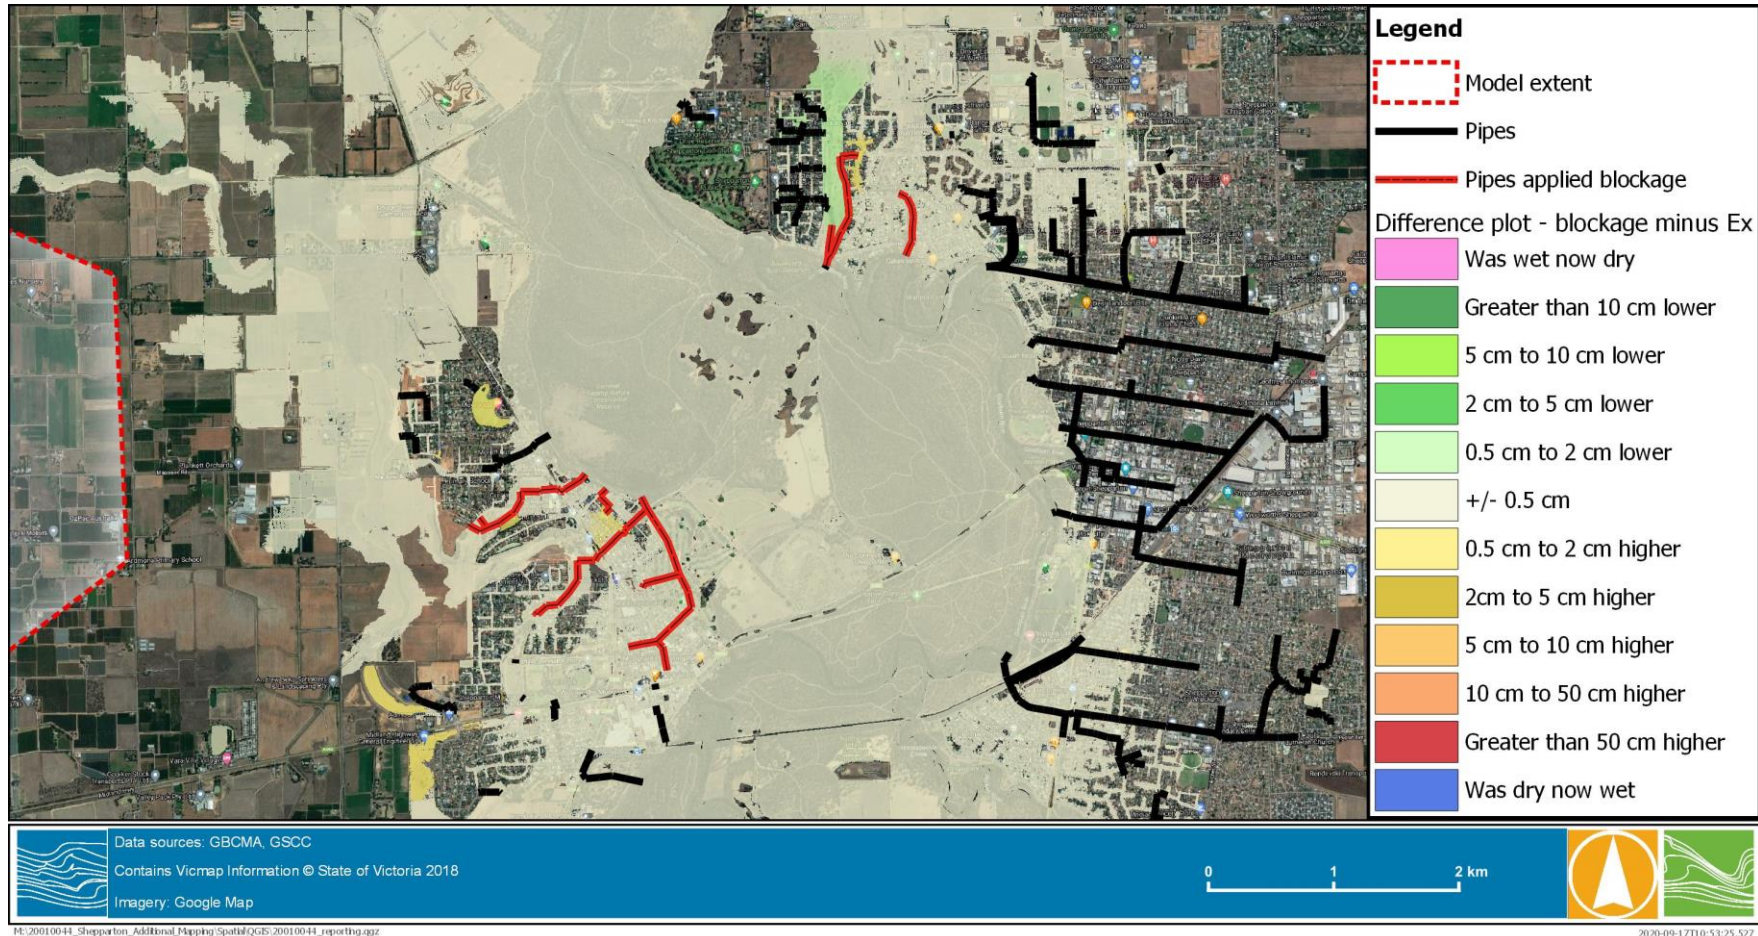
FIGURE 7-4 FLOOD LEVEL DIFFERENCE PLOT (CULVERT BLOCKAGE ASSESSMENT)

Figure 7-4 shows a water level comparison of “blocked” and existing conditions. The comparison shows blockage of these major pipes does not significantly impact peak flood levels. This is a result of the relatively minor capacity of the pipe network in comparison to the overland flow across the floodplain.

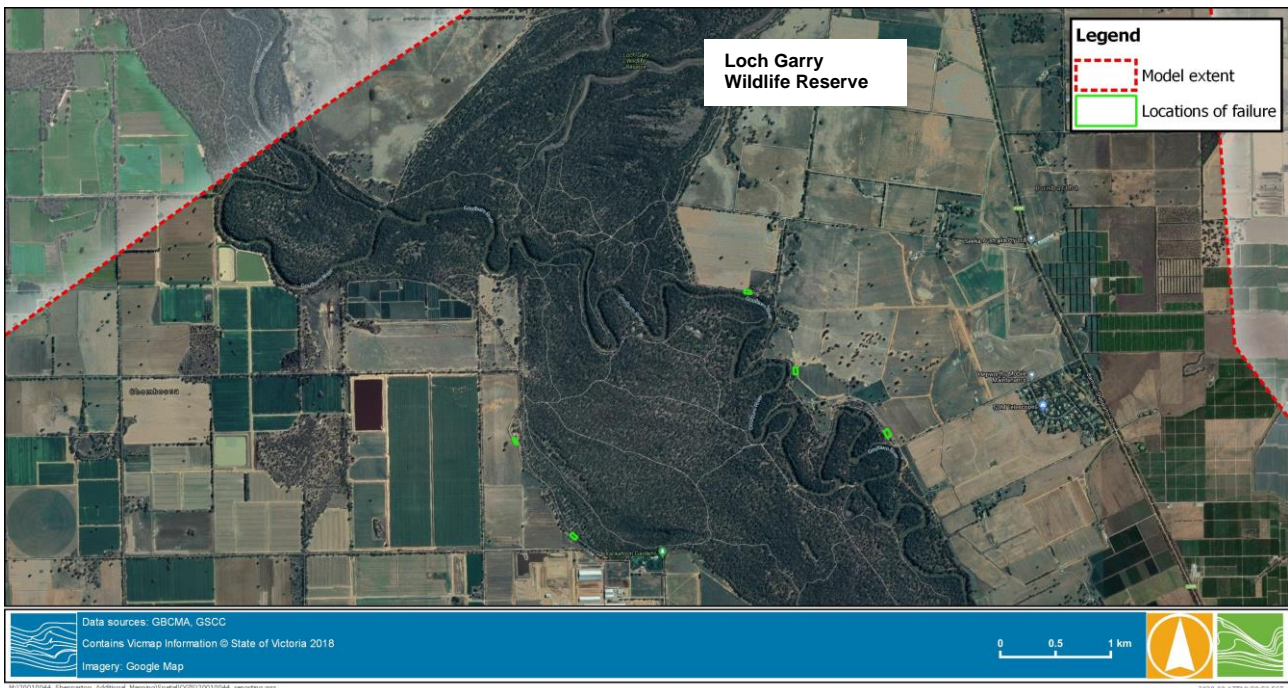
FIGURE 8-1 LOCATIONS OF LEVEE FAILURES

To model the levee failure condition, the levees at these locations were removed from the topography for a distance of approximately 60 metres. An example of the model topography after removing the levee is shown in Figure 8-2.

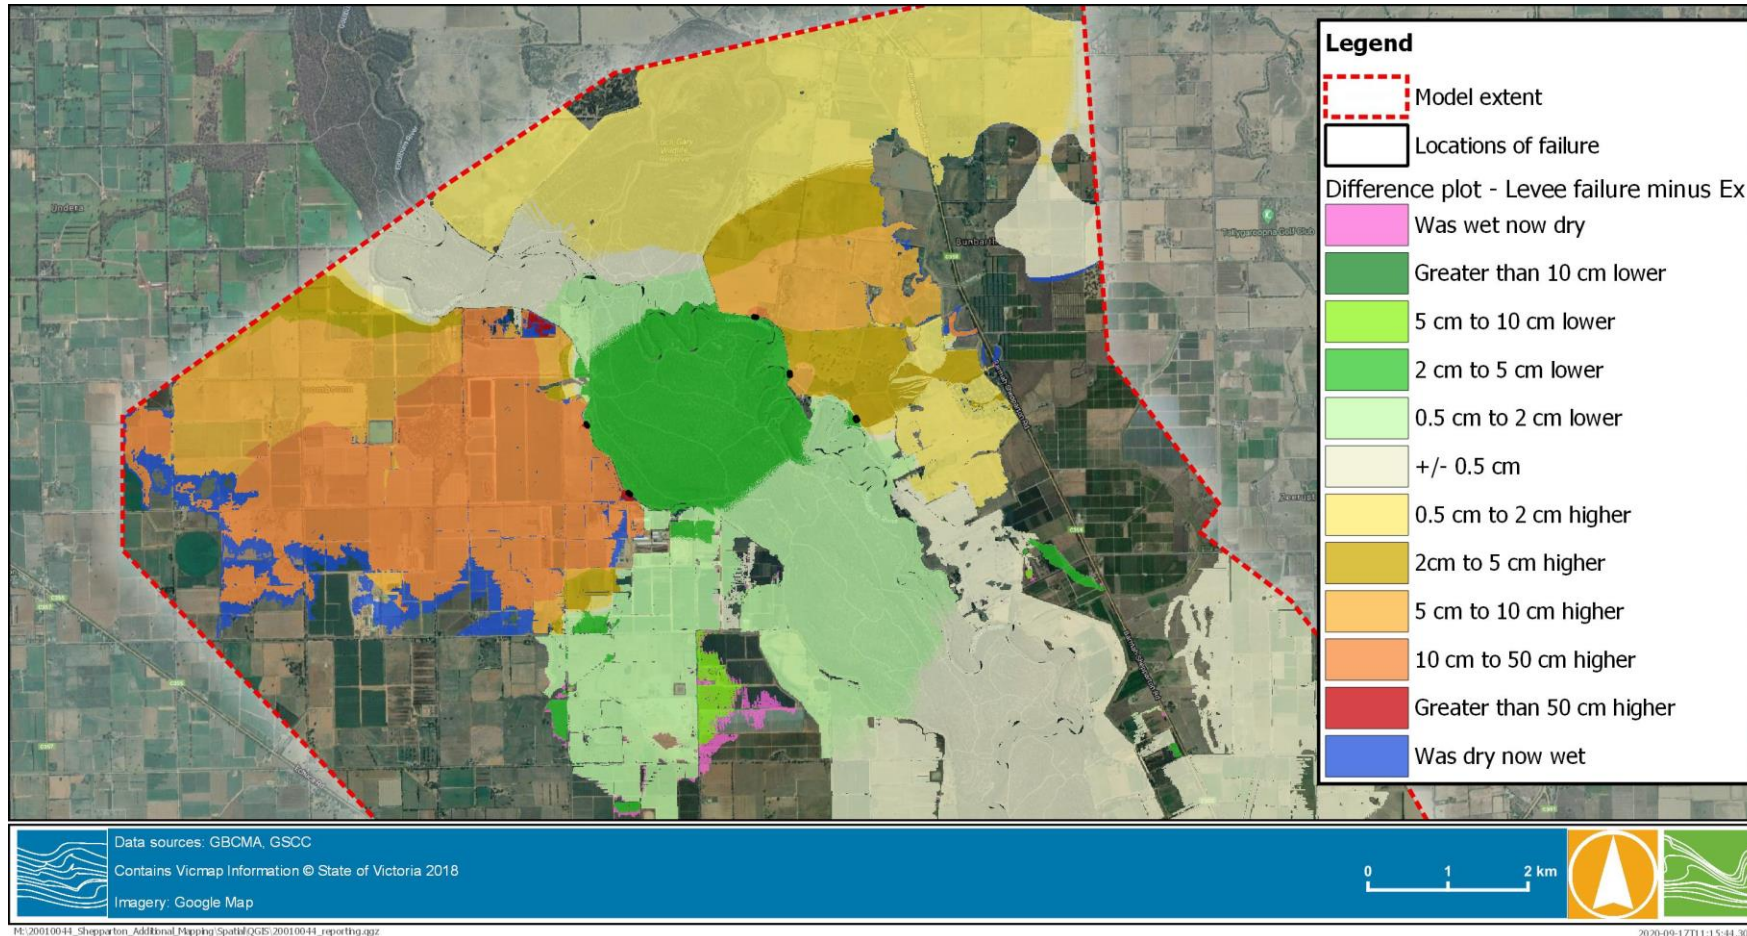
FIGURE 8-3 FLOOD LEVEL DIFFERENCE PLOT – LEVEE FAILURE SCENARIO MODELLING

Figure 8-3 shows a comparison of peak 1% AEP flood levels between the levee failure scenario and existing conditions. A large area of private property has increased in peak flood levels by 20 cm to the west of the Goulburn River while the increase to the east of the Goulburn River side is relatively minor. Results demonstrate the impact of the levee failure at these locations is relatively minor and localised. These levees are overtopped in a 1% AEP event. Levee breaches are likely to show more of a significant impact on flood levels and extents for flood events with flows less than 40,000ML/d.
